NUMBER: 12-236-23

SERVICE BULLETIN

APPLICABILITY: 2018-21MY Crosstrek

SUBJECT: Leather Wrapped Steering Wheel – Design Change

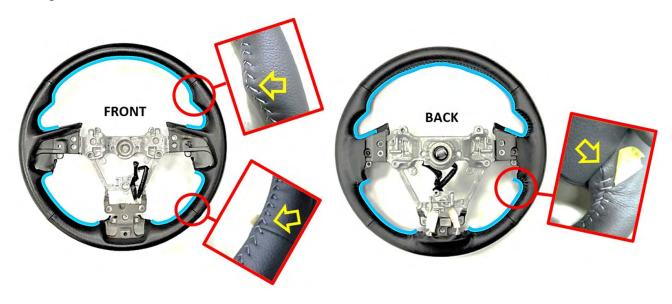
This bulletin announces the design change made to the leather wrapped steering wheels. Refined tailoring and stitching has been applied to the production of the steering wheels to address the small number of cases when a customer may experience an "uncomfortable feel" from the steering wheel caused by loose material or stitching. If this situation is reported, replace the steering wheel with the new part.
