Subarunet Announcement

From: Subaru of America, Inc.

Date: November 10, 2023

New Safety Recall/STOP SALE: WRP-23 Driveshaft Failure

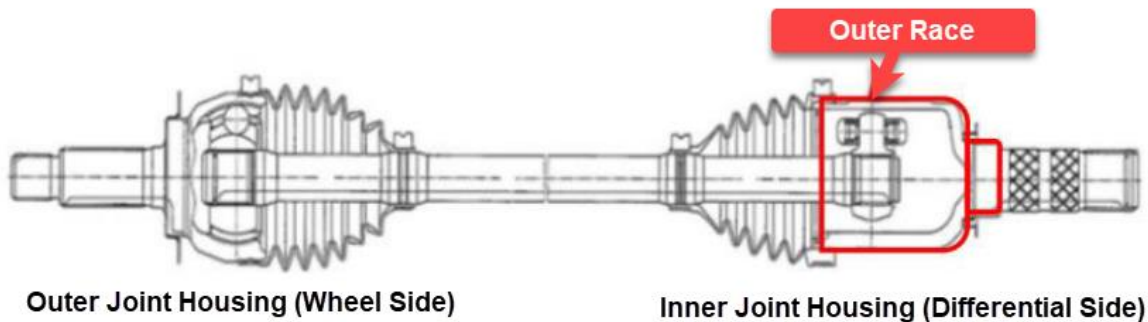
The vehicles included in this recall may be equipped with a front drive shaft assembly with an outer race (shown below) that could crack, due to improper cooling during the manufacturing process.

Over time, a cracked outer race could break, potentially resulting in loss of motive power. Additionally, if the outer race breaks, the vehicle may roll when parked if the parking brake is not applied. Both conditions increase the risk of a crash.

For stop sale vehicles only, Subaru retailers should inspect the front drive shaft lot numbers. If the affected lot number is found, the vehicle is to remain on HOLD under this stop sale until recall remedy parts are available. A future announcement will be made when parts are available.

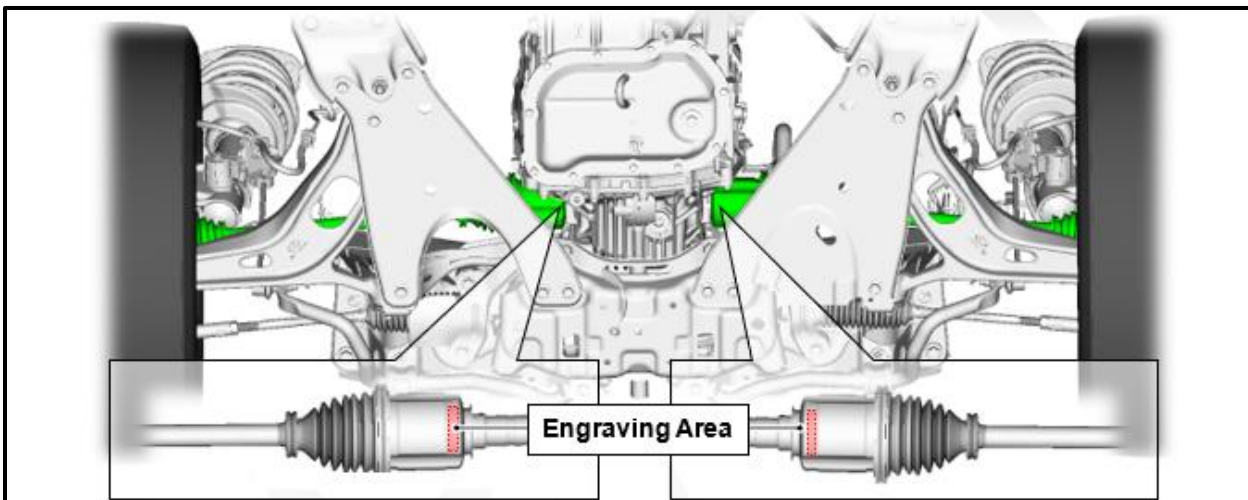
- There are three engravings on the drive shaft outer race. One is the lot number, and the others are NOT lot numbers. The lot number engraving is shown in the images below.
- SLOWLY rotate the wheel to find the lot number. Remove dust and/or dirt using a clean cloth to make the numbers more visible. A flashlight will also aid in the reading.

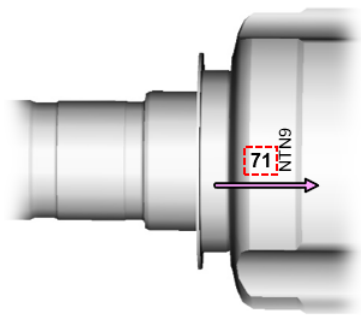
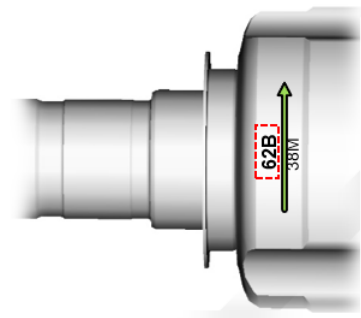
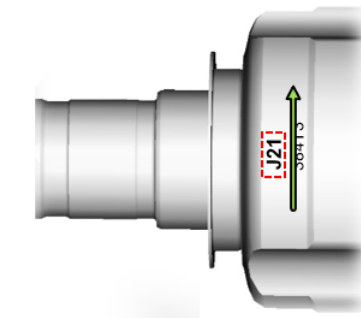
Engraving Type 1	Engraving Type 2	Engraving Type 3
2-digit number is engraved in the axis direction.	3 digit-character starting with a number is engraved in the circumferential direction.	3 digit-character starting with a number is engraved in the circumferential direction.

Results		
Engraving style 1	Refer to the table below for further details.	
Engraving style 2 or 3	The drive shaft is a good part. Record and attach the lot number to the repair order.

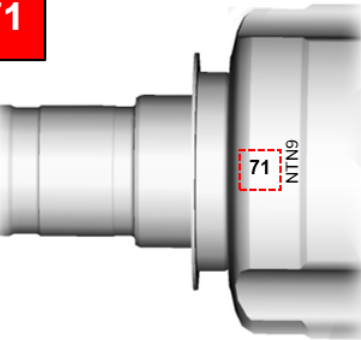
71

Results					
71, 73 or 75		The drive shaft is a defective part. The vehicle is to be placed on HOLD under Stop Sale until further notice.			
Other 2-digit numbers		The drive shaft is a good part. Record and attach the lot number to the repair order.

YES: The vehicle should remain on HOLD under Stop Sale until remedy parts are available. No claim should be submitted until the affected driveshaft(s) are replaced.
