## SERVICE BULLETIN

**APPLICABILITY:** 2020-22MY Legacy and Outback Models

**NUMBER:** 15-261-20R

**SUBJECT:** Reprogramming File Availability for Optimization  
 of Gen 4 Denso CP1 Infotainment Systems

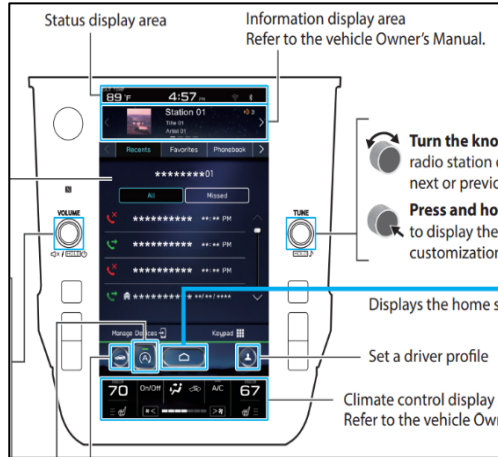
| Number | Symptoms to be Improved: |
|---|---|
| 5 | <p>The Information Display Area at the top of the CID screen displays a different information screen from the last time.</p> <p>The diagram shows the CID screen interface with the following labels and descriptions:</p> <ul style="list-style-type: none"> <li><b>Status display area:</b> Points to the top status bar showing time (4:57) and battery level (89%).</li> <li><b>Information display area:</b> Points to the main content area, with a note: "Refer to the vehicle Owner's Manual."</li> <li><b>Turn the knob:</b> Points to the volume knob, with a note: "radio station or next or previous."</li> <li><b>Press and hold:</b> Points to the touch screen, with a note: "to display the customization."</li> <li><b>Displays the home screen:</b> Points to the home screen icon at the bottom.</li> <li><b>Set a driver profile:</b> Points to the driver profile icon at the bottom.</li> <li><b>Climate control display area:</b> Points to the climate control area at the bottom, with a note: "Refer to the vehicle Owner's Manual."</li> </ul> |

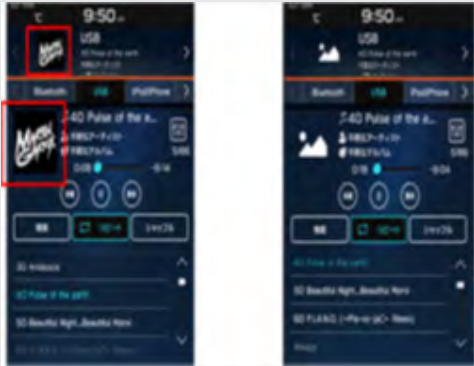
| Number | Symptoms to be Improved: |
|---|---|
| 18 | <p>Cover art of previous music is displayed when playing music without cover art in USB audio. It can occur when music with and without cover art is mixed and stored together a single USB.</p> |

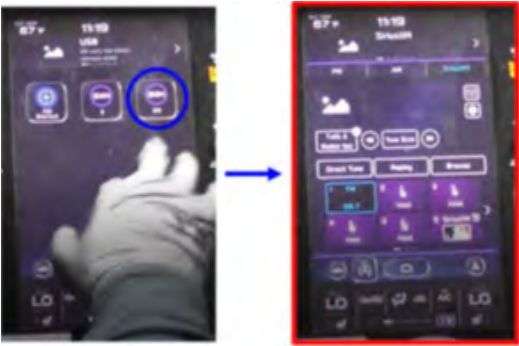
| Number | Symptoms to be Improved: |
|---|---|
| 23 | <p>When selecting shortcut for SXM channel on “Home” screen, the screen is changed to SXM but no sound is coming or no channel name is displayed.</p> |

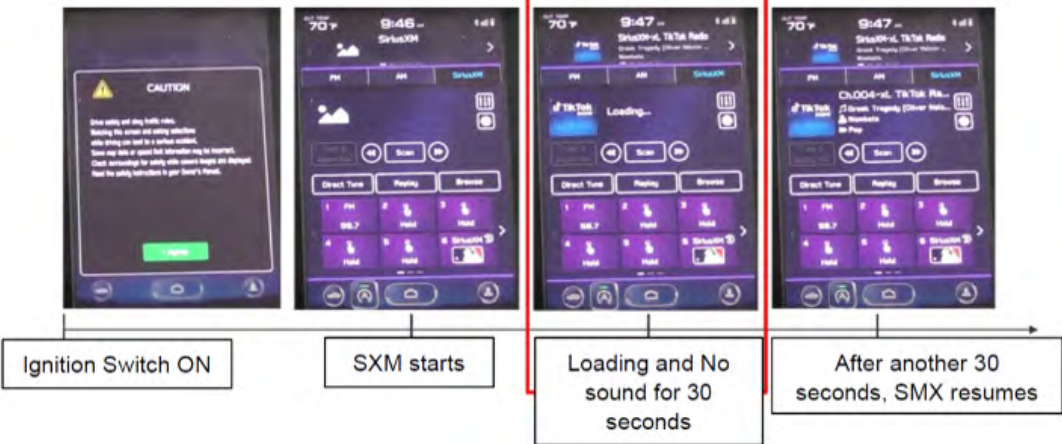
| Number | Symptoms to be Improved: |
|---|---|
| 27 | <p>About 30 seconds after starting the SXM the operation is paused with loading screen and resume after another 30 seconds. This symptom occurs when the SXM screen had been selected as audio source at the previous ignition off timing.</p> |

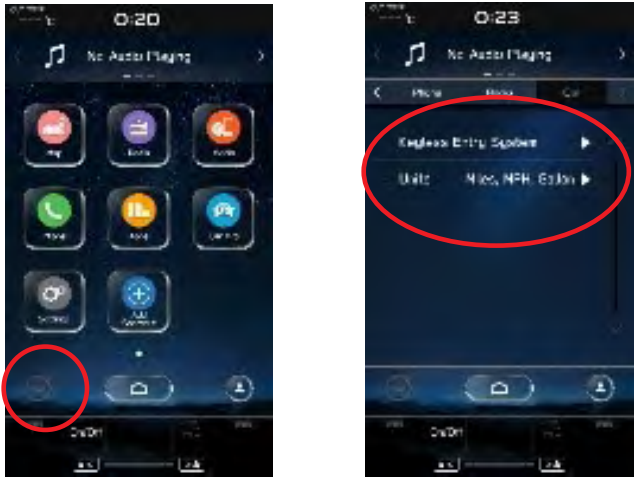
| Number | Symptoms to be Improved: |
|---|---|
| 4 | <p>Vehicle Setting Icon in &lt;Home&gt; menu is grayed out.<br/>Menu list in the “Car” tab in the Setting Menu is not displayed.</p> <div data-bbox="589 237 1218 711"> </div> |

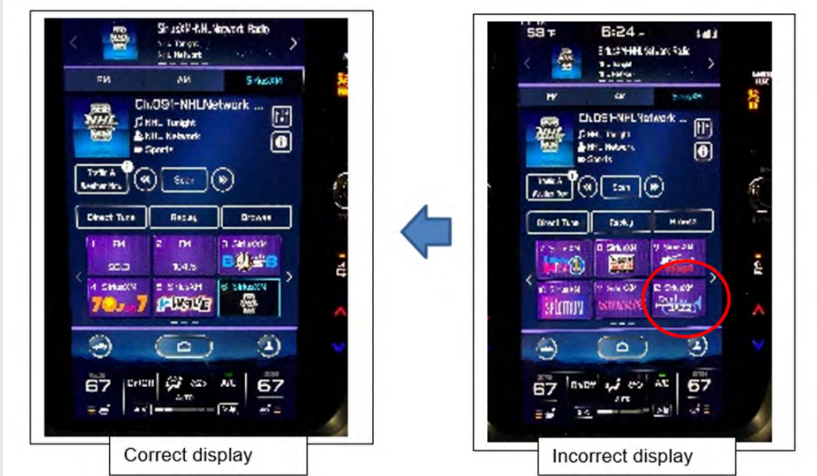
| Number | Symptoms to be Improved: |
|---|---|
| 29 | Preset outline is not shown following station selection using steering switch <div style="display: flex; justify-content: space-around; align-items: center;"> </div> |

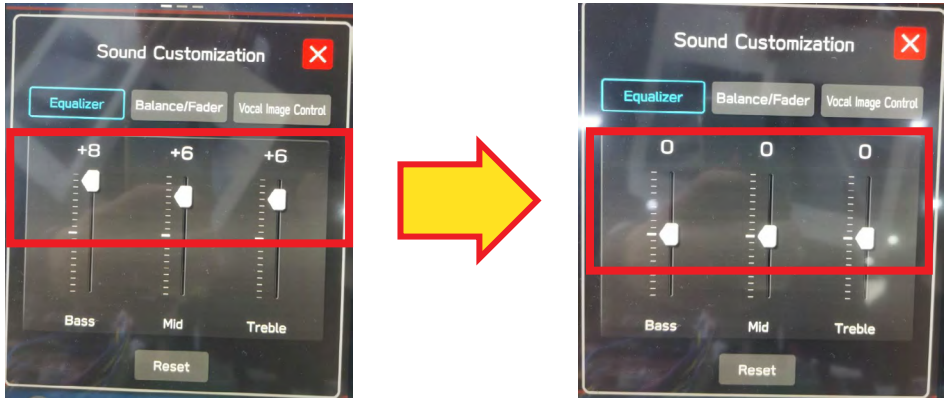
| Symptom # | Description of Symptom: |
|---|---|
| 7 | Customer-selected Equalizer settings are lost. Equalizer returns to the default settings after ignition switch is turned OFF and back ON.<br><br> |

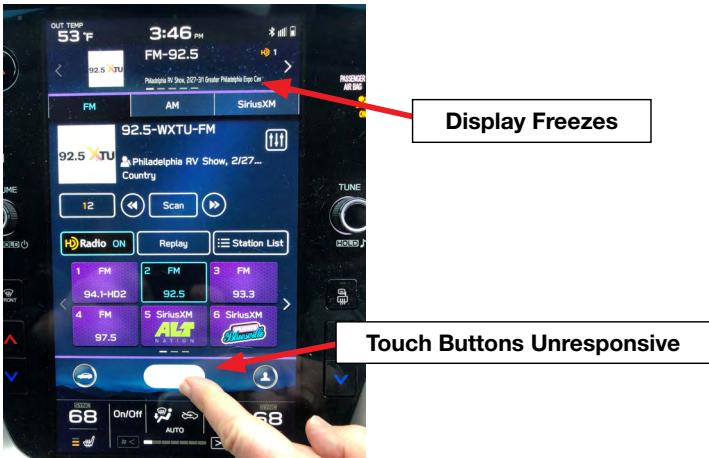
| Symptom # | Description of Symptom: |
|---|---|
| 1 | <p>The CP1 display and/or center Combination Meter display freezes. No response from touch screen or voice guidance. After switching the ignition off and opening the driver's door, the system does not recover**.</p> <p><b>**NOTE:</b> After switching the ignition off and leaving the driver's door open more than 70 seconds, the system <i>may</i> recover after switching the ignition back on.</p> |

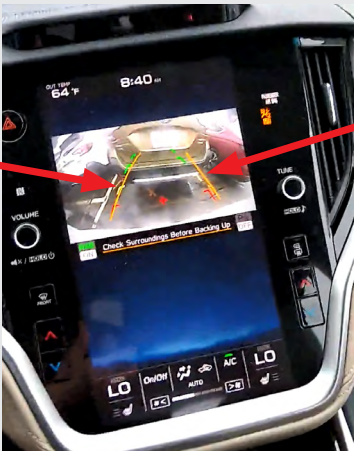
| Symptom # | Description of Symptom: |
|---|---|
| 2 | <p>Delayed response of rear view camera guide lines.<br/>When the rear view camera is activated and the steering wheel is turned, there is a delay before the steering-responsive guide lines respond to the steering wheel input.</p> <p>The image shows a vehicle's infotainment screen displaying the rear view camera feed. Two red arrows point to the yellow and green guide lines, which appear slightly misaligned or delayed in response to the steering wheel input. The screen also shows a temperature of 64°F, a time of 8:40 AM, and a warning message 'Check Surroundings Before Backing Up'.</p> |

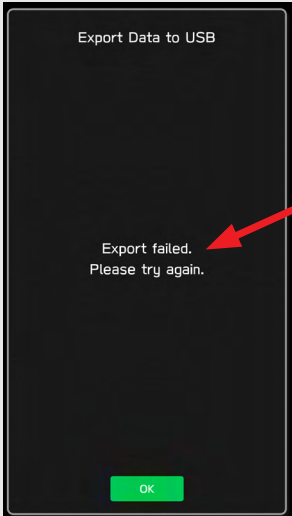
| Symptom # | Description of Symptom: |
|---|---|
| 4 | <p>Diagnostics Recorder Data cannot be exported to the USB memory device. When the diagnostic log data is being downloaded (by selecting: Dealership Menu &gt; Diagnostics Recorder &gt; Export Data to USB), it fails after the progress bar reaches almost 90% with an error message of Export failed. Please try again.</p> <p>The image shows a screen titled 'Export Data to USB'. It displays a progress bar that is nearly full, followed by the message 'Export failed. Please try again.' and an 'OK' button. A red arrow points from a text box to the failure message.</p> <div data-bbox="688 1335 1154 1388" style="border: 1px solid black; padding: 5px; display: inline-block;"> <b>Export Failed. Please Try Again.</b> </div> |
