SERVICE PROGRAM BULLETIN

APPLICABILITY: 2020-2021MY Legacy and Outback **NUMBER:** WRI-20R
SUBJECT: Reprogramming of Denso CP1 Infotainment Units to Optimize System Performance **DATE:** 12/11/20
REVISED: 11/13/23

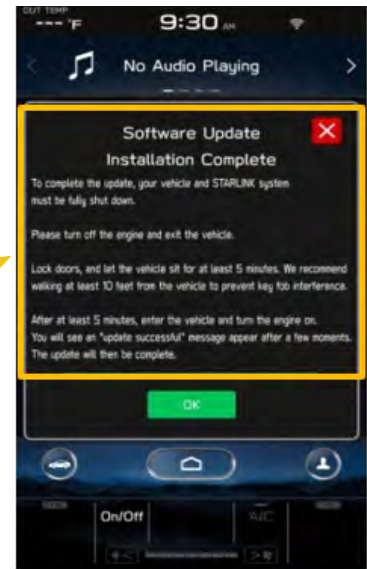
- Clarification of the post-FOTA procedure instructions required to complete the update. The screenshot below will appear and explain what must be done to complete the update installation.

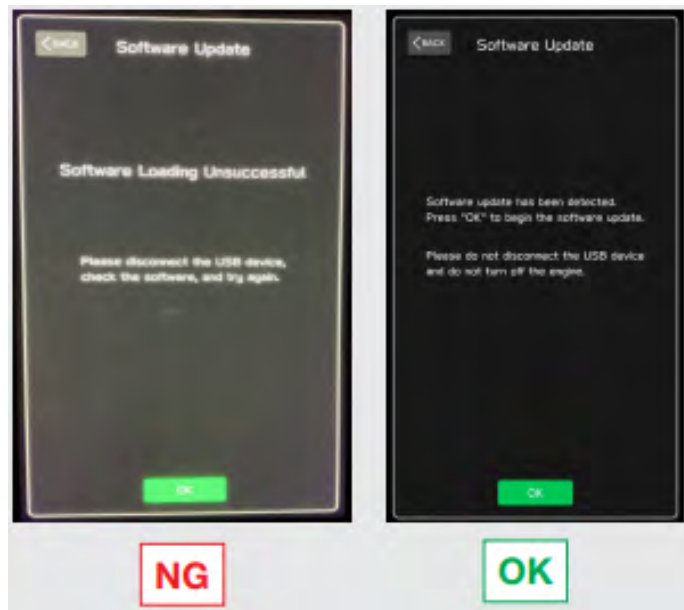
NOTE: If after plugging in the USB, the screen displays a Software Loading Unsuccessful message, confirm the USB device has been properly formatted and the software on the device matches the H/U being reprogrammed (example: **MID** software is being used to update a **MID** H/U).

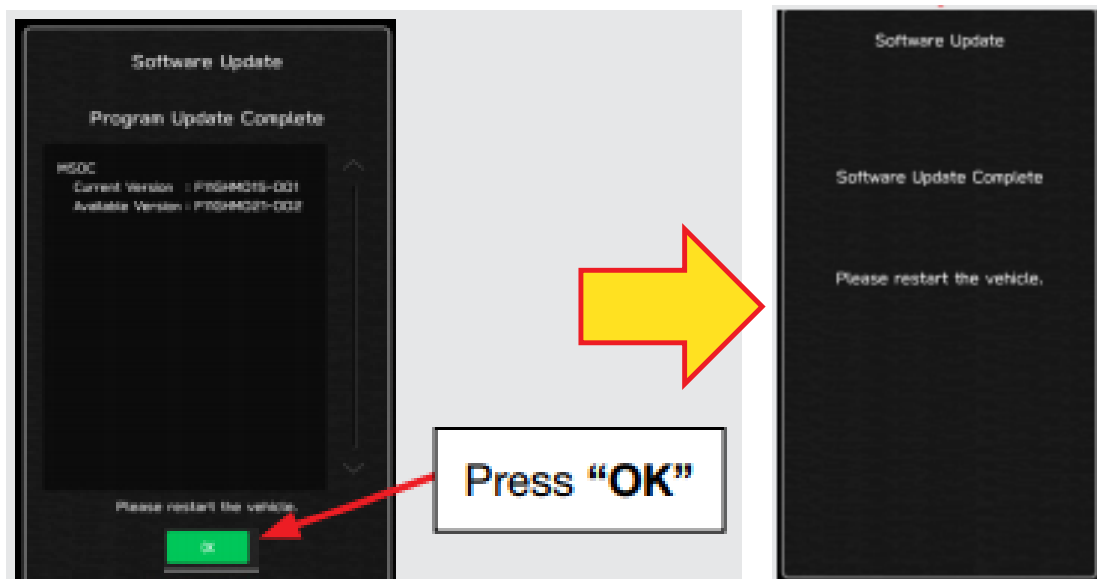
IMPORTANT NOTE: On rare occasions a “Software Update Incomplete” message may appear in this step which occurs due to a bug in the software update procedure. DO NOT attempt to install the update again, proceed to **5i)** below to confirm the software version has been updated to the latest version.

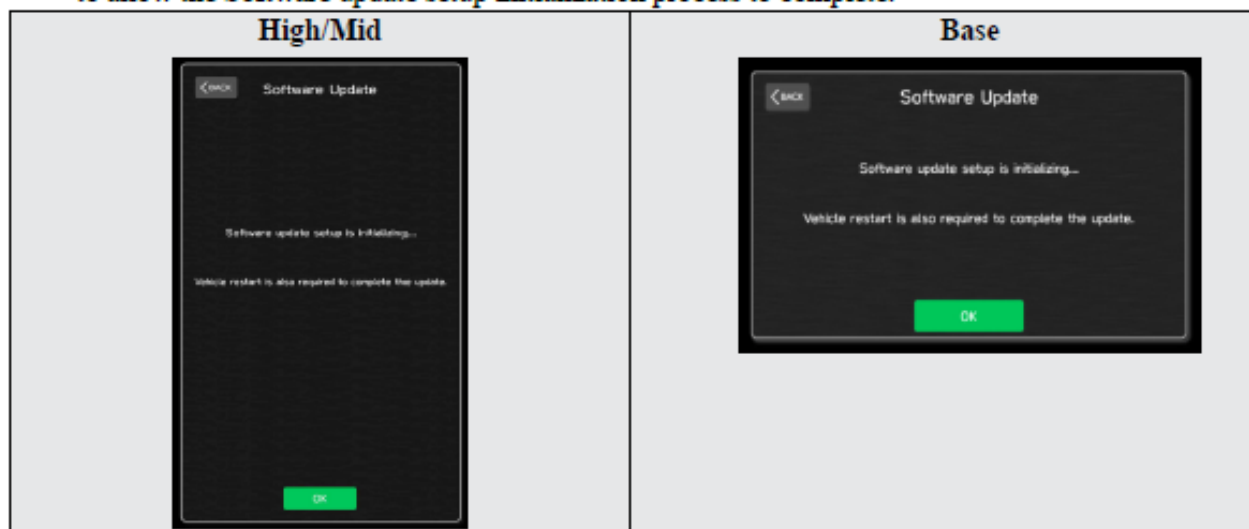
Follow this procedure in the RARE case of “Software update setup is initializing...” message is displayed:

- If the screen shown below appears, **WAIT** for approximately **30** minutes or as long as necessary to allow the Software update setup initialization process to complete.

1. Turn the ignition OFF, open the driver's door, close the driver's door and **WAIT** for 3 or more minutes before proceeding further.
2. Open the driver's door again and either turn the ignition ON (if a charger is connected) or start the engine.
3. Go to Dealership Mode menu again (PRESS and HOLD the RIGHT-side temperature control buttons (both up and down) and press the Tune / Scroll knob 6 times then release all to display the Dealership Mode) and select Software Update as in STEP 3 beginning on pg. 8.

IMPORTANT NOTE: If this procedure is required, contact Techline as additional action may be necessary.
