PRODUCT CAMPAIGN BULLETIN

APPLICABILITY: 2020MY Legacy and Outback **NUMBER:** WRH-20R
SUBJECT: Rear Visibility FMVSS 111 Non-Compliance **DATE:** 12/11/20
REVISED: 11/13/23
NHTSA ID: 20V-766

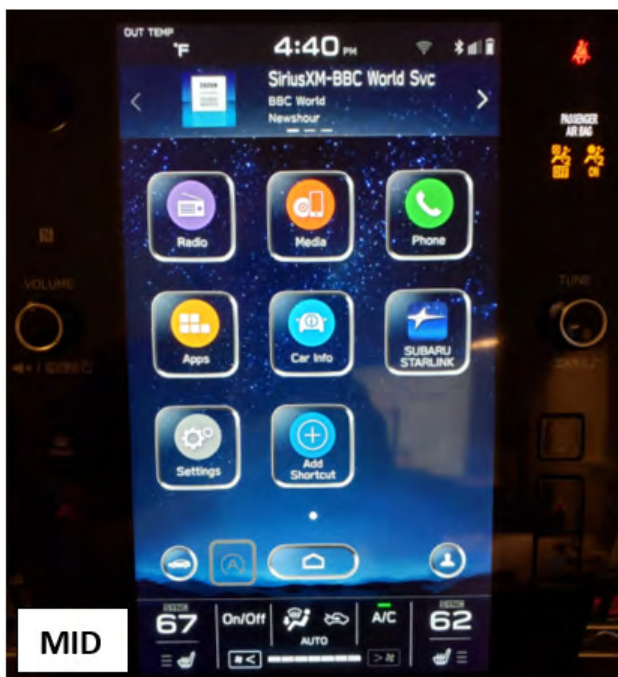
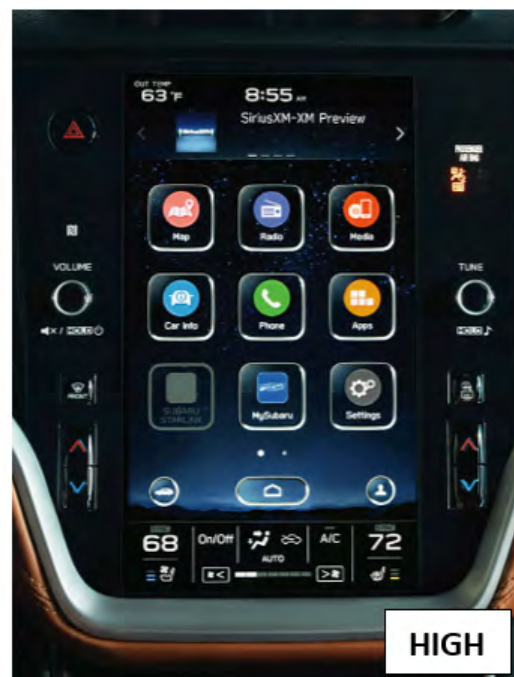
This Campaign affects certain “Mid” and “High” (w/ Navigation) -level CP1 Head Units with 11.6-inch display ONLY as pictured below. The “Base” model (2- 7.0-inch display screen unit) is NOT affected.

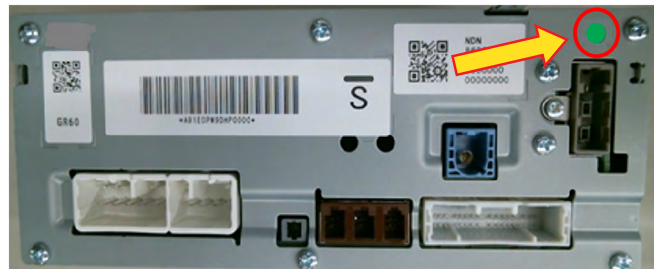
STEP 2a: When receiving the exchange CCM, inspect the back of the module for a GREEN dot as shown here. This **GREEN** dot signifies the module has already been updated with the latest Version 4.0 software. **NOTE:** All related CCMs shipped to retailers after 12/3/2020 have this dot. The **GREEN** dot will be applied to related exchange modules for six months. After that time, the dot will be discontinued but the modules will be OK for use. Proceed with CCM R&R following the procedure in the applicable Service Manual.

- Always record the serial number of the exchange CCM being installed on the Repair Order (RO).
- Confirm and record the software version number installed in the exchange CCM on the RO. See **STEP 3** for instructions.
- After CCM replacement, ALWAYS confirm proper back-up camera operation before releasing the vehicle.

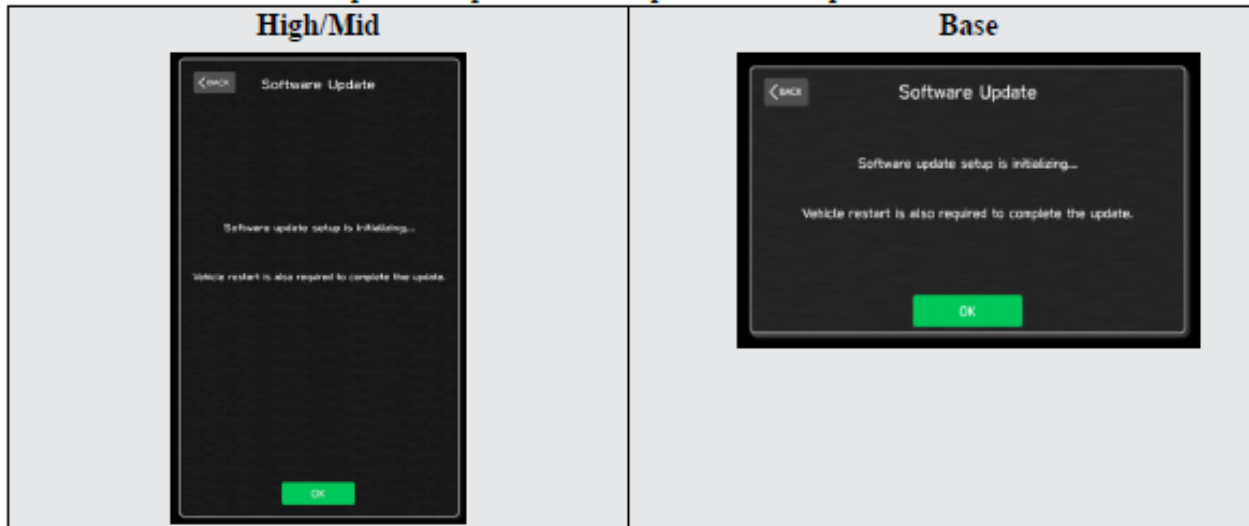
- If the screen shown below appears, **WAIT** for approximately **30** minutes or as long as necessary to allow the Software update setup initialization process to complete.

1. Turn the ignition OFF, open the driver's door, close the driver's door and **WAIT** for 3 or more minutes before proceeding further.
2. Open the driver's door again and either turn the ignition ON (if a charger is connected) or start the engine.
3. Go to Dealership Mode menu again (PRESS and HOLD the RIGHT-side temperature control buttons (both up and down) and press the Tune / Scroll knob 6 times then release all to display the Dealership Mode) and select Software Update as in STEP 3 beginning on pg. 8.
