**SERVICE BULLETIN**

**APPLICABILITY:** 2017-18MY Impreza  
 2018MY Crosstrek  
 2018MY Legacy and Outback  
 2018MY BRZ\*

**NUMBER:** 15-211-17R  
**DATE:** 06/13/17  
**REVISED:** 11/13/23

**SUBJECT:** Reprogramming File Availability for Additional Optimization of Harman Gen 3 Audio and Navigation Head Units

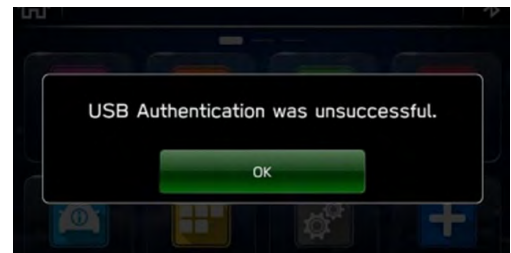
**CAUTION: NEVER** attempt to install this software on any 2019 MY vehicles as they are equipped with Gen 3.1 Audio/ Navigation systems. This update is **ONLY** for models equipped with Gen 3.0 Audio/ Navigation systems. Should an attempt be made to install any of these files into a Gen 3.1 head unit, the authentication error screen to the right will be displayed.

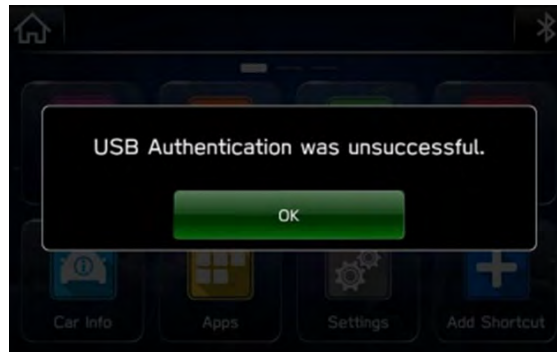
**NOTE:** If an attempt is made to install the wrong “grade” file into the wrong grade head unit (EXAMPLE: “Base” update file into a “Mid” or “High” head unit), the USB Authentication error screen below will be displayed:

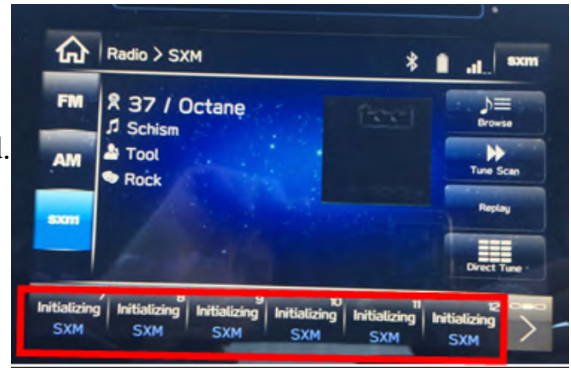
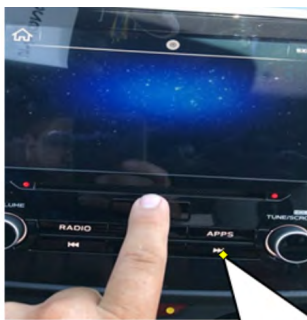
**Background shown, but no icons**

- On 2018MY Legacy / Outback models with Navigation (High) head units, the update corrects a condition where the head unit remains powered even after the ignition is OFF and the driver door is opened.
- Update for a condition where the SXM presets become lost and only “Initializing” appears as shown below.
- Update for condition where only the star field background is displayed (without icons) after the HOME button is pressed.

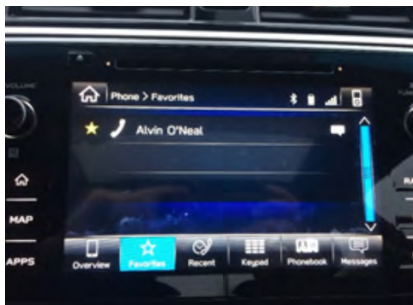
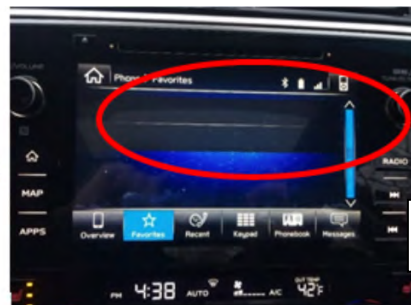
**List is blank**

- Update for a “Pop” or “Crackling“ sound concern when listening to AM radio.
- Update for a concern of the head unit continually resetting itself.
- Update for a concern of after selecting a contact to be a “Favorite” and the “Favorite” list display is blank.

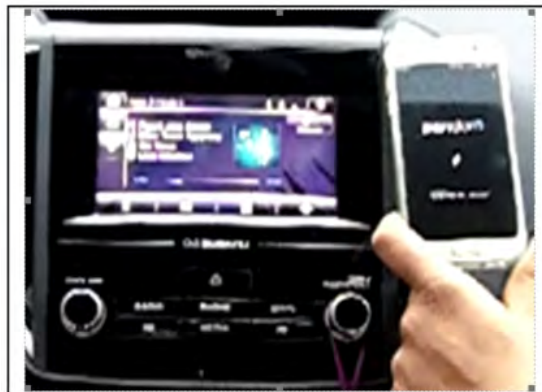
- 1- No streaming audio; when using the Pandora® app, there is no audio output.

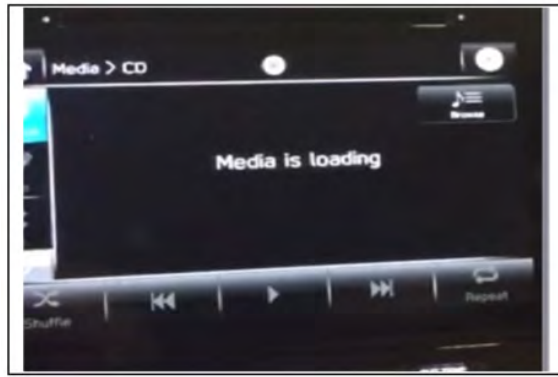
- 2- “Media is loading” is displayed on the screen but, the media never completes loading.

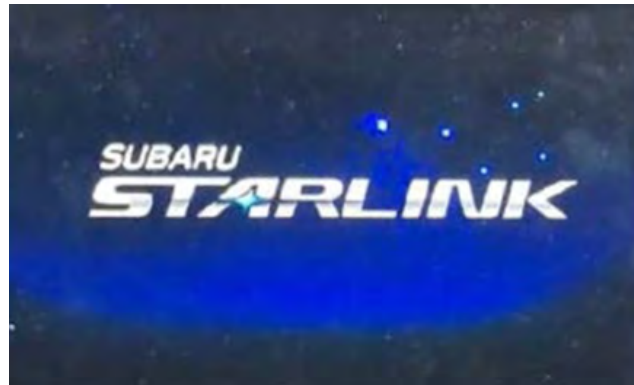
- 3- The screen freezes when the STARLINK screen is displayed.

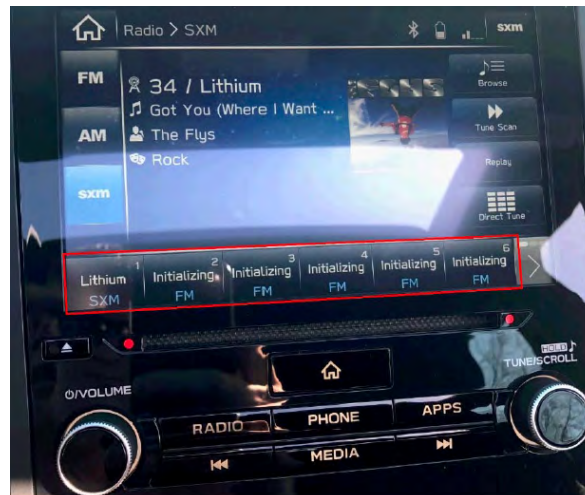
- 1- Radio station presets disappear (touch screen buttons return to “Initializing”).

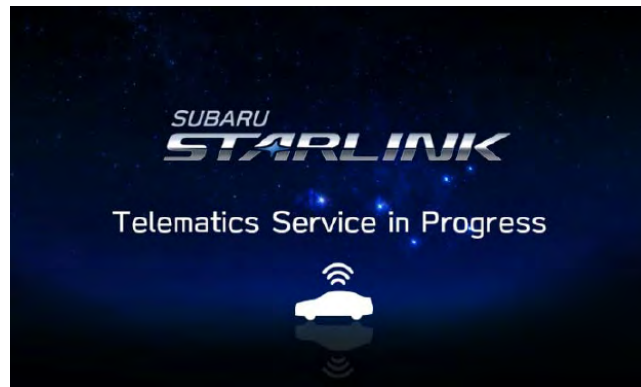
- 2- STARLINK “Telematics Service in Progress” screen freezes.

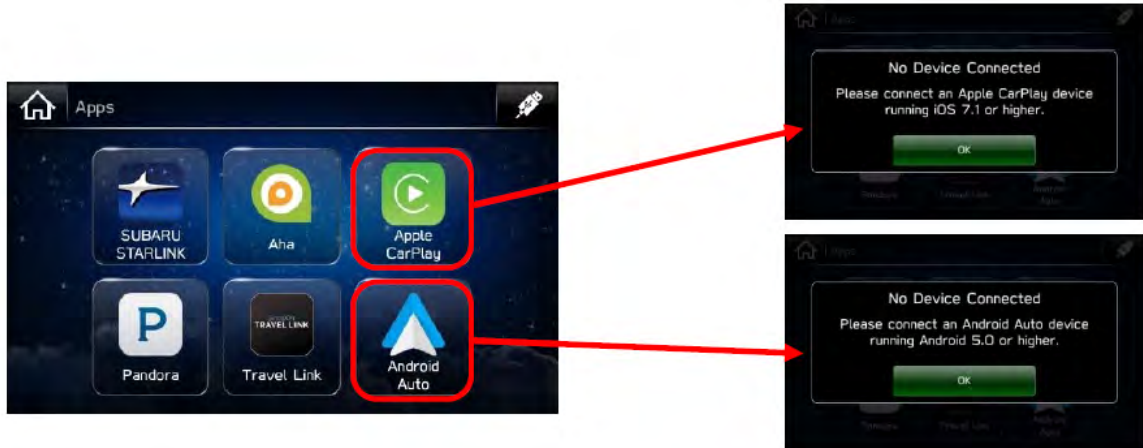
3- Apple Car Play / Android Auto function does not operate (“No Device Connected”).

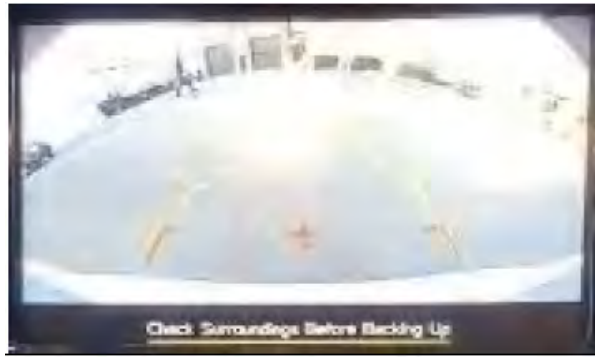
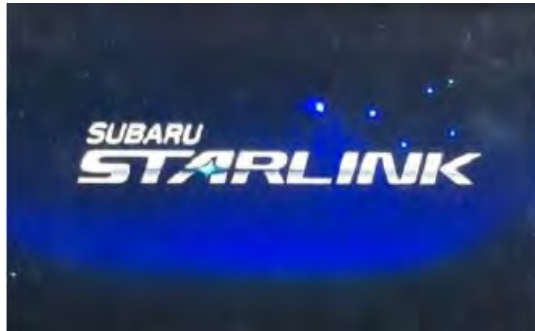
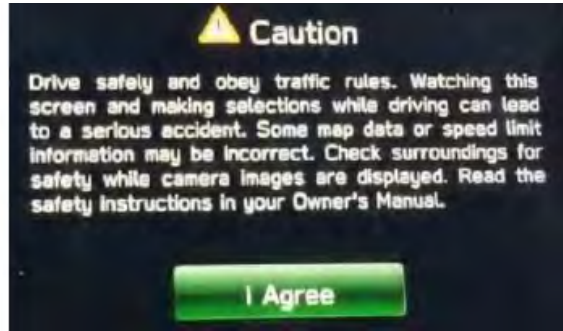
For reference, the previously released WTN-74R symptoms are also provided below. The main purpose of WTN-74R was to address display screen freeze-up during Back-Up Camera display (when the shifter is in “R”). In addition, the screen may also freeze when either the Subaru STARLINK or Disclaimer Caution / I Agree screen is displayed.

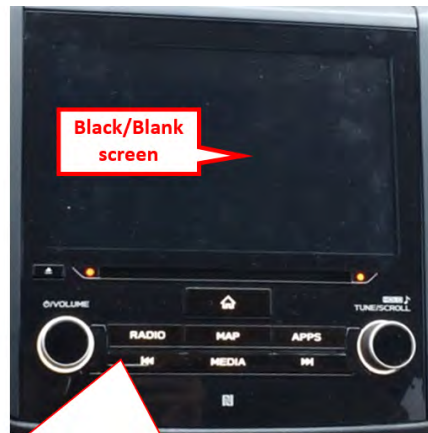
- 1) After switching the vehicle (ACC or IGN) on, the display screen goes black with no audio output and the hard key buttons are illuminated (on solid, or flashing / blinking).

Black/Blank screen

Hard key (button) illuminated, on solid or flashing / blinking

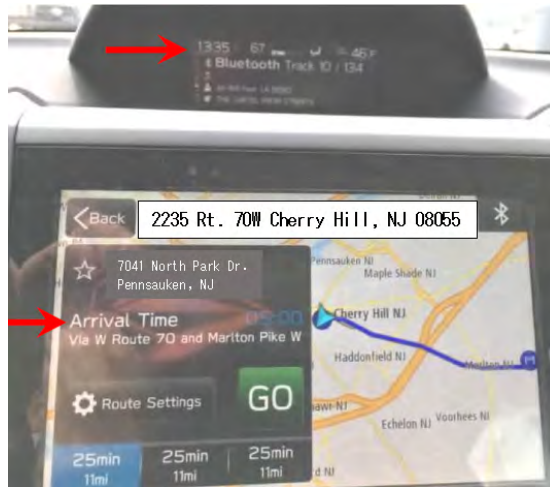
- 2) Time of day displayed in the MFD is incorrect and the arrival time displayed in Navigation unit is also incorrect.

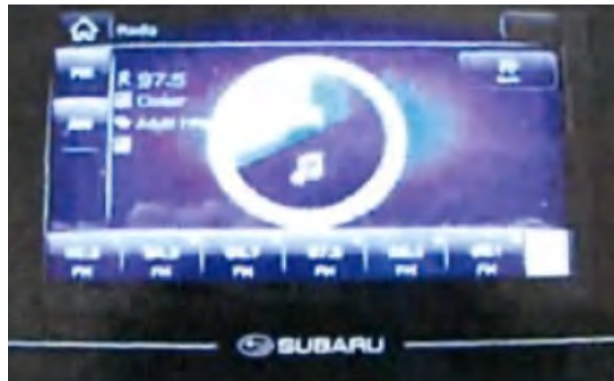
- 3) The time in the MFD automatically reverts to a “default” setting, even after setting the time using “Manual” mode.
- 4) Audio volume goes to maximum automatically after one click of the volume up button on the steering wheel. In some cases, this condition may also occur without input from the operator. Maximum volume is also displayed on the screen.
