## 2020+ Slingshot Steering Angle Sensors

This article contains some of the theory of operation with the Steering Angle Sensors (SAS) on Slingshot models. It highlights the operation of the MY20+ models as well as some issues we have been seeing and some of the challenges in diagnostics.

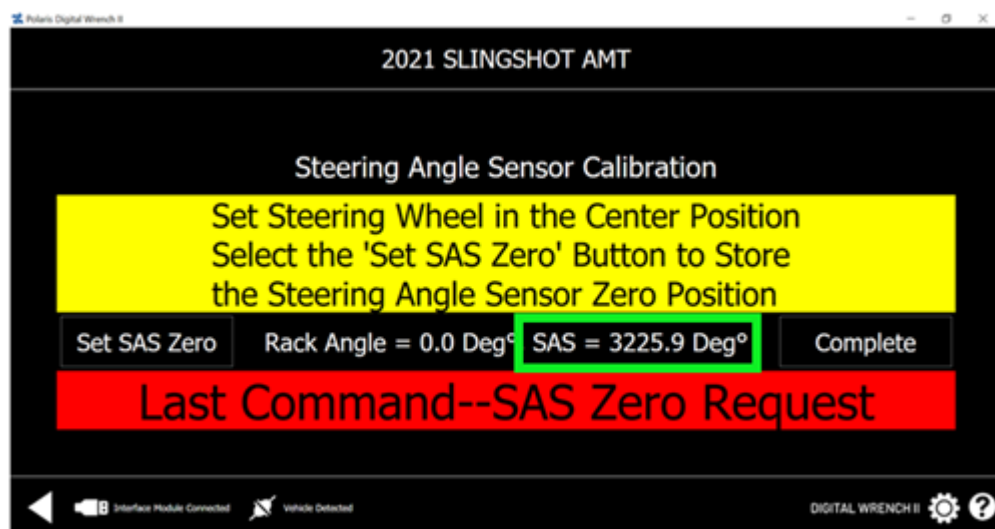
The first step when experiencing an SAS error code is to open Digital Wrench II (DWII) and attempt to see what reading you have under "Rack Angle" on the Steering Angle Sensor calibration page. The Rack Angle sensor should never read outside of +/- 15 Deg° with the steering wheel straight. If it does, there is an issue that needs to be resolved before moving to the zeroing of the sensor (Set SAS Zero). Some of the root causes can be seen below.

In the situations where the SAS was calibrated with the Rack Angle Sensor above or below the allowed 15 Deg°, you will have to recalibrate the SAS in 15-degree increments back to "true zero." DWII will only allow corrections of 15-degree increments.

**Note:** If the SAS reading is showing 3225.9, DWII will require you to back out of the calibration screen and erase all controller fault codes before starting the zeroing procedure.

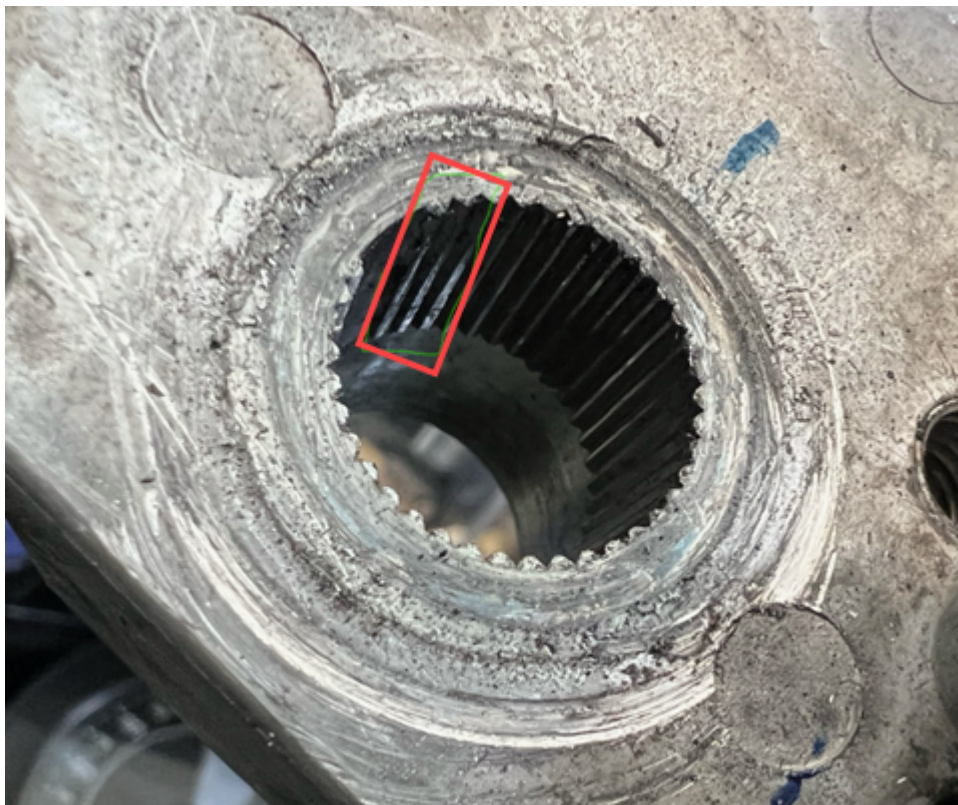
The steering wheel has a master spline on the steering shaft. If installed incorrectly, the Rack Angle will read outside the accepted +/- 15 Deg° window.

The image below shows steering wheel damage.

Once the steering wheel is repositioned in the master spline, move the steering wheel so that the SAS reading is zero. You will have to turn the steering wheel towards the center position in 15-degree increments, resetting the value each time until the steering wheel is straight.

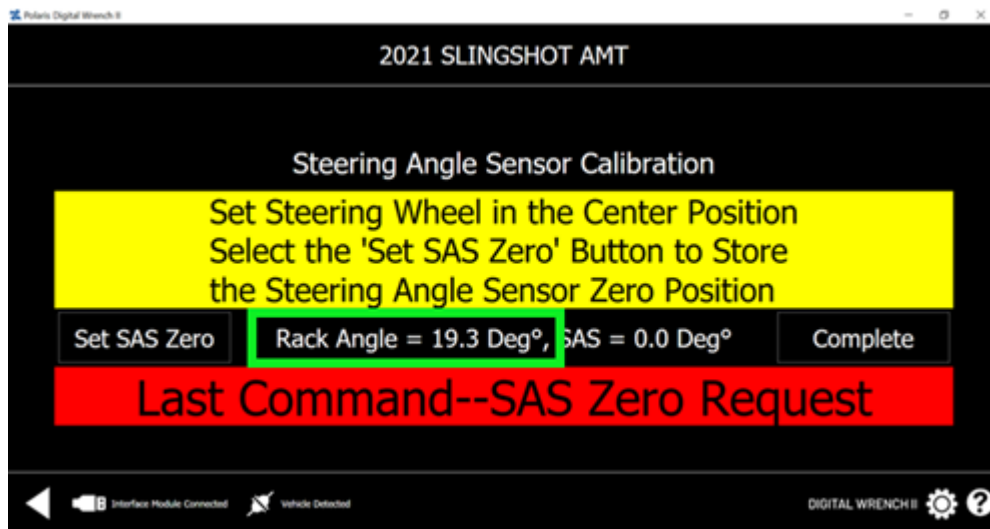
**Example:** Due to the damage to the steering wheel splines, the Rack Angle is reading 19.3 Deg° and is out of spec for the "SAS calibration."

\*\* Digital wrench will only allow corrections of 15-degree increments.
