Subject: SQUEAKING NOISE FROM REAR OF VEHICLE WHEN DRIVING ON BUMPY ROADS AND TURNING	Bulletin No.: 02-004/23
	Last Issued : 11/08/2023

2024 CX-90

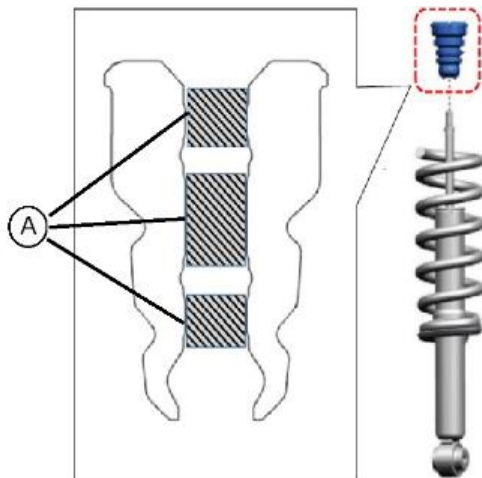
Some customers may complain about squeaking noise coming from the rear of vehicle when driving on bumpy roads and turning. This is caused when the lubricant coating comes out of the bump stopper, changing the resistance between the damper rod and bump stopper. To eliminate this concern, a mass production change is under study. Customers having this concern should have their vehicle repaired using the following repair procedure.

1. Verify the customer concern.
2. Remove both rear bump stoppers according to the instructions in MGSSI (REAR SHOCK ABSORBER AND COIL SPRING REMOVAL/INSTALLATION) and (REAR SHOCK ABSORBER AND COIL SPRING DISASSEMBLY/ASSEMBLY).
3. Apply rubber grease (0.5-1.0g) inside the bump stopper, principally at the areas indicated in the image below (A).

4. Install the parts in the reverse order of removal.
5. Verify the repair.
