SERVICE BULLETIN

APPLICABILITY: 2023MY Ascent
 2024MY Crosstrek
 2023-24MY Legacy/Outback

NUMBER: 15-315-23
DATE: 11/17/23

SUBJECT: Telematics Data Communications Module (DCM) Product Improvement Reprogramming

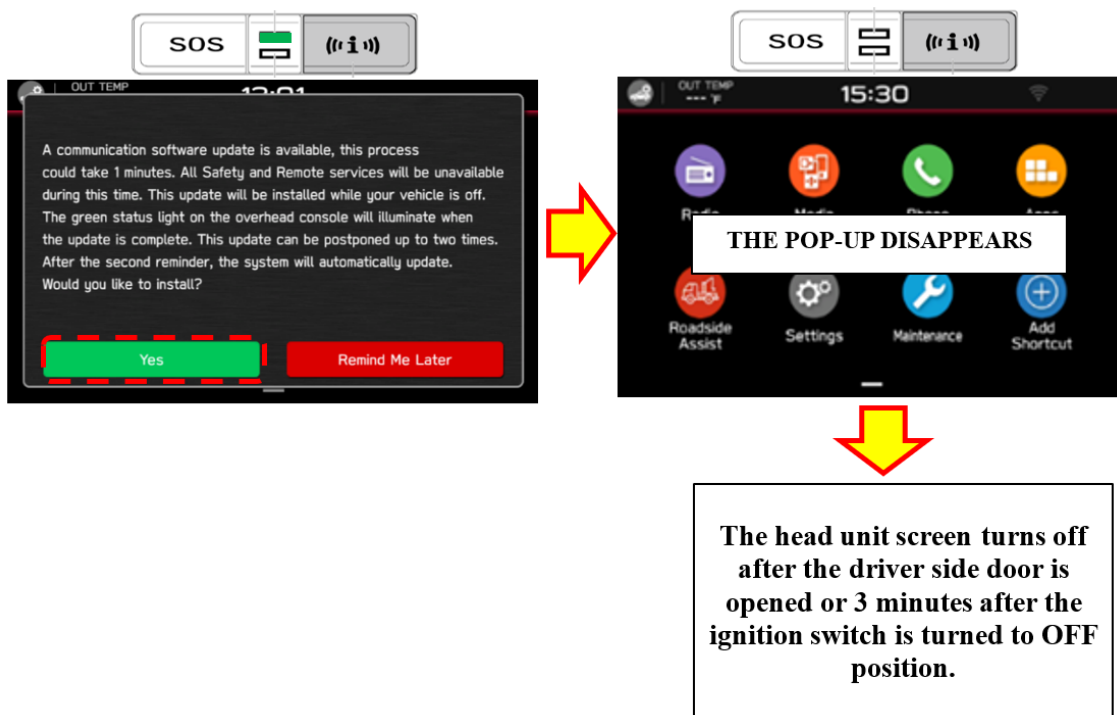
STEP 3A: An installation notification pop-up will automatically appear when the ignition switch is OFF and after the background downloading is completed. Select “Yes,” and installation will start. The green LED light turns off when installation begins.

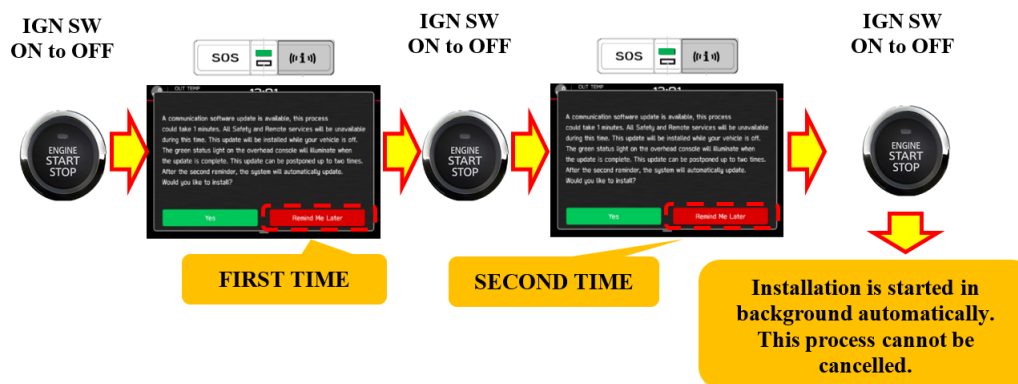
NOTE: Customers can skip the installation by selecting “Remind Me Later” or no operation until the installation notification pop-up disappears up to two times. However, after skipping the installation two times, the software installation will start automatically as soon as the ignition switch is turned OFF without any notification. If that is the case, the installation notification will no longer appear.

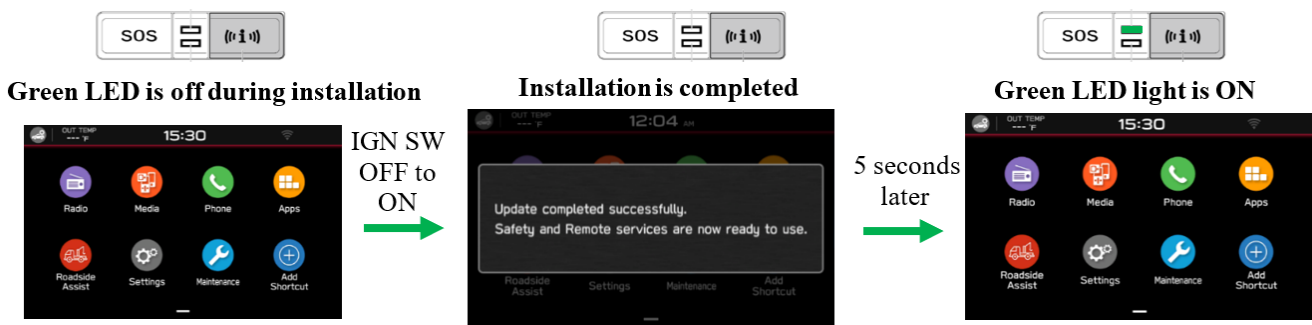
STEP 3B: The installation takes about 10 minutes. Turn the ignition switch to the ON position. After 10 minutes or more, an “Update completed successfully” pop-up appears on the head unit if the installation has been completed. After 5 seconds, the pop-up disappears and the green LED light turns on.

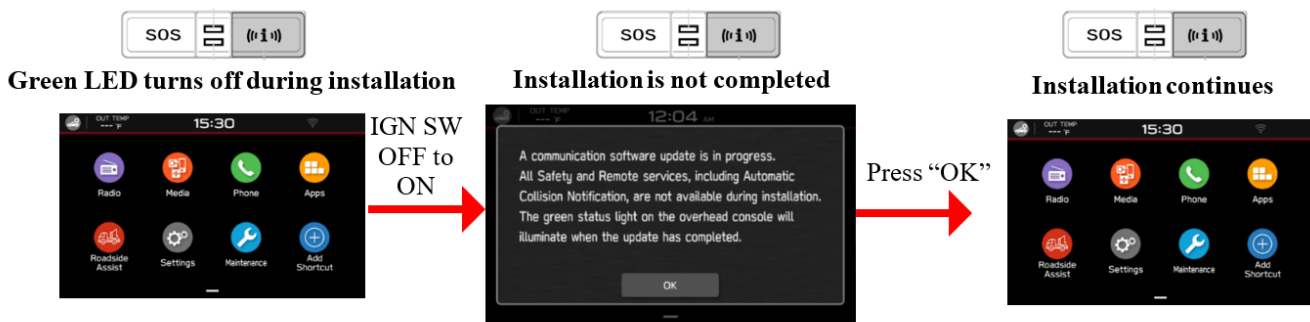
If the installation has not been completed, a pop-up of “A communication software update is in progress.” may appear on the head unit after the ignition switch is turned ON. In that case, wait until the installation is completed and the green LED light turns on.
