# Technical Service Bulletin

<b>Subject:</b>  <b>WRINKLES ON LEATHER SEAT SURFACE OF NEW (UNSOLD) VEHICLE</b>	<b>Bulletin No.: 09-007/23</b>
	<b>Last Issued : 11/20/2023</b>

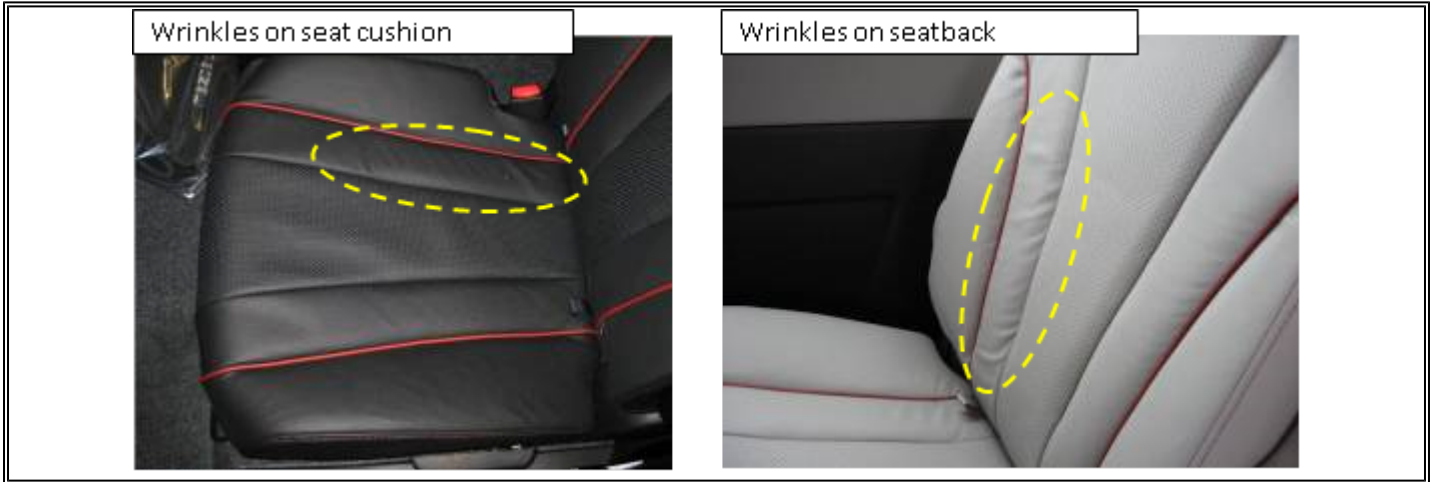
**At PDI or when new vehicle is delivered**, some customers may complain about wrinkles on the leather seat cushion and/or seat back surface.

Customers experiencing this concern should have their vehicle repaired according to the following repair procedure.

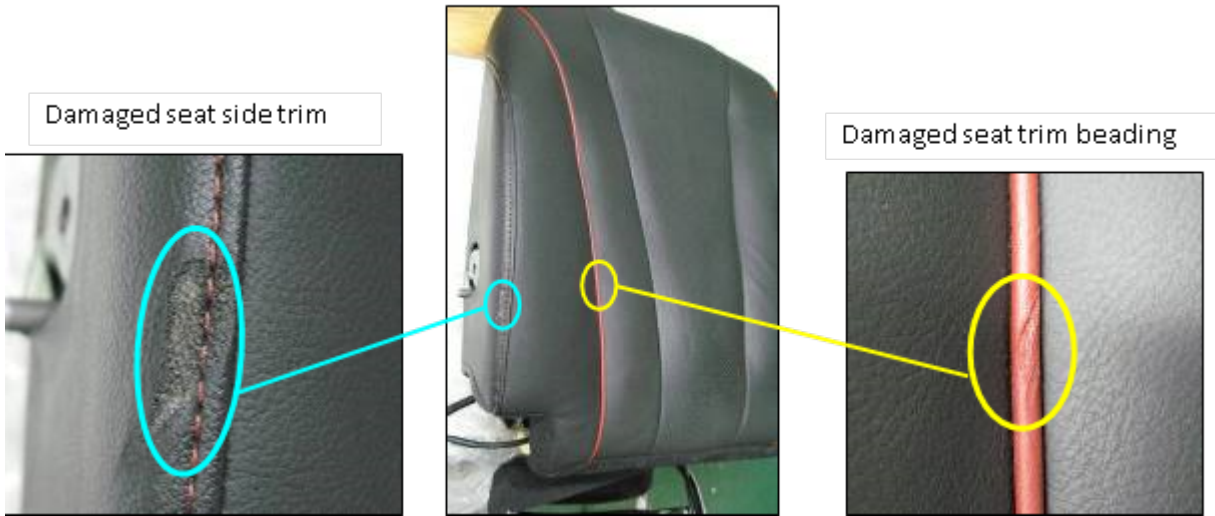
- **DO NOT** keep the iron in the same area for a long time. Doing so could damage the seat surface, as shown below.
- **DO NOT** run the iron without a water-soaked cloth, especially over the seat trim beading and seat side trim areas.
