## TECHNICAL SERVICE BULLETIN

### Water Leak Into Liftgate - Built On Or Before 29-Sep-2023

**23-2360**

| <b>Ford</b><br>2021-2023 Mustang Mach-E | Built on or before 29-Sep-2023 |

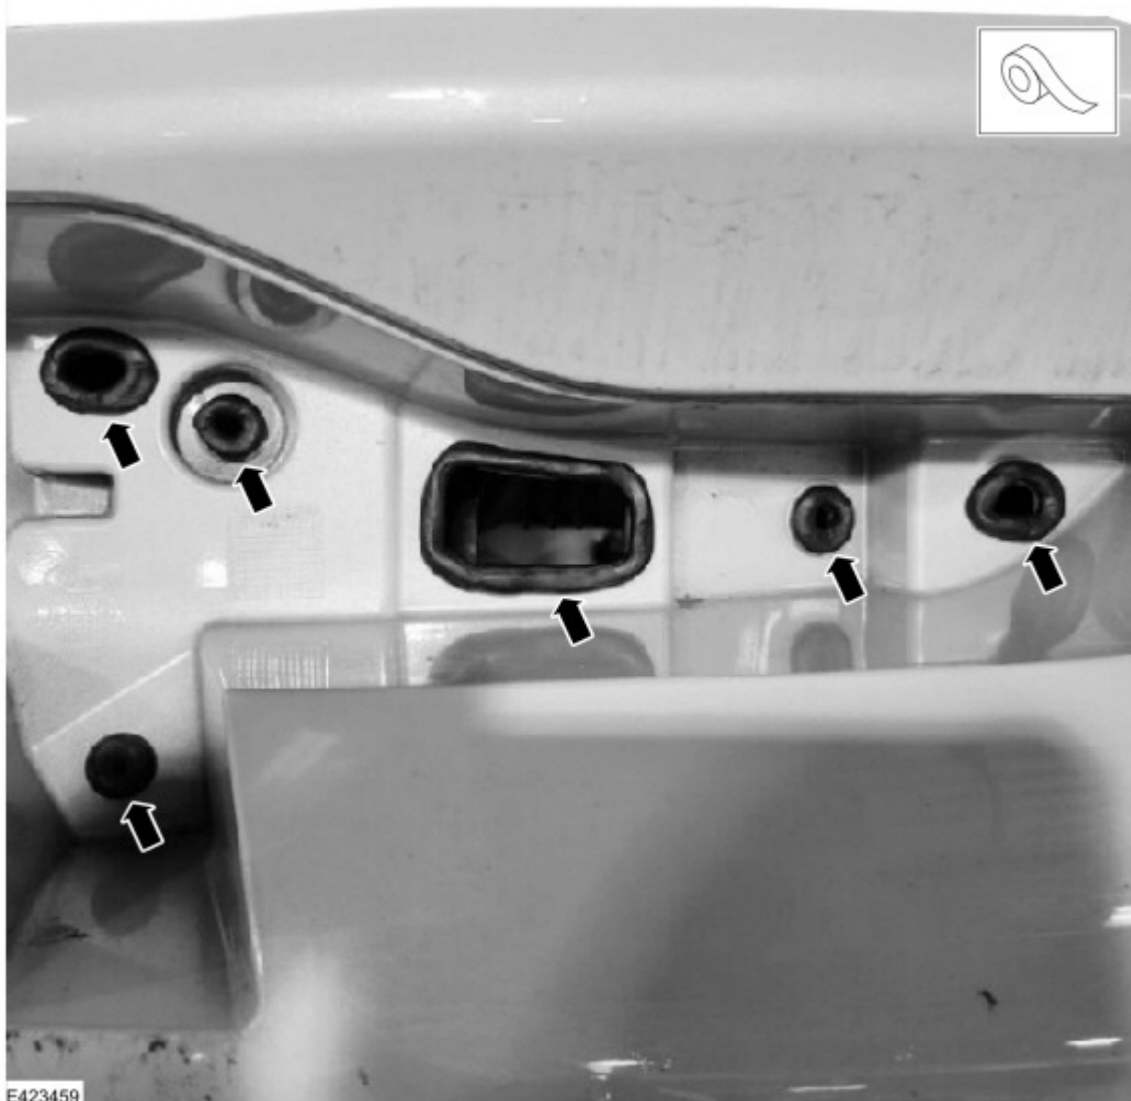
Figure 1

**Issue:** Some 2021-2023 Mustang Mach-E vehicles built on or before 29-Sep-2023 may experience a water leak into the liftgate. This may be due to water intruding past the seals on the liftgate mounted rear lamp assemblies. To correct the condition, follow the Service Procedure to seal the lamp cavities.

1. Remove both liftgate mounted rear lamp assemblies. Refer to Workshop Manual (WSM), Section 417-01 > Removal And Installation > Rear Lamp Assembly > Liftgate Mounted Rear Lamp Assemblies.
2. Inspect and remove any sealant residue around the rear lamps studs and the surface that the studs pass through the body.
3. Clean all sealing surfaces.
4. Using butyl sealant tape, create a bead around each cavity of both liftgate mounted rear lamps as shown in Figures 1-2.
