SERVICE BULLETIN

APPLICABILITY: 2020-23MY Outback & Legacy With 2.4L DIT
 2019-23MY Ascent
 2022-23MY WRX

NUMBER: 09-106-23R

SUBJECT: Exhaust Pipe Front (EPF) Design Change

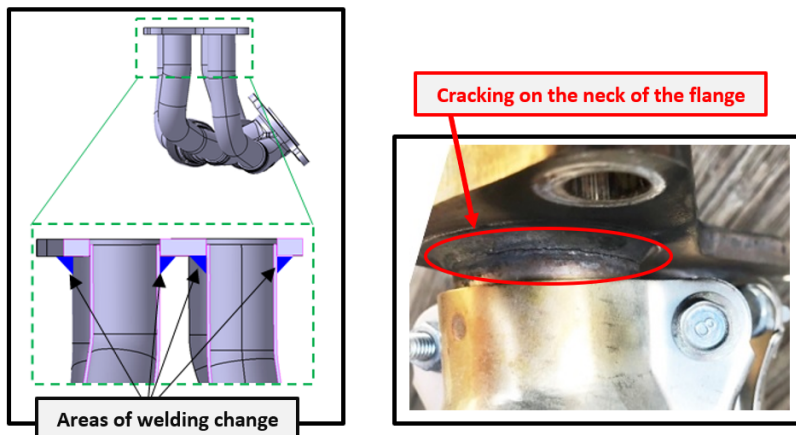
DESCRIPTION OF DESIGN CHANGE:

This bulletin announces design changes made to the Exhaust Pipe Front (EPF) to address concerns of rattle-type or fluttering sounds coming from the undercarriage during acceleration caused by cracking in the EPF. A welding material with enhanced durability has been incorporated into the production of the EPF. If the condition described is confirmed, the EPF should be inspected and if determined necessary, replaced.
