# TECHNICAL SERVICE BULLETIN

## 400 Watt DC/AC Inverter System Inoperative With B1330:9A In The BCM

**23-2367**

Ford 2021-2023 F-150
-------------------------

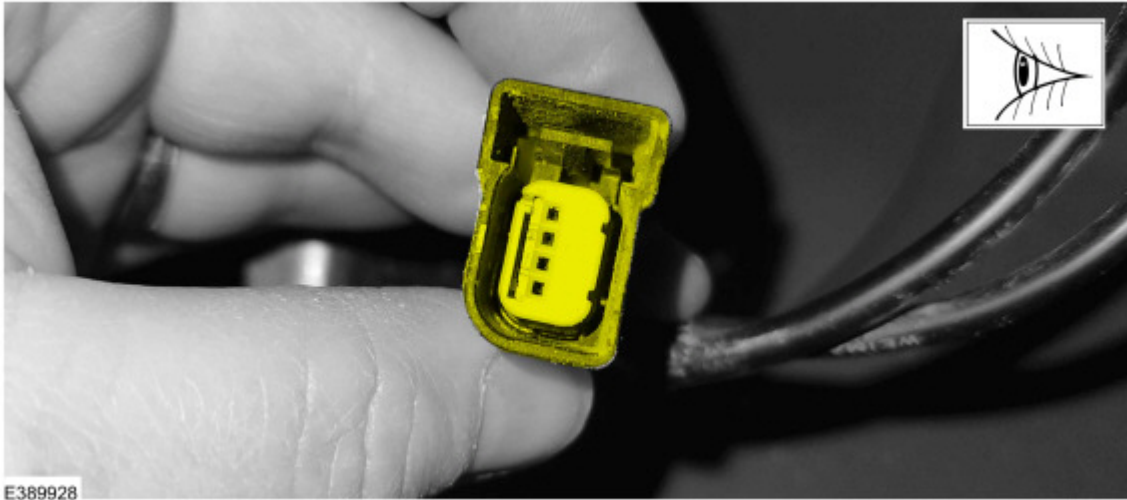
2. Using a suitable tool, carefully cut and remove the pickup bed AC power outlet socket harness retainer from the pickup bed AC power outlet socket harness. Discard the retainer.
  3. Inspect connector C4628 for the presence of corrosion, dirt and/or damage. Is corrosion, dirt and/or damage present in connector C4628? (Figure 2)
- Figure 2

- (1). Yes - replace the pickup bed AC power outlet socket assembly. Refer to Workshop Manual (WSM), Section 414-05. Replace the body side harness assembly (13A409) of connector C4628. Proceed to Step 4.
- (2). No - proceed to Step 4.
- 4.** Install a new pickup bed AC power outlet socket harness retainer 4.3 in. (110 mm) from the back of the pickup bed power outlet harness connector. If the pickup bed AC power outlet socket has been replaced, remove and discard the factory-installed harness retainer and install the new harness retainer. (Figure 3)

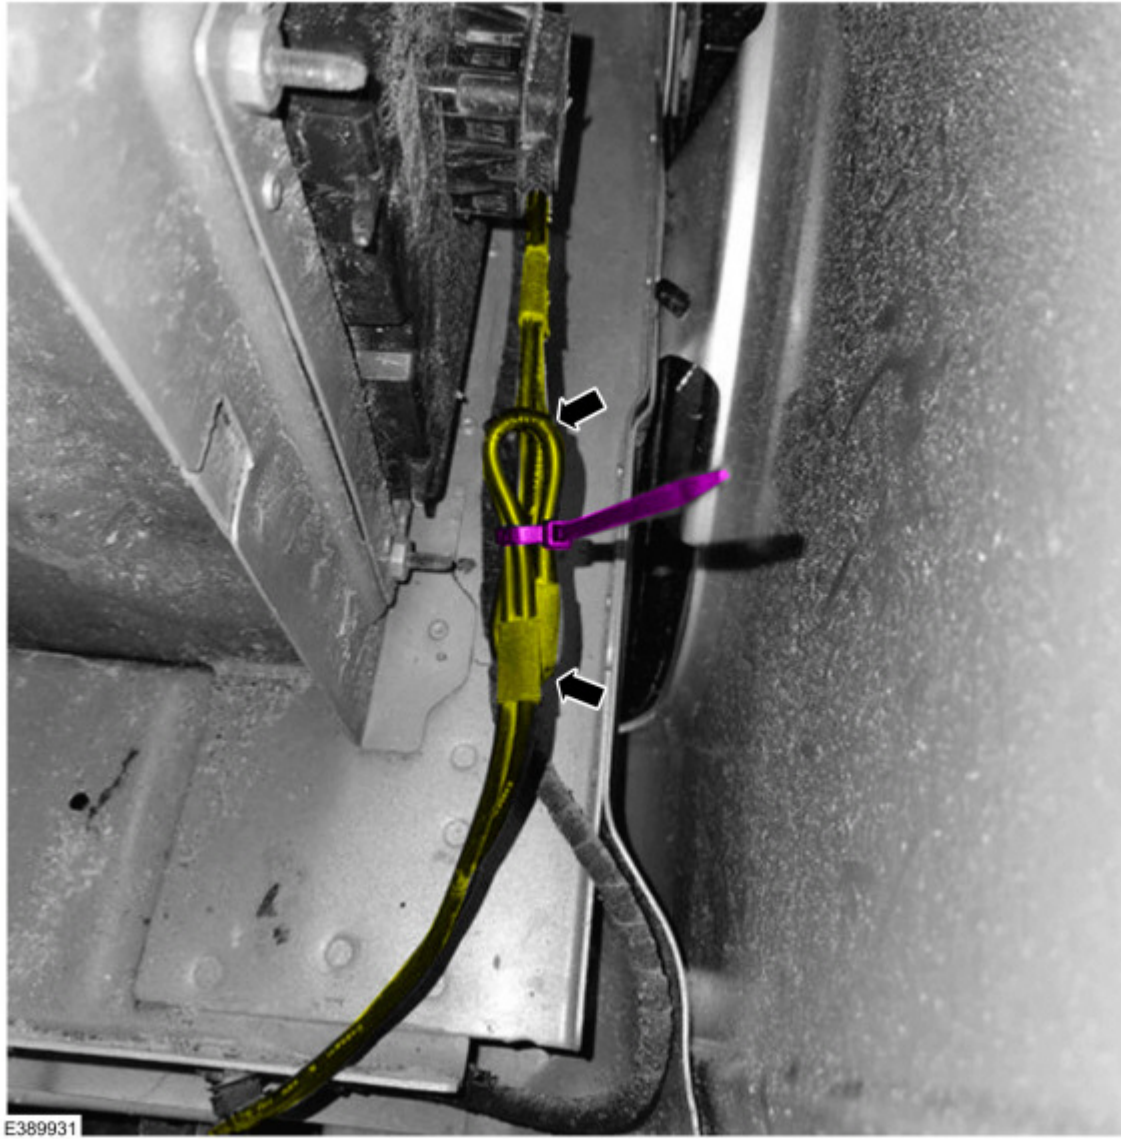
Figure 5

**⚠ CAUTION: The bend radius of the pickup bed AC power outlet socket harness should be no less than 4 mm. Hard kinks and tight bends of the pickup bed AC power outlet socket harness can lead to wire damage.**

6. Fold approximately 7 in. (185 mm) of the remaining/loose pickup bed AC power outlet socket harness in 2 bends just behind the pickup bed AC power outlet socket panel. Secure the folded wire with a wire tie. Inspect the routing of the harness to make sure it is not pulled too tight against the body sheet metal near the harness retainer and provides just enough length. (Figure 5)
