# Technical Service Bulletin

<b>Subject:</b>  <b>POOR APPEARANCE DUE TO UNEVEN REAR BELTLINE MOLDING JOINTS (5-DOOR HB ONLY)</b>	<b>Bulletin No.: 09-038/23</b>
	<b>Last Issued : 11/08/2023</b>

2019-2024 Mazda3 5-Door HB (Japan built) vehicles with VINs lower than JM1 BP\*\*\*\* \*\* 700253 (Produced before Sept. 1, 2023)

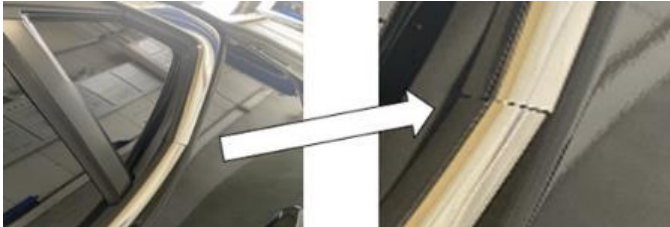
Some customers may complain about the poor appearance due to an uneven rear beltline molding joint.

This concern is caused by the rear beltline molding not being manufactured according to the original designed shape. To eliminate this concern, the rear beltline molding manufacturing process was improved to prevent form shape discrepancies from the original design.

1. Verify customer concern.
2. Replace the rear beltline molding(s) with a new one(s) according to the instructions on MGSS (REAR BELTLINE MOLDING REMOVAL/INSTALLATION).
3. Verify the repair.
