Technical Service Bulletin

90 Flickering lines in Audi virtual cockpit

90 23 57 2072065/1 November 20, 2023.

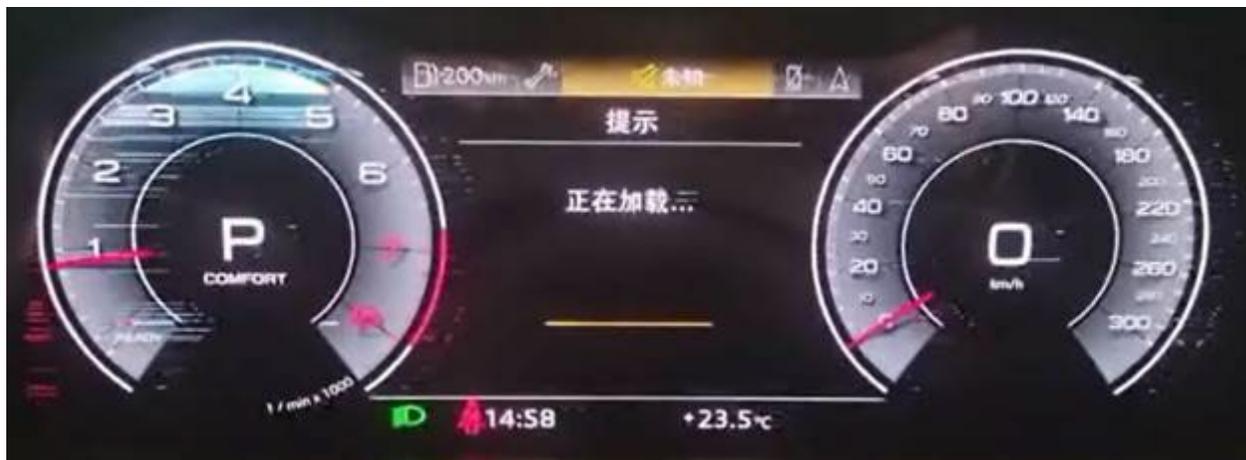
Figure 1: This is an example of horizontal lines in the virtual cockpit.

Hardware issue in the Audi virtual cockpit.

1. In your warranty claim notes document the production date of the instrument cluster. To do so:
 - a. Using ODIS: Right click diagnostic address 17>>Identification>>Production date
2. Replace the Audi Virtual Cockpit -J285- according to the instructions of the ELSA repair manual.

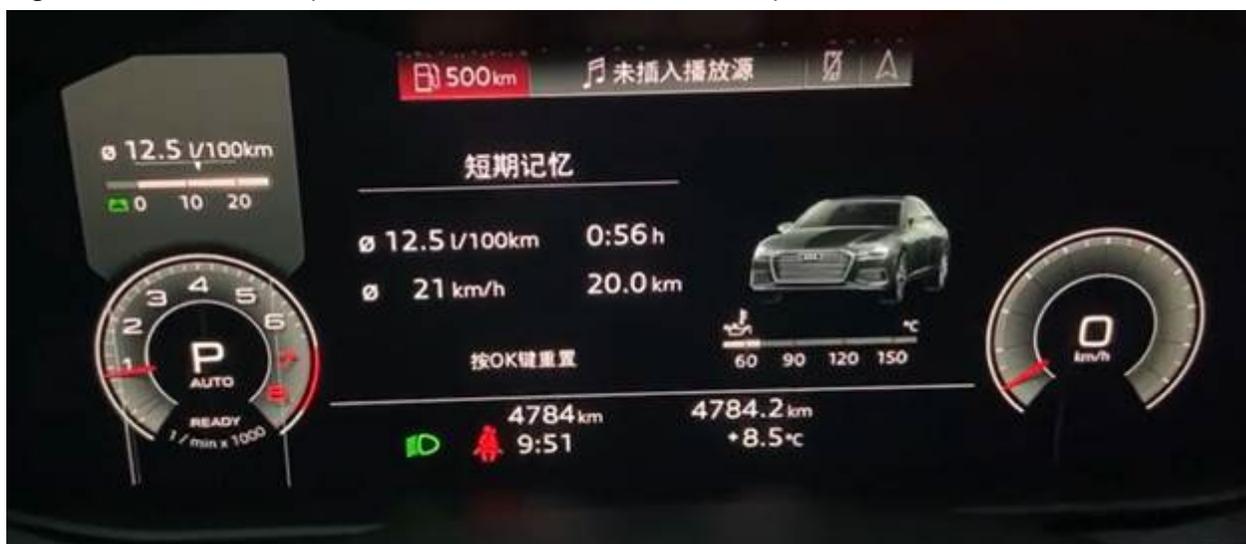
Figure 2: This is an example of vertical lines in the virtual cockpit.
