# Technical Service Bulletin

<b>Subject:</b>  ACCUMULATION OF WATER AND/OR SAND IN FUEL-FILLER LID BOX	<b>Bulletin No.:</b> 09-040/23
	<b>Last Issued :</b> 11/14/2023

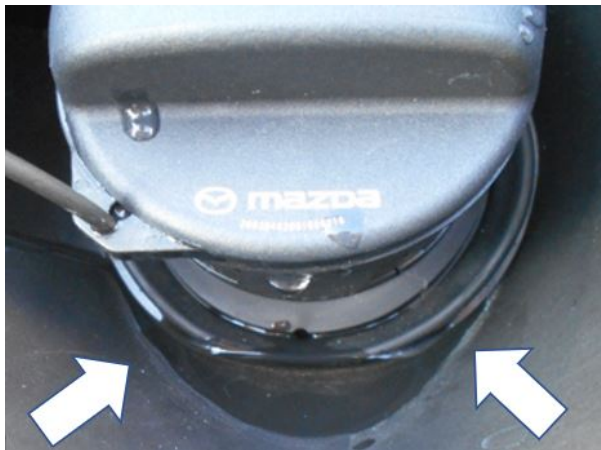
When opening the fuel-filler lid to refuel, some customers may notice water and/or sand in the fuel-filler lid box area. They may complain about dried sand causing poor appearance.

**NOTE:** The arrows in the image above indicate where the water and/or sand accumulates.

Since the drain hole on the dust cover is located in an improper position, water may not be able to completely drain which results in the accumulation of water and sand. To eliminate this concern, the dust cover (below) has been modified to drain the water more easily.

1. Verify the customer concern.
2. Replace the dust cover with a modified one according to the instructions on MGSS online FUEL-FILLER LID LOCK ACTUATOR REMOVAL/INSTALLATION.
