Subject: FOGGY HEADLIGHTS (INNER CONDENSATION) AND WATER SPOTS INSIDE HEADLIGHT LENSES	Bulletin No.: 09-041/23
	Last Issued : 11/27/2023

2017-2020 CX-5 vehicles with VINs lower than JM3 KF**** ** 869654 (Produced before Aug. 24, 2020)

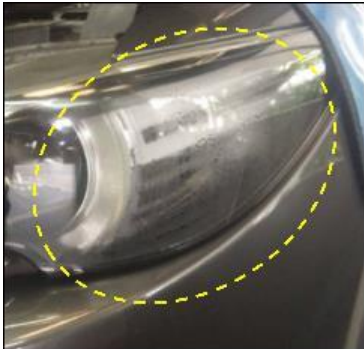
Some customers may complain that the headlights get foggy or have water spots inside. This concern may be caused by the anti-fog coating not preventing inner condensation under certain situations. To eliminate this concern, the anti-fog coating performance was improved.

Customers having this concern should have their vehicle repaired using the following repair procedure.

1. Verify the customer concern.
2. Replace the headlights with new ones according to the instructions on MGSS FRONT COMBINATION LIGHT
