# Service Alert

<b>Subject:</b>  A/T WARNING LIGHT FLASHING AT PDI WITHOUT ANY DTCs	<b>Service Alert No.:</b> SA-071/23
	<b>Last Issued :</b> 11/14/2023

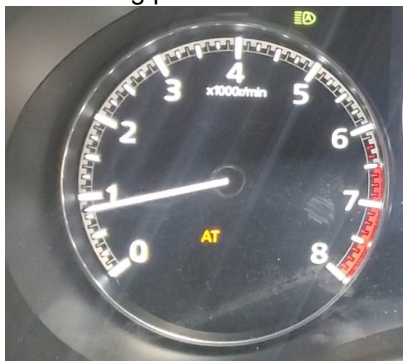
The A/T (Automatic Transmission) warning light is flashing in the instrument cluster at new car delivery, without any DTCs being present.

The TCM may still be in Factory Mode causing the A/T warning light to flash continuously. To take the TCM out of Factory Mode, turn the IG OFF -> IG ON -> IG OFF approximately 120 times at a steady pace to clear the warning light.

Vehicles having this concern should be repaired using the following repair procedure prior to delivery to the customer.
