Service Bulletin

Bulletin No.: 23-NA-165

Subject: Vehicle Will Not Lock and Unlock (Loss of Active Functions) Crank or Start (Loss of Passive Functions) with DTC P0513 Set

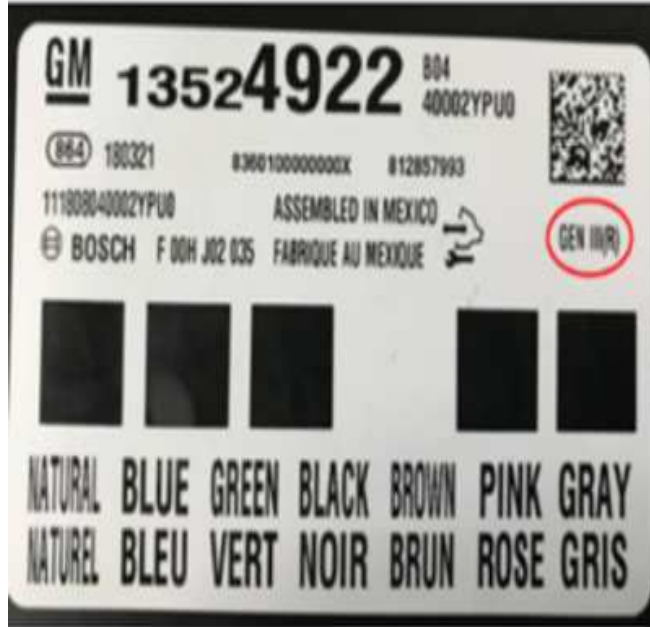
GEN3R BCMs can be identified by either the label on the module or looking up the BMPN part number information in GDS2.

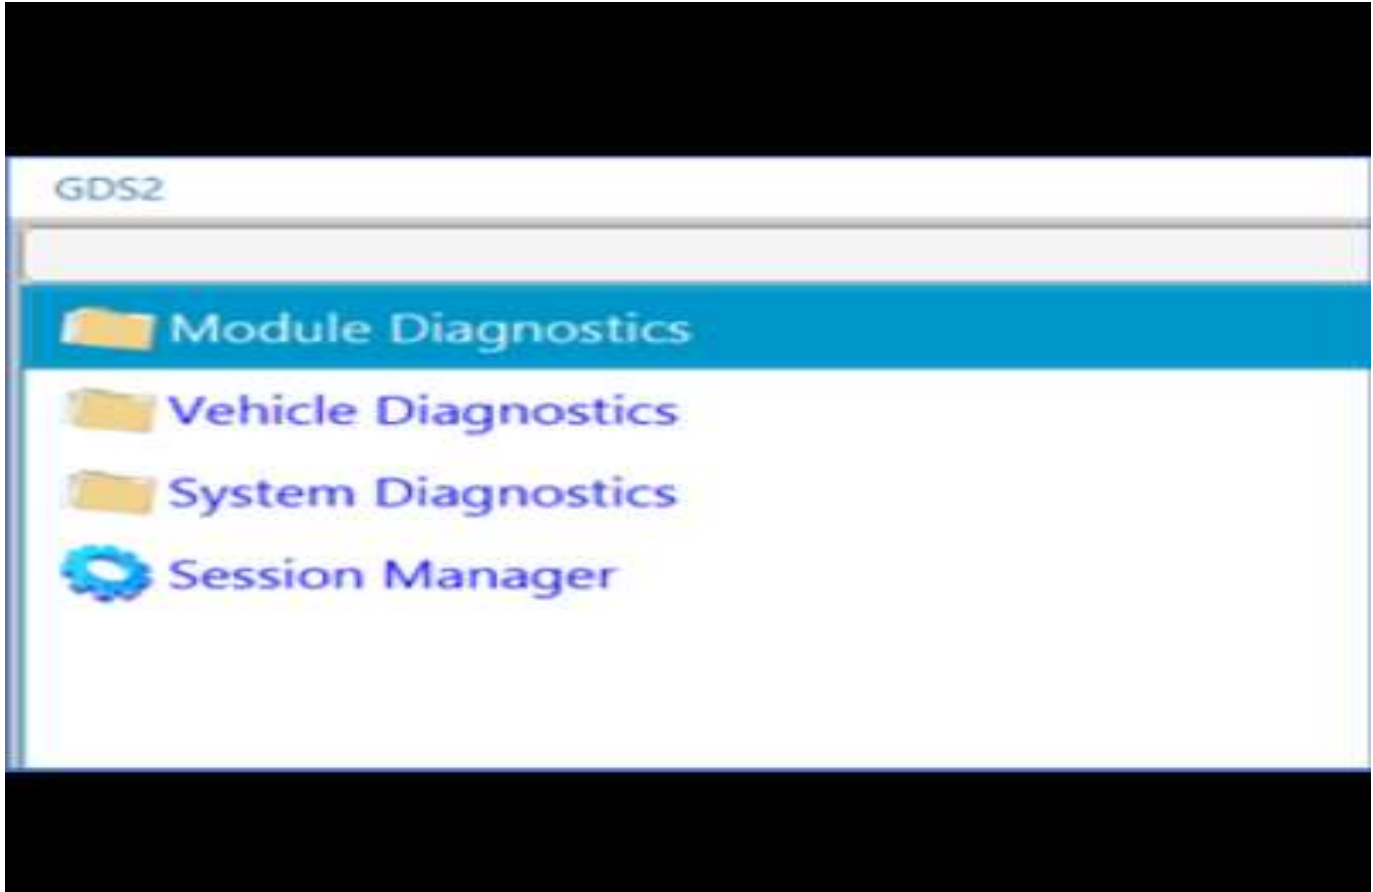
Verify you have a GEN3R BCM Base Model Part Number. Only GEN3R BCMS are eligible for this bulletin. Navigate to GDS2 > Module Diagnostics > [K9] Body Control Module > Identification Information > Identification Information.
