SIB 51 17 23

2023-11-28

WIND NOISE FROM THE FRONT DOOR(S) EXTERIOR MIRROR ASSEMBLY

E-Series	Model Description	Production Date
G70	7 Series Sedan	June 1, 2022 - September 30, 2023

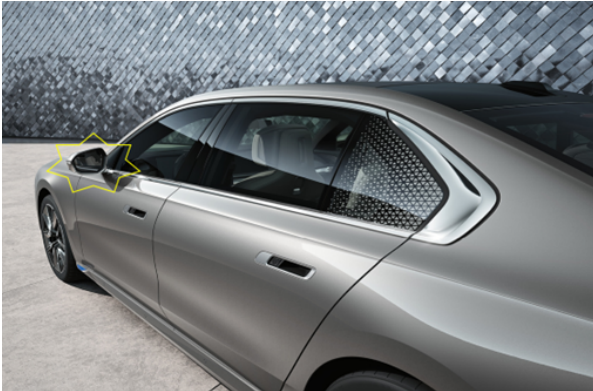
While driving at highway speeds, wind noise can be heard from the exterior mirror assembly. In some cases, this can be also felt in the B-pillar area.

The yellow shape around the mirror indicates the location of the noise.

Vacuum in the area of the exterior window trim/external mirror assembly triangle seal results in aero-acoustic noise.

Replace the exterior window trim(s) along with the exterior mirror assembly triangle seal(s) on both sides.

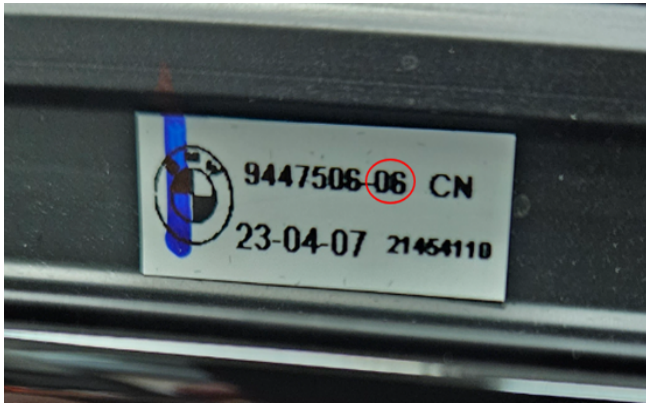
Note: The new part must have an index (AI) number of 07 or higher.

The photo shows an AI of 06 (circled) which will not improve the wind noise.

Replace the front exterior window trim(s) and exterior mirror assembly triangle seal following repair instructions listed in ISTA/AIR (51 16 001).
