SIB 65 01 22

KNEE AIR BAG CCM G01 VARIANT WIRE HARNESS REPAIRThis Service Information Bulletin (Revision 6) replaces SI B65 01 22 **dated August 2023**.**What's New:**

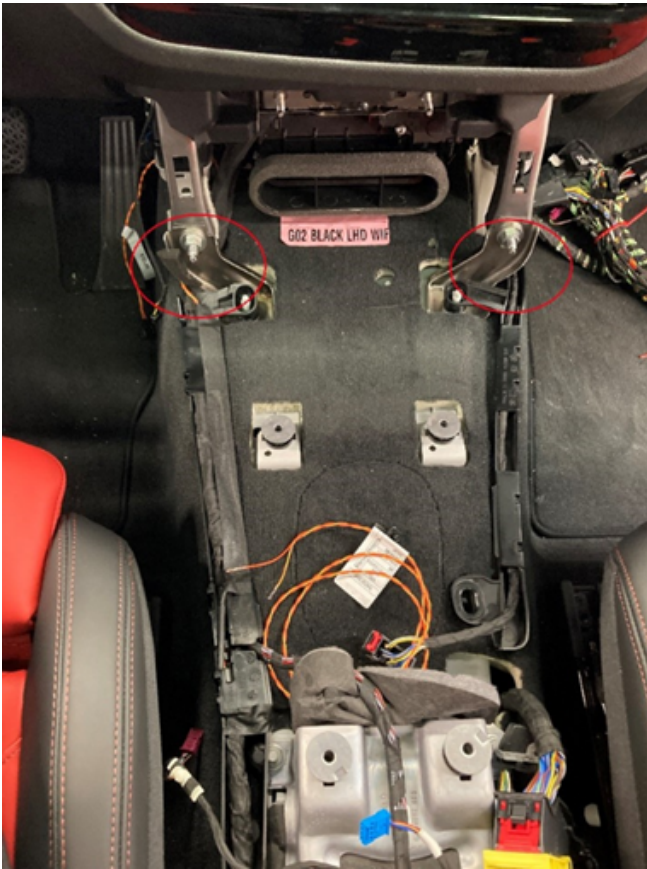
Over time, the wiring harness going to the knee air bag(s) can rub against the metal support tubes for the instrument panel, chafing and damaging the wiring.

5- Apply felt tape to the locations pictured.

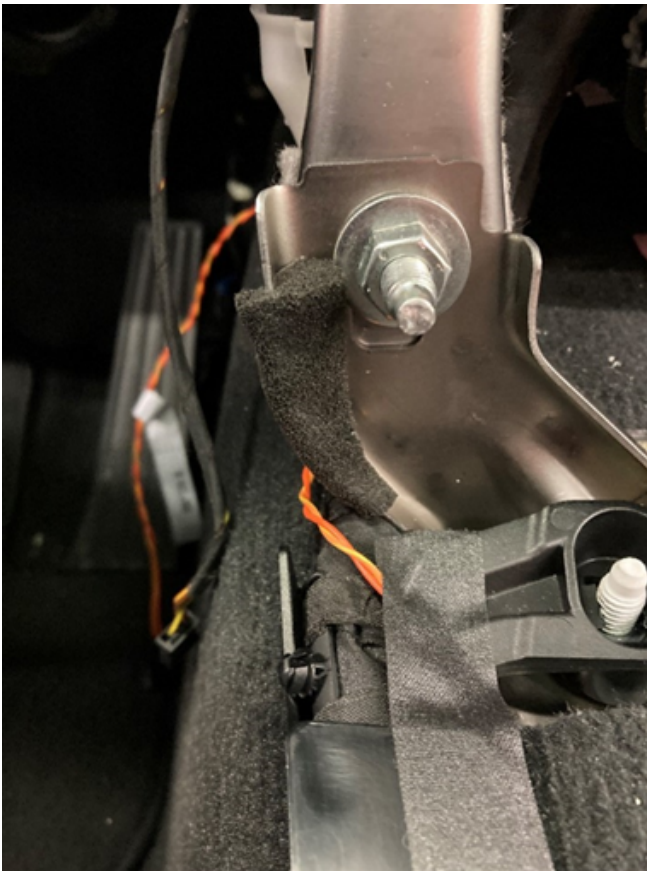
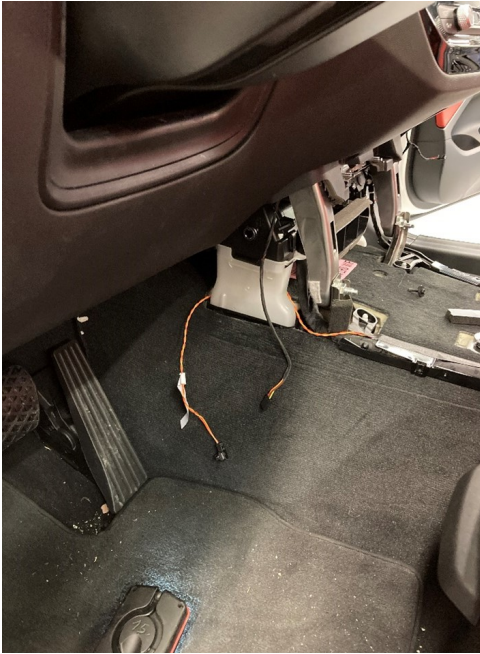
6- The knee air bag wiring should be protected from chafing at the dash support bracket.

Glue the felt generously onto the support tube or to the corresponding edge.

(Felt tape part number **54 34 7 248 700**).

Important: The felt must be glued around the edge!
