Service Bulletin

Bulletin No.: 23-NA-204

Subject: Service Front Camera Message Intermittently Displayed on the DIC

Brand:	Model:	Model Year:		VIN:		Engine:	Transmission:
		from	to	from	to		
Buick	Encore GX	2024	2024				
	Envista						
Chevrolet	Trailblazer	2024	2024				
	Trax

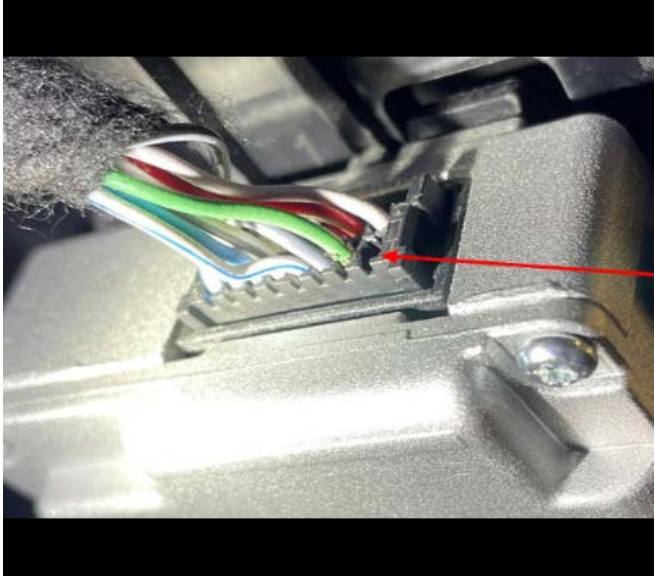
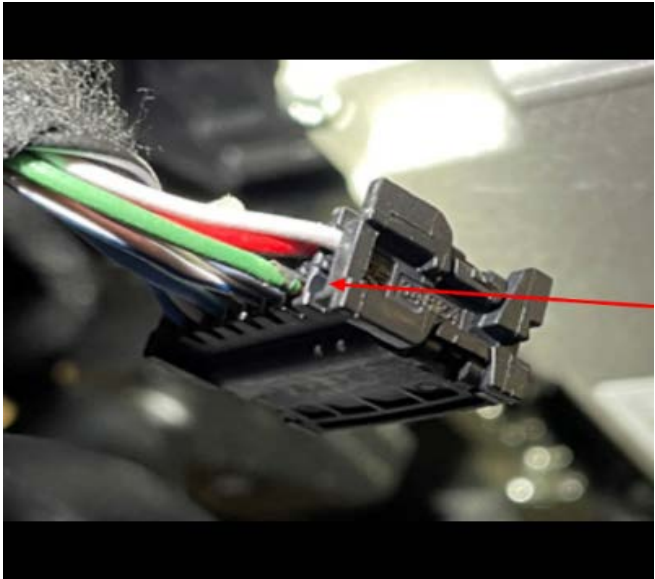
<p style="text-align: right;">6482584</p> <p>The causes of the condition may be that terminal 11, Low Speed Serial Data at the Frontview Camera Module Connector (FCM) is not staying seated in the connector.</p>
<p>Correction</p>	<p>Refer to the Service Procedure below.</p>

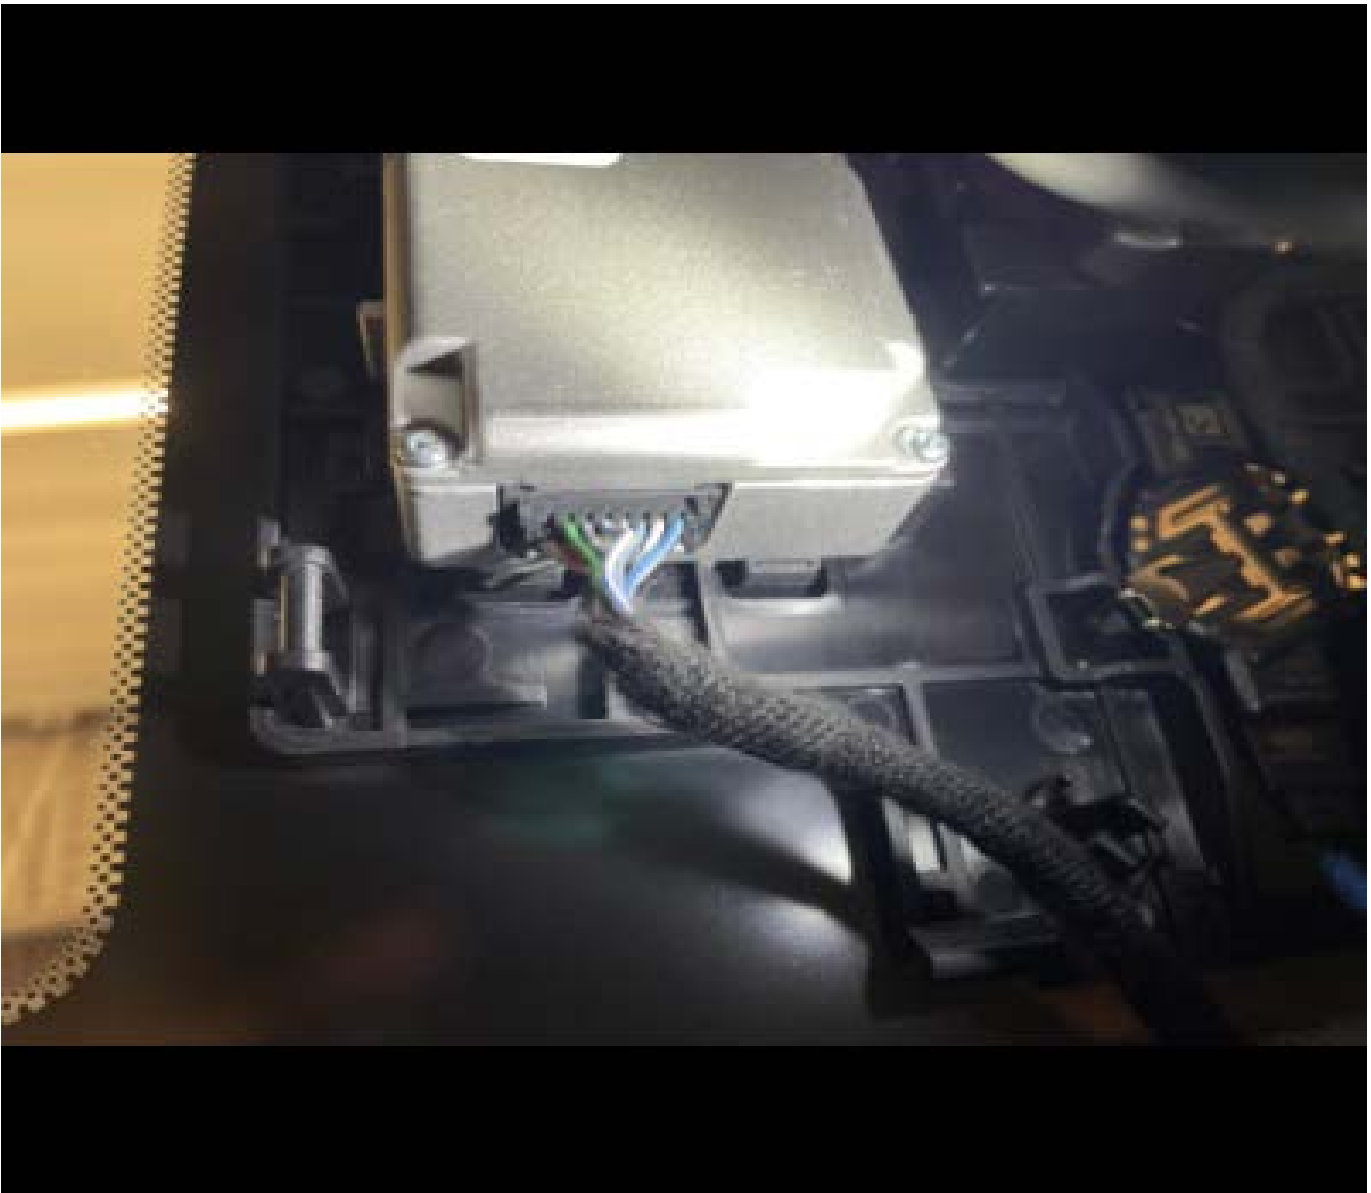
6480619

Check the connection at the FCM for terminal tension and backed out terminals and inspect the FCM Pins to ensure all pins are the same length and no pins have been pushed in. Refer to **B174W Frontview Camera - Windshield Connector View** in SI, Document ID: 6310609.

Replace the connector body and terminate the lead(s) for the LS circuits, *Connector Repairs in SI*.

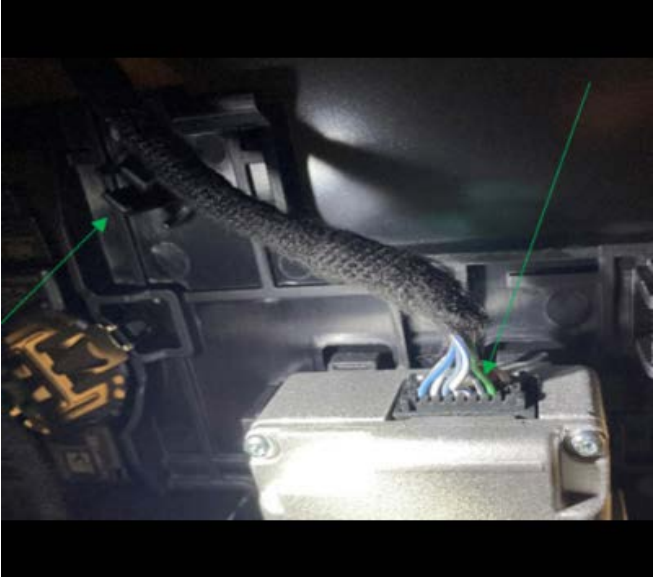
Good Tension

Check the tension on the harness. If there is too much tension, the LS terminated lead may not hold in the connector body. If you find all of the terminals are holding normally in the body, then peel back the tape on the harness so it isn't so tight. If you find the LS terminal 11 or any other terminal(s) will not stay in the connector body, despite releasing the harness tension, then replace the connector body and terminated lead(s) as needed.
