Technical product information

Topic	DTC B101C29 and/or DTC B101D29 evident within the airbag control unit (J234)
Market area	Australia E04 Bentley rest Asia and Australia (6E04),China 723 Volkswagen (Anhui) Automotive CO (6723),China 796 VW Import Comp. Ltd (Vico), Beijing (6796),Germany E02 Bentley rest Europe (6E02),Japan E03 Bentley Japan (6E03),Korea, (South) E08 Bentley South Korea (6E08),United Arab Emirates E06 Bentley Middle East and Africa (6E06),United Kingdom E01 Bentley UK (6E01),United States E05 Bentley USA and rest America (6E05)
Brand	Bentley
Transaction No.	2071047/3
Level	EH
Status	Approval
Release date

DTC B101C29 and/or DTC B101D29 evident within the airbag control unit (J234)

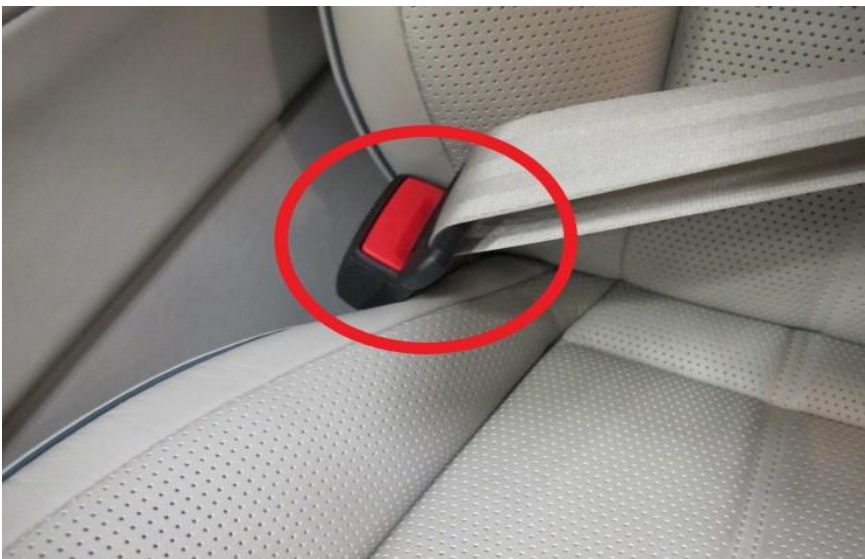
Figure 1

- 1) Insert the drivers side seatbelt tongue into the seatbelt buckle (Figure 1)
- 2) Referring to TPI 2071131/- Measured values - Cycle recording instructions - Record MVB IDE01193 (Drivers side) whilst manoeuvring the seatbelt buckle assembly - Reference the Bentley Hub TPI 2071047/- (Video 1)

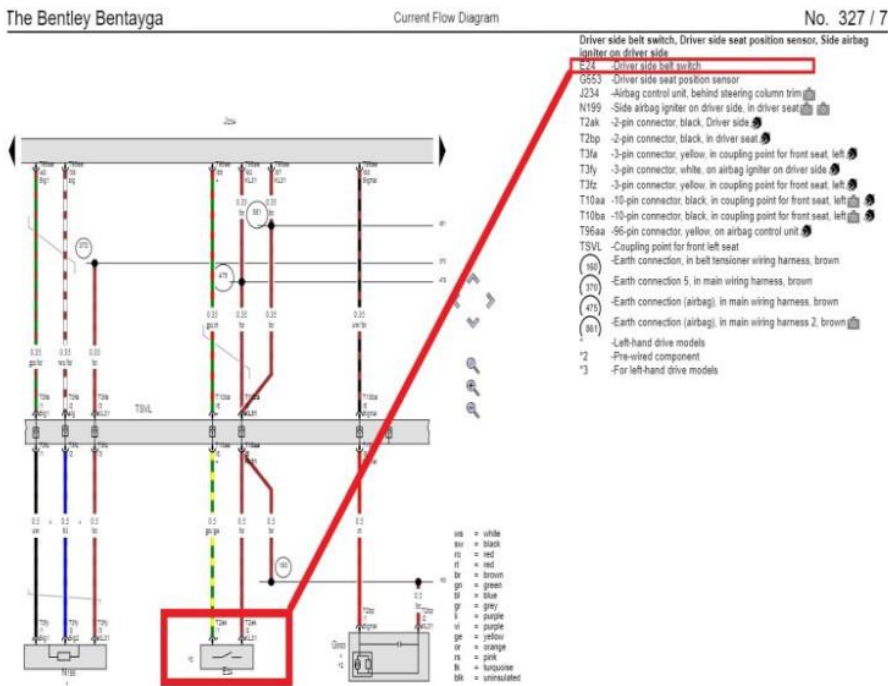
Figure 2

4) Referring to the applicable wiring diagram/Figure 2 - Locate E24

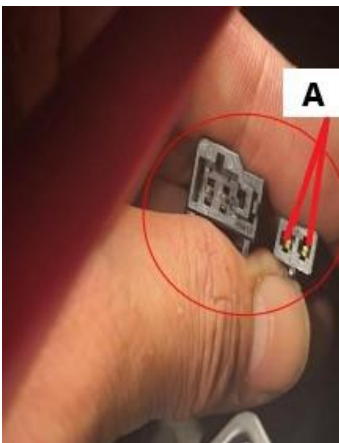
5) Referring to Figure 3 - Disconnect the E24 connection (circle)

Hint: The next part of the procedure requires the resistance of the seat belt buckle harness to be measured. The resistance measurement must be taken at the location shown in Figure 3 (Point A) The operative must take care not to damage the terminals shown at point A when taking the resistance measurements

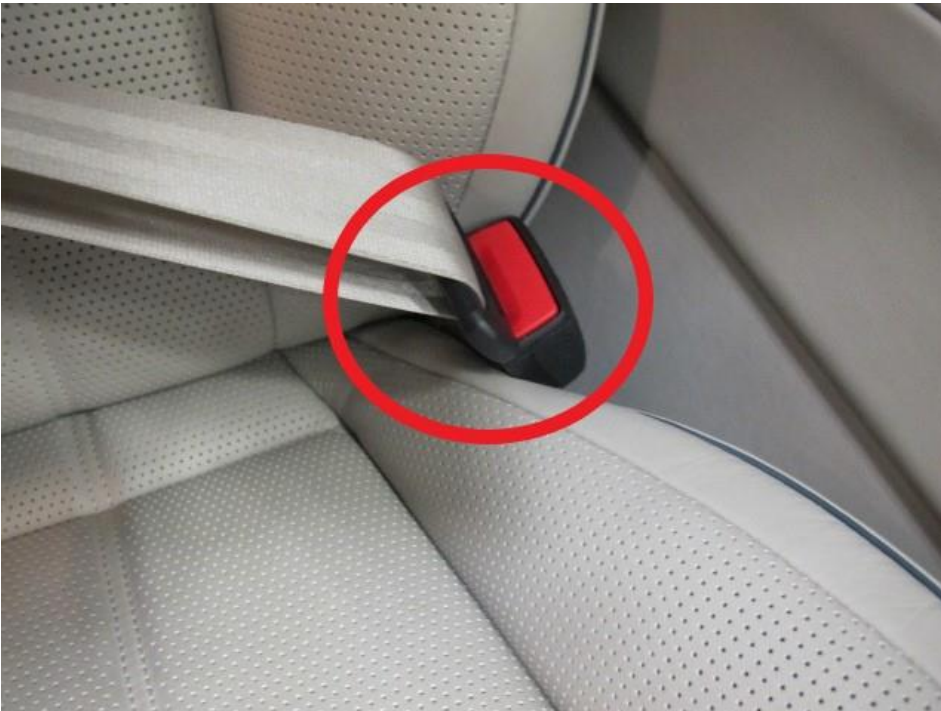
- 1) Referring to Figure 4 - Insert the passenger side seatbelt tongue into the seatbelt buckle
- 2) Referring to TPI 2071131/- Measured values - Cycle recording instructions - Record MVB IDE01194 (passenger side) whilst manoeuvring the seatbelt buckle assembly - *Reference the Bentley Hub TPI 2071047/- (Video 1)*

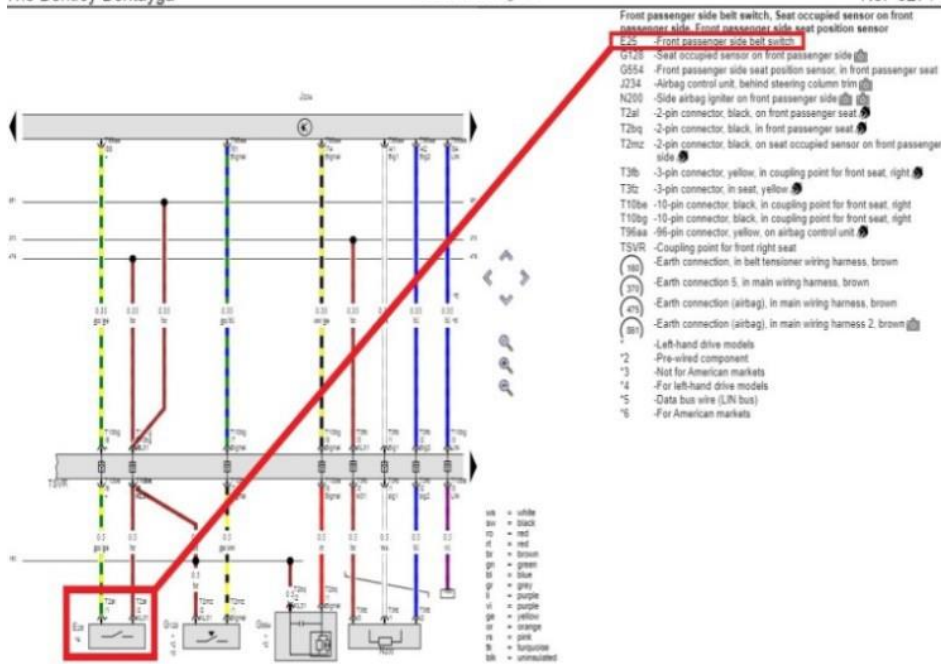
Figure 5

- 3) Referring to TPI 2071131/- Measured values - Cycle recording instructions - Record MVB IDE01194 (passenger side) whilst installing and removing the seatbelt tongue from the buckle the seatbelt buckle assembly - *Reference the Bentley Hub TPI 2071047/- (Video 2)*
- 4) Referring to the applicable wiring diagram/Figure 5 - Locate E25

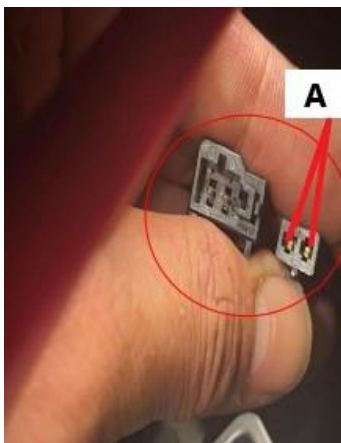
5) Referring to Figure 6 - Disconnect the E25 connection (circle)
