SIB 52 09 20

HEAD RESTRAINT AND/OR BACKREST OF 3RD ROW SEATS CANNOT BE FOLDED DOWN

E-Series	Model Description
G07	X7 Sports Activity Vehicle

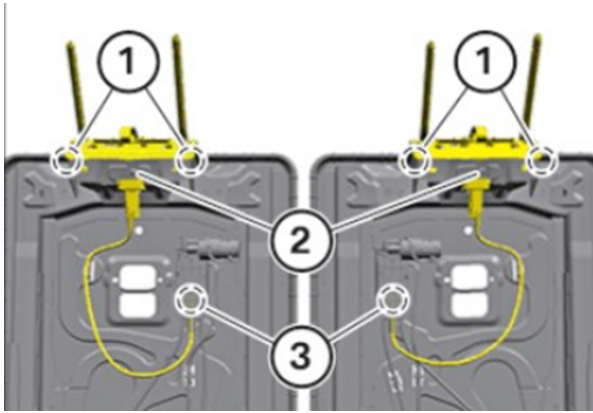
Can the head restraint be manually unlocked using the release loop beneath the headrest (see picture) and thus folded down?

YES = Head restraint mechanism is faulty. Determine root cause of Bowden cable not moving (see steps below). If the cable is moving fully but the headrest is not folding, then replace the folding module of the head restraint (#2 in picture).

See REP 52 30 118 Remove and install/replace folding module of left or right head restraint

NOTE: The head restraint cannot be removed without destroying the covering material. **A new cover (leather) will be required to perform this repair.**

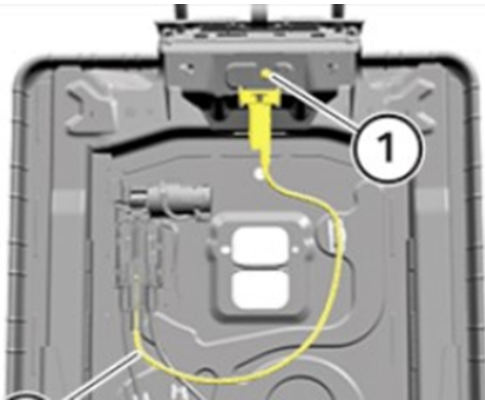
Cable routing UP TO February 2023 shown.

If the Bowden cable is mounted properly and cable correctly routed and the electric motor moving the common housing pulls all 3 Bowden cables equally but the headrest Bowden cable does not travel far enough, replace the Bowden cable for the headrest (shown in yellow in picture).

NOTE: A Bowden cable routing change was made in the third seat row backrest. This change was implemented starting in February 2023 production.

See REP 52 30 253 Replace Bowden cable for left or right head restraint (Bowden cable unlocking device for head restraint).

Replacement parts are all the new shortened design cable and require a new routing to install in vehicles produced prior to February 2023.

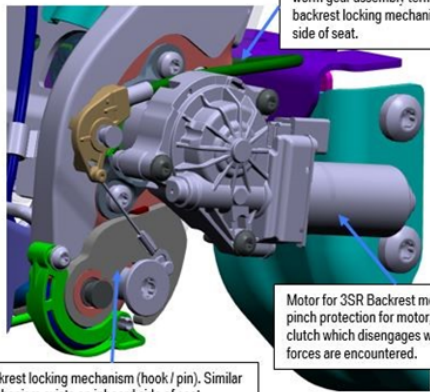
G07 3rd Row Seat – Overview Picture.

Bowden cable which originates at motor / worm gear assembly terminating at backrest locking mechanism on outboard side of seat.

Motor for 3SR Backrest movement. No pinch protection for motor, but has clutch which disengages when high forces are encountered.

Backrest locking mechanism (hook / pin). Similar mechanism exists on inboard side of seat.

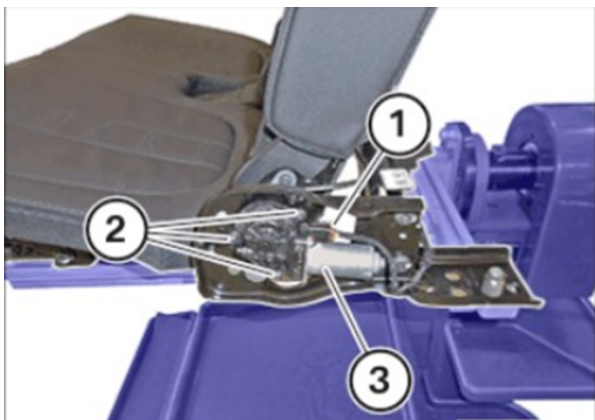
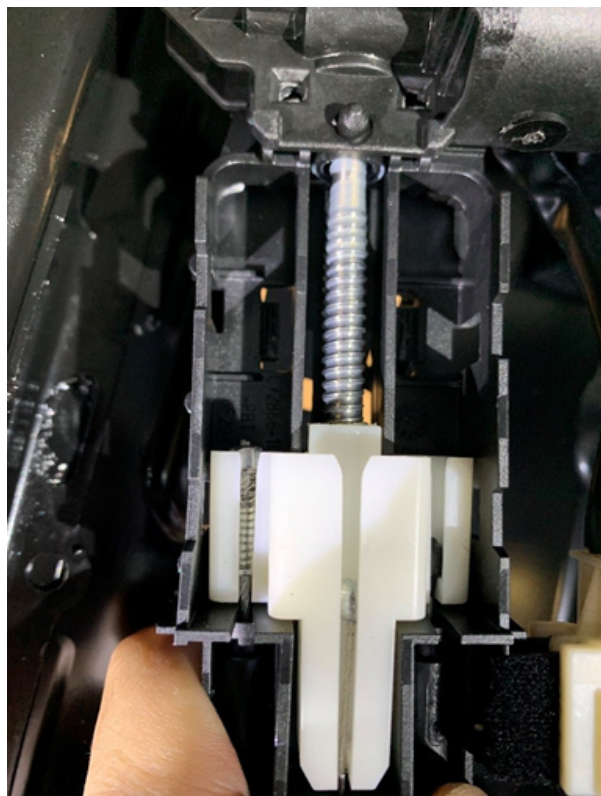
NOTE: If the seat was moved manually with excessive force, it may cause damage to the internal gear of this actuator. The motor may spin but the seat backrest may not move. In this case replacement of the drivetrain for backrest tilt adjustment is needed and the seat frame would not need replacement. **There may be noise from the motor**

if it is internally damaged. To check the gear mechanism, the motor can be removed for inspection.

YES (Latch is open) = Replace drivetrain of backrest tilt adjustment.

See REP 67 31 635 Remove and install/replace drivetrain for backrest tilt adjustment of third-row seating (left or right) (according to vehicle diagnosis)

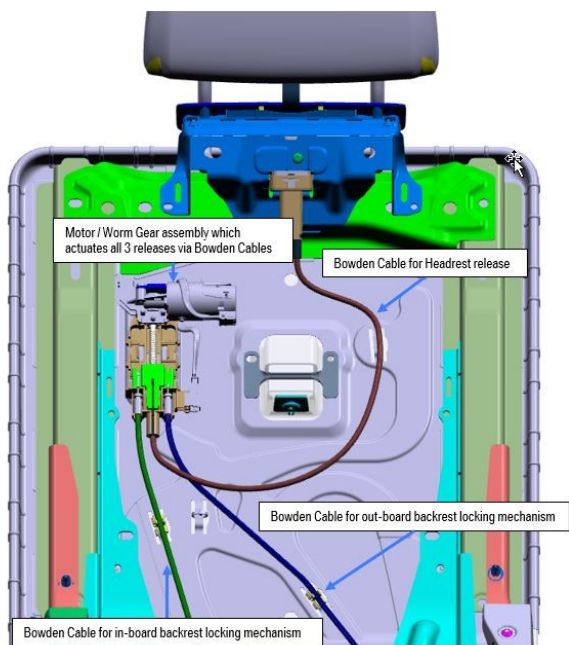
NOTE: The 3 Bowden cables are housed in a common housing that moves along a worm gear assembly.

When the electric motor activates, it spins the worm gear to pull up on the housing so that all 3 cables move simultaneously.

One of the cables controls the head restraint folding. Once pulled, the headrest will release and pivot downwards. **Raising the headrest back into the upright position must be done by pushing up on it by hand.**

(The other two cables control the latch release at the seat pivot to enable the seat to fold.)

Is the drivetrain for the backrest release (actuator) broken?

YES = Replace only the drivetrain for backrest release (actuator).

See REP 67 31 645 Remove and install/replace drivetrain for backrest release of third-row seating (left or right) (according to vehicle diagnosis)

NO = Replace BOTH the Bowden cable(s) and drivetrain for backrest release (actuator).

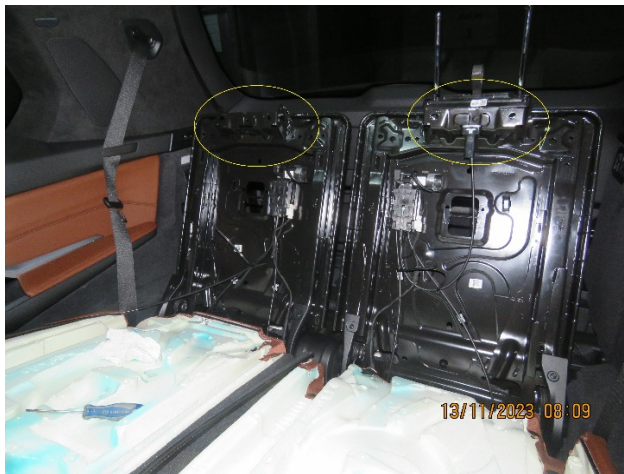
3. Noise from third-row seat backrest when vehicle goes over bumps:

The wire harness going to the electric motor for the Bowden cables is supposed to be routed underneath the Bowden cables to keep the cables from vibrating against the back metal panel.

If necessary, unplug electrical connector, route harness between Bowden cable and metal seat backrest assembly. Reconnect electrical connector.

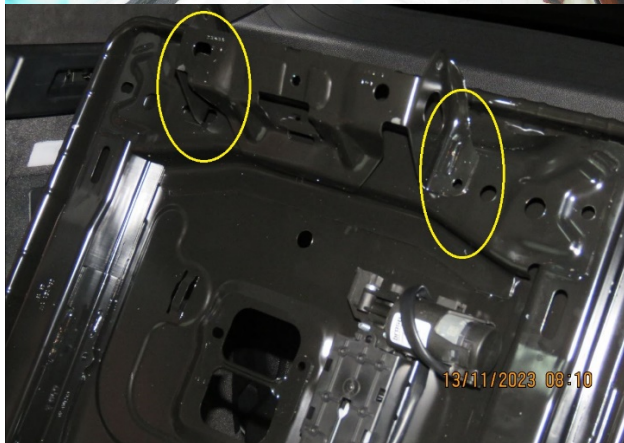
The metal bracket that holds the headrest assembly is welded to the seat backrest assembly.

If any of the welds did not penetrate well this bracket may make noise.

Replace seat frame assembly if necessary.
