# Technical product information

<b>Topic</b>	Bentayga - Auxiliary tail lights in bumper operating instead of main tail lights when not intended
<b>Market area</b>	Australia E04 Bentley rest Asia and Australia (6E04),China 723 Volkswagen (Anhui) Automotive CO (6723),China 796 VW Import Comp. Ltd (Vico), Beijing (6796),Germany E02 Bentley rest Europe (6E02),Japan E03 Bentley Japan (6E03),Korea, (South) E08 Bentley South Korea (6E08),United Arab Emirates E06 Bentley Middle East and Africa (6E06),United Kingdom E01 Bentley UK (6E01),United States E05 Bentley USA and rest America (6E05)
<b>Brand</b>	Bentley
<b>Transaction No.</b>	2063070/3
<b>Level</b>	EH
<b>Status</b>	Approval
<b>Release date</b>

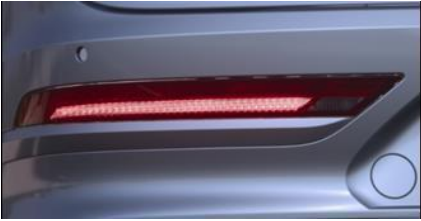
Figure 1

The auxiliary tail lamps in the rear bumper are illuminated instead of the main tail lamps with the tailgate closed, there is no fault with the main tail lamps (Figure 1)

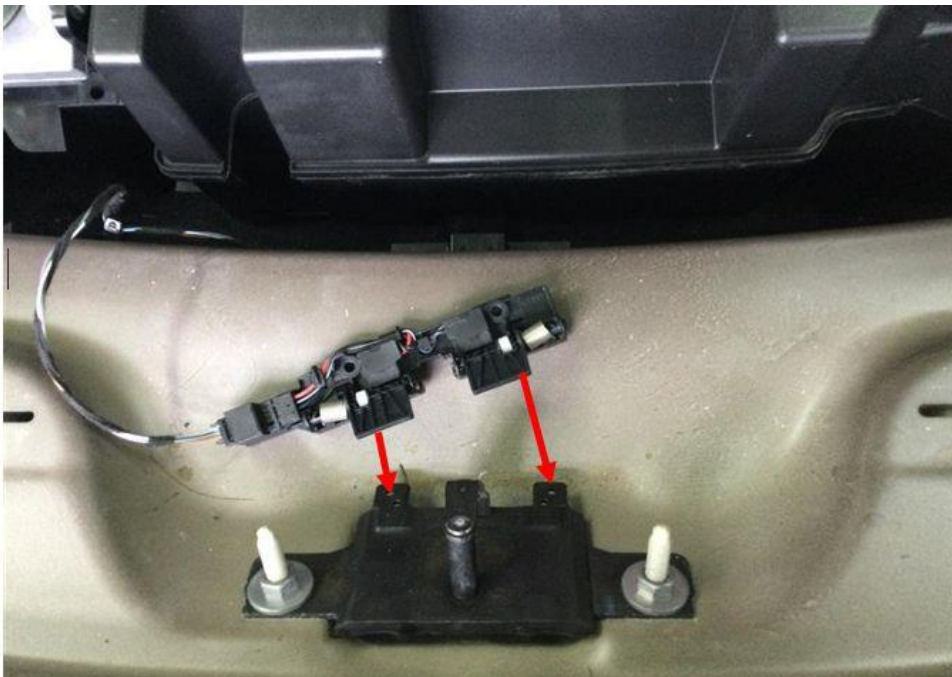
If the tailgate is closed and diagnosis has proven, by way of no DTC's, that the main tail lamps are not faulty, then the Rear lid closed sensor (G525) switch must be checked for locational and electrical integrity

- Figure 2 - Shows a sensor which is not fixed correctly

In this case, fit the sensor to the latch as shown by the arrows

- Use (x2) screws to secure the sensor into position
