Technical product information

Topic	Steering rack diagnosed as faulty (Requires replacement) - Guidelines prior to replacing the steering rack
Market area	Australia E04 Bentley rest Asia and Australia (6E04),China 796 VW Import Comp. Ltd (Vico), Beijing (6796),Germany E02 Bentley rest Europe (6E02),Japan E03 Bentley Japan (6E03),Korea, (South) E08 Bentley South Korea (6E08),United Arab Emirates E06 Bentley Middle East and Africa (6E06),United Kingdom E01 Bentley UK (6E01),United States E05 Bentley USA and rest America (6E05)
Brand	Bentley
Transaction No.	2072029/1
Level	EH
Status	Approval
Release date

Steering rack diagnosed as faulty (requires replacement)

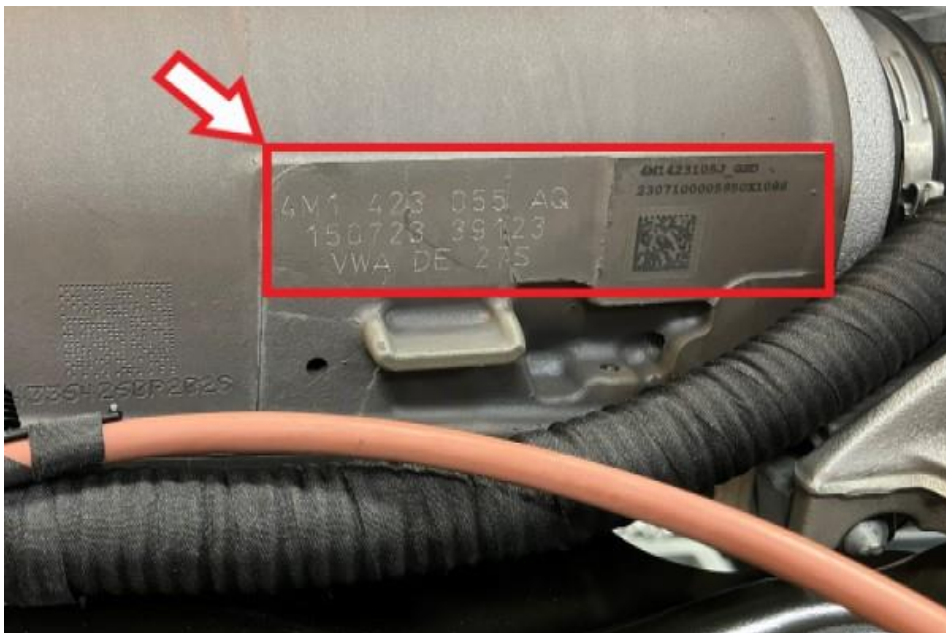
Figure 1

- Clear description of the issue for example - Noisy steering rack
- Clear video of the issue
- Clear photograph of the steering rack serial numbers (Figure 1)
