718 GTS 4.0 - Brake Booster (Power Brake) Warning in Instrument Cluster

Models	Model Year	Model Type	VIN Range	Vehicle-Specific Equipment
718	2021 - 2024	982160 982360 982370	n/a	n/a

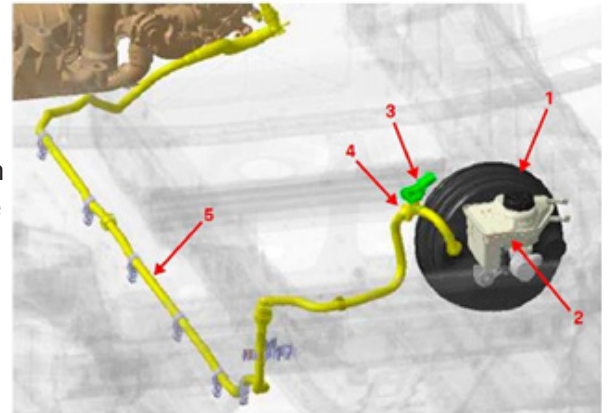
The value of the vacuum line pressure sensor (3 in Figure 1 below) upstream of the brake booster is stored immediately after Terminal 15 is activated. The value is recorded again after 1.5 seconds. Fault P055600 sets if the difference between the two values does not meet or exceed the threshold defined by the DME.

Although this fault is possible at any altitude, it is more likely to occur at higher altitudes due to the lower ambient pressure.
