# **Advanced Technical Information**

Bulletin #: 2331

### VTS Remote Services Fail due to False 3G

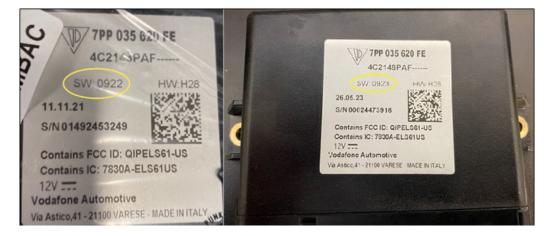
Figure 2

If you receive this part with a software version lower than 0924, please submit a Parts Claims and Returns PRMS ticket to your Area Parts Support Specialist for further instructions. (See figure 2 for 'bad' part examples.)
