# TECHNICAL SERVICE BULLETIN

EC23-009

## MIL IS ON WITH DTC P0300 STORED IN THE ECM

**APPLIED VEHICLES:** 2022-2023 QX60 (L51)

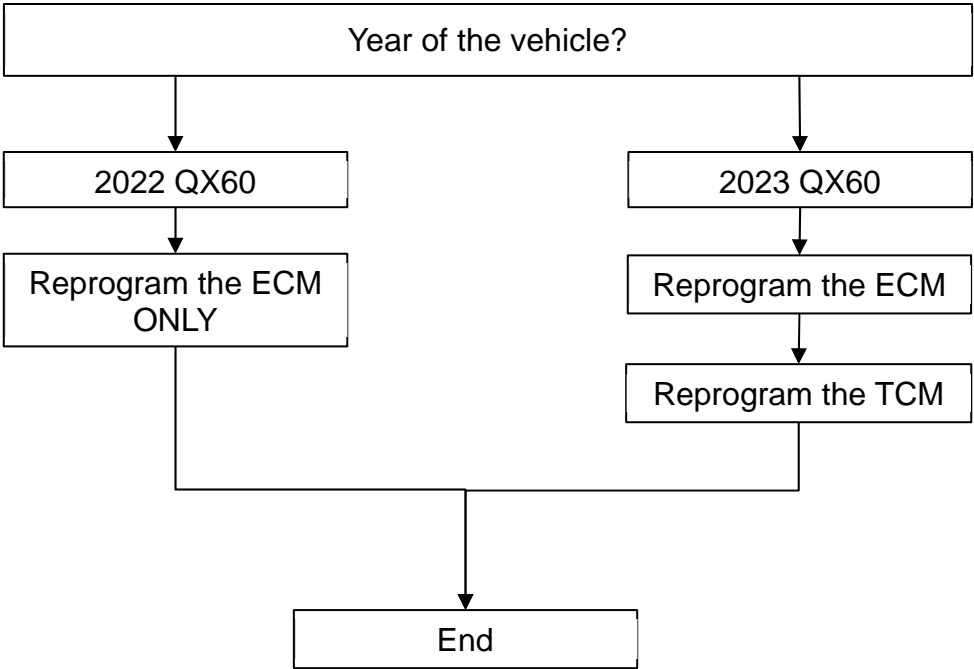
# Repair Overview

The MIL is ON with DTC P0300 for “MULTI CYL MISFIRE” stored in the ECM.

1. Determine applicable model year specific **SERVICE PROCEDURE** with the **Repair Overview** on page 2.
2. Confirm the current ECM and TCM part numbers.
3. Reprogram the ECM and/or the TCM, if applicable.
