**Y1A Taycan**

**On Board Charger (OBC) Fault P31D200 “Charging Socket – Overtemperature”**

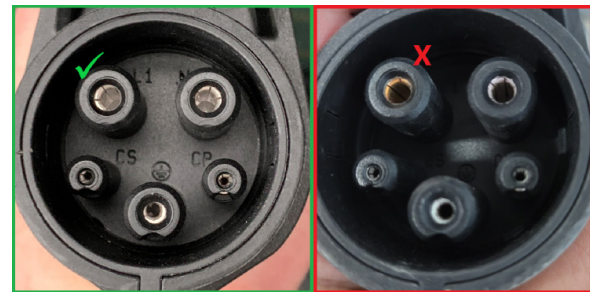
Figure 3

Visually inspect the pins in the vehicle cable connector for signs of overheating, paying particular attention to the L1 Pin. A vehicle cable and L1 Pin which was significantly or repeatedly overheated will show signs of discoloration (refer to Figure 3).

New vehicle cables are available with thicker wiring to prevent repeat occurrence of this condition.

Customers with a Mobile Charger Connect (PMCC) who experience the condition described above shall receive a new, thicker vehicle cable in exchange for the failed vehicle cable.
