Technical product information

Topic	New Continental GT and GTC - Window drop glass operation
Market area	Australia E04 Bentley rest Asia and Australia (6E04),China 723 Volkswagen (Anhui) Automotive CO (6723),China 796 VW Import Comp. Ltd (Vico), Beijing (6796),Germany E02 Bentley rest Europe (6E02),Japan E03 Bentley Japan (6E03),Korea, (South) E08 Bentley South Korea (6E08),United Arab Emirates E06 Bentley Middle East and Africa (6E06),United Kingdom E01 Bentley UK (6E01),United States E05 Bentley USA and rest America (6E05)
Brand	Bentley
Transaction No.	2070497/6
Level	EH
Status	Approval
Release date

Retailer glass reset procedure for GT/GTC

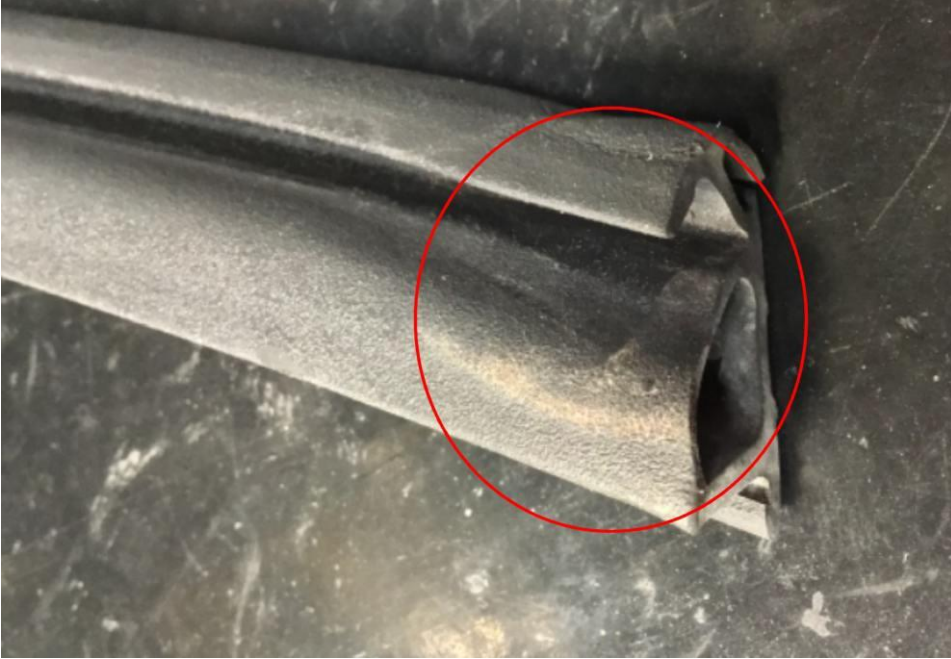
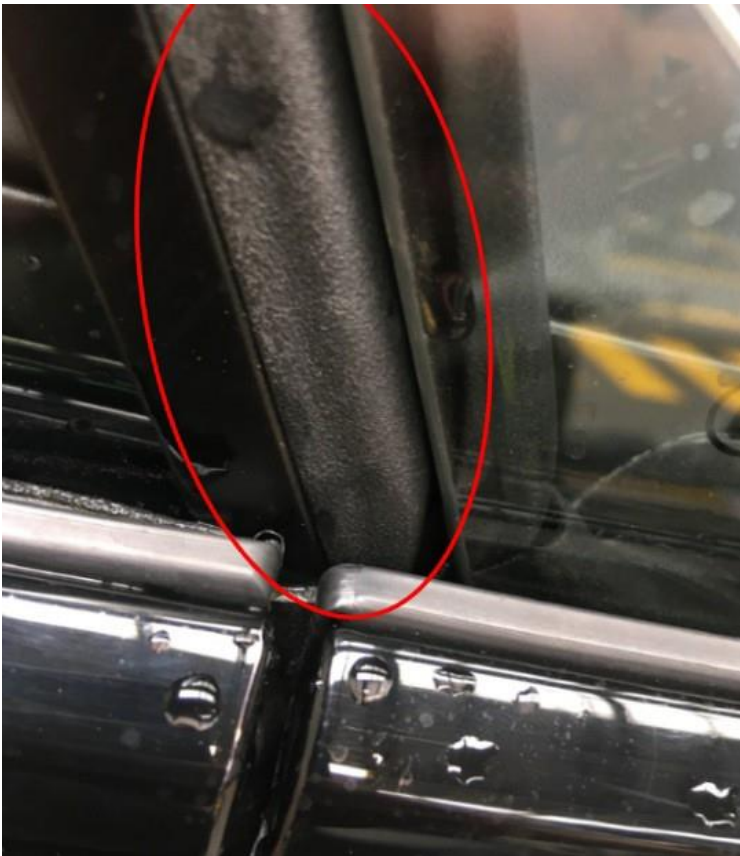
- Damage
- Splits
- Tears
- Misalignment
- Incorrectly fitted/located
- Drop glass seal deformation (see Figures 9 and 10 as examples)

NOTE: Any issues found with the window seals must be rectified before conducting the remaining steps

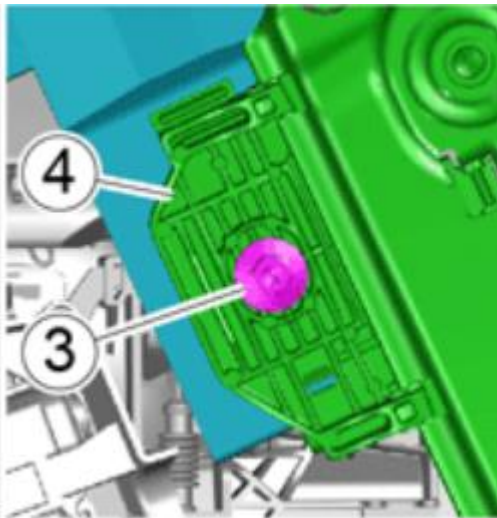
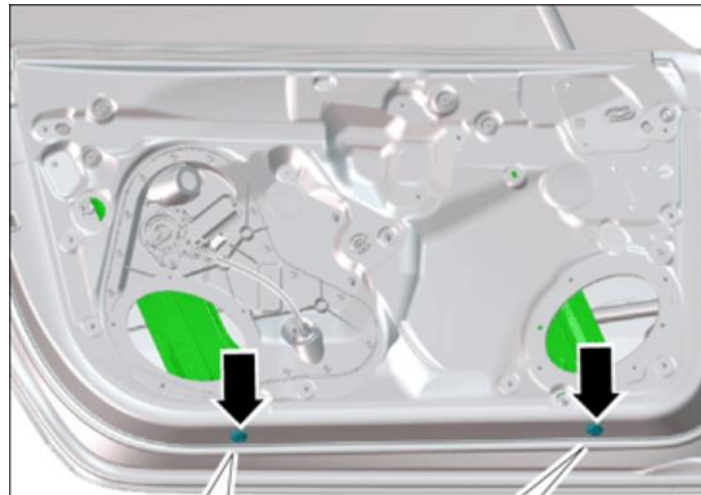
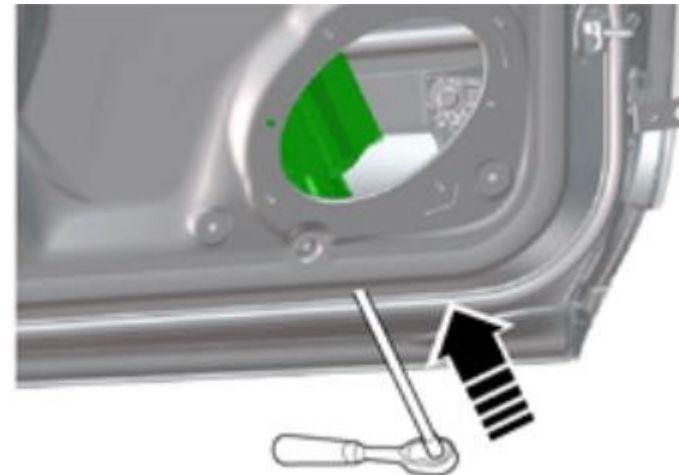
Example: Front drop glass Z axis not adjusted correctly. Bottom of tape was level with waist rail seal, after slackening pinch bolt (3 in bottom left image) front drop glass lowered 14mm to where pen marked line is.

Z-axis adjusters (bottom middle and right images) had not been used, pinch bolt had been slacked and glass lifted out of the regulator to achieve specification. This has a knock on effect of altering the 10mm division bar intrusion seen in previous slide as glass is loose and can be accidentally moved in X-axis.

This also creates a risk that the window will bottom out on the cant rail seals rather than the regulator bump stops meaning that the glass can raise further as the seals soften over time and affect end stop learning.

Z-Axis height should only be adjusted by the 4mm Allen key adjusters as per ELSAPRO

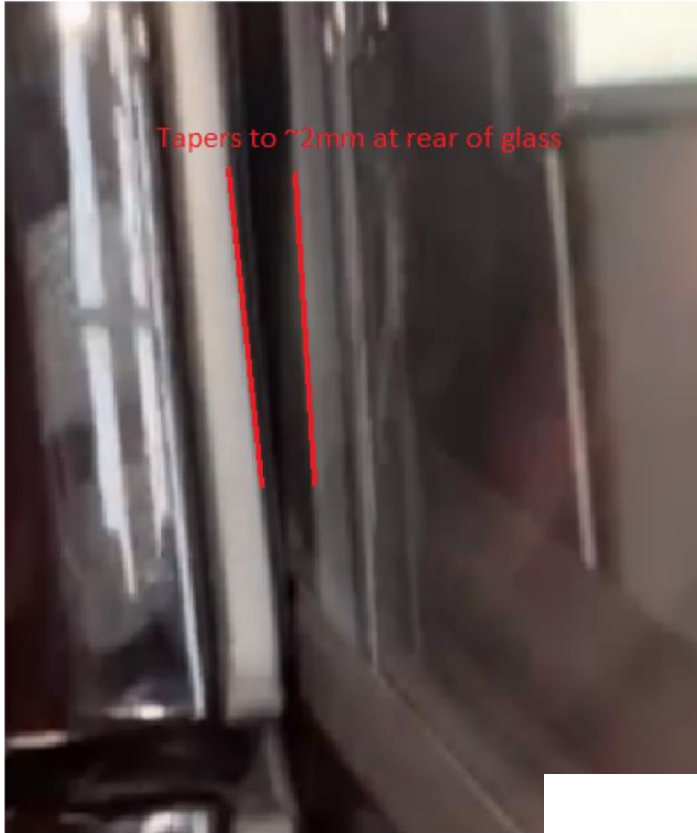
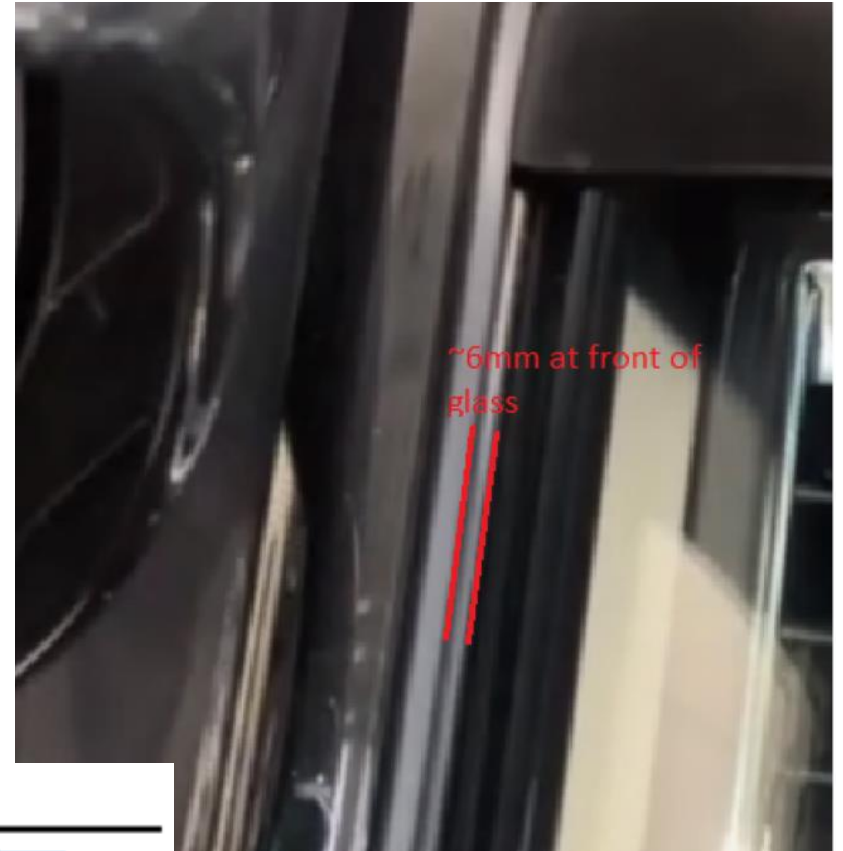
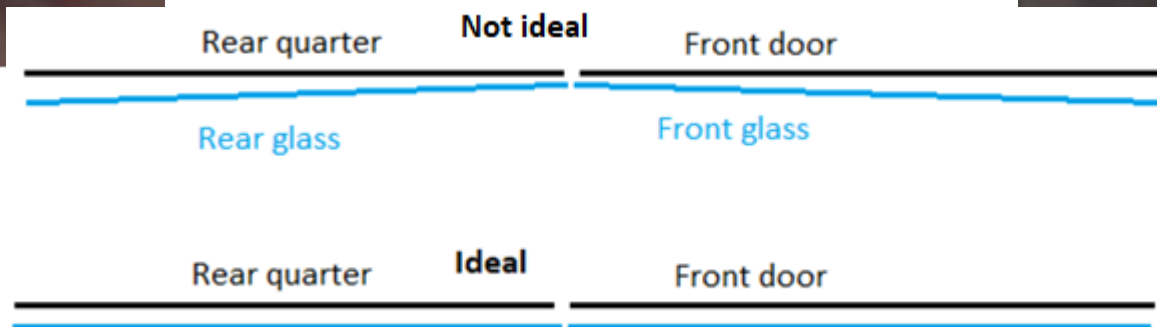
Images show a poor setting.
Circa 6mm at front edge (near wing mirror)
closing up to 2mm at the rear edge.

2mm at rear edge would have been set to achieve specified flush/2mm underflush profile condition between front and rear glasses, the rear quarter glass mirrors this taper condition. This potentially increases the risk of false anti trap as rear window/seal does not engage with front window at the correct angle. Suggested to set to specification on problem vehicles as per next slide. If both windows are set between 4-6mm then the flush/2mm underflush profile can be easily achieved.
