# TECHNICAL SERVICE BULLETIN

Classification: EC23-008	Reference: NTB23-079	Date: November 6, 2023
-----------------------------	-------------------------	---------------------------

## MIL IS ON WITH DTC P0300 STORED IN THE ECM

**APPLIED VEHICLES:** 2022-2023 Pathfinder (R53)  
**APPLIED ENGINES:** VQ35DD

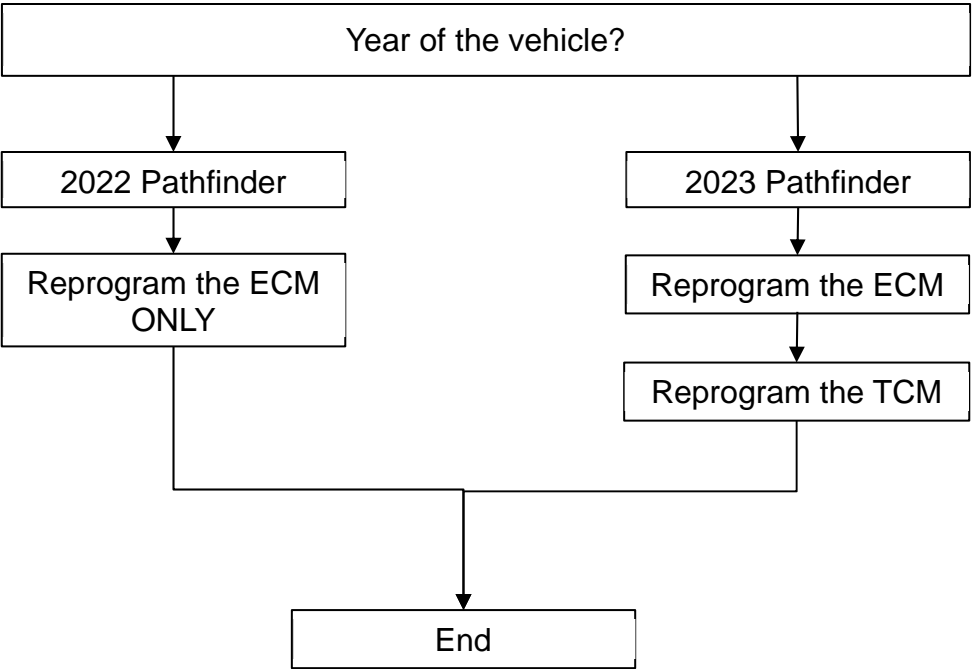
# Repair Overview

The MIL is ON with DTC P0300 for “MULTI CYL MISFIRE” stored in the ECM.

1. Determine applicable model year specific **SERVICE PROCEDURE** with the **Repair Overview** on page 2.
2. Confirm the current ECM and TCM part numbers.
3. Reprogram the ECM and/or the TCM, if applicable.
