TECHNICAL SERVICE BULLETIN

TSB #:	TSB55102302	Release Date:	10/26/2023
Main Group:	55 - Body Closures		
Subject:	Hood Bolt Rivet Nut Attachment		
Vehicle: 32	FM29 OCEAN	Production Range:	ALL
Model Year(s):	2023	Region(s):	Global
Mobile Service:	NO

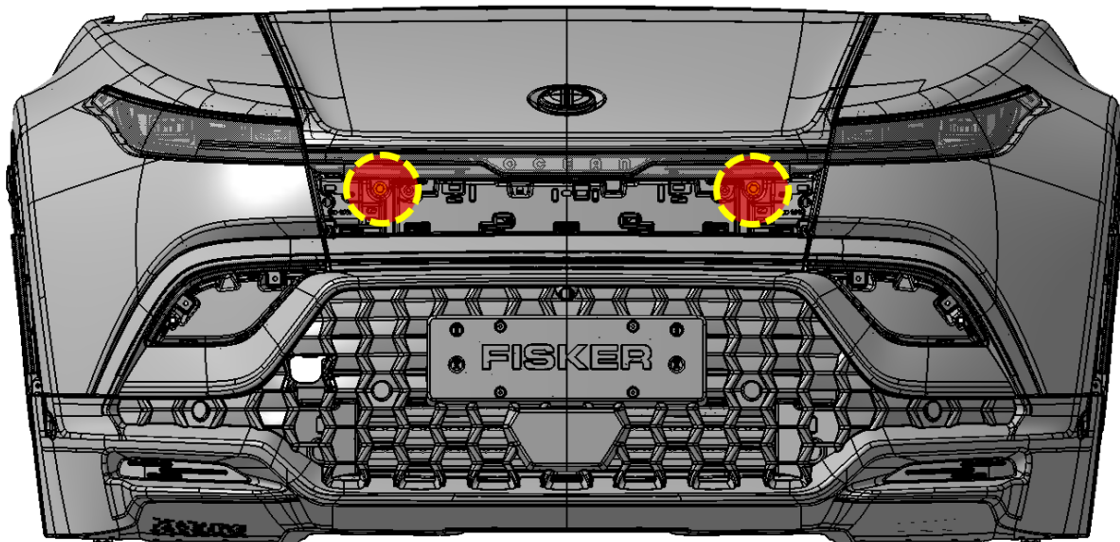
The mounting brackets & bolts that keep the hood in a closed position are located behind the service lid on the front end of the vehicle. The bolts are attached to a Rivet nut fitted on the upper metal bracket cross member.

Figure 1.- Ocean front view, highlighted bolts position.

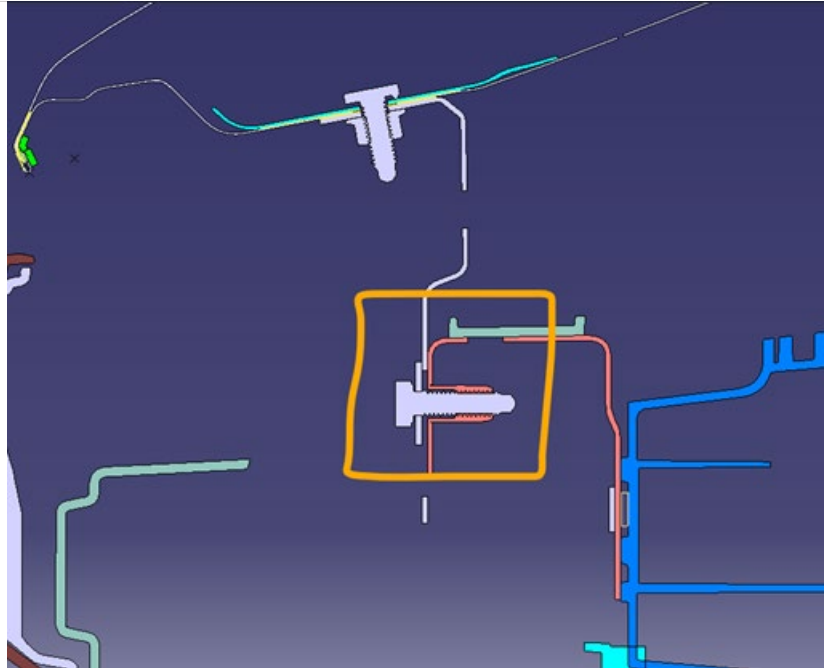
Usage of excessive force (such as power tools) for removing the bolts securing the hood to the upper metal bracket can damage or break loose the rivet nut. When this happens, a new rivet nut needs to be attached to the vehicle.

Figure 2.- cross section showing bracket, bolt & rivet nut interaction.

The Bolt is attached to 19Nm without the addition of any Loctite (or similar thread lock adhesive) thread addition.

When removing the bolts for opening the hood, you need to make sure that the applicable torque of the tool does not exceed **24Nm** for removal.

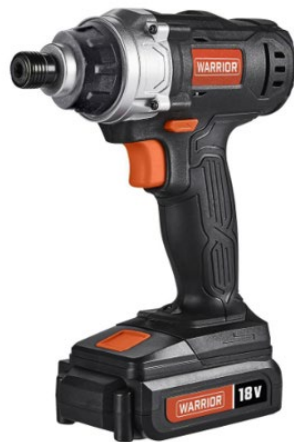
Any power tool that can generate more than 24Nm is strictly forbidden from being used to remove the hood bolts. Ignoring this crucial step can damage the rivet and cause it to start spinning with the bolt.

A) Impact drill

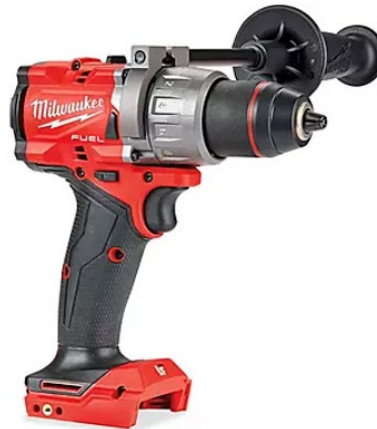
B) Hammer drill
