## Rangeline TSB

Airstream has identified a few service opportunities on Rangeline models built before 5/22/2023. The following service bulletin will help identify the issues and the solutions. Please complete each procedure in the order provided. Not all Rangeline's will require every update. All Rangeline's, even those built between 5/22/2023 and 10/10/2023, will require the Firefly firmware to be updated to 1.28.

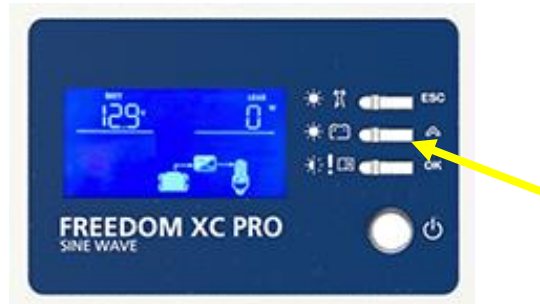
2. Verify the U3 by pressing the middle button on the inverters display a few times, until the firmware version is shown. Use the chart below to determine which firmware file is needed, based on the U3 displayed.

3. After determining which firmware is needed, download the zipped Xantrex firmware folder onto a freshly formatted FAT32 USB drive.

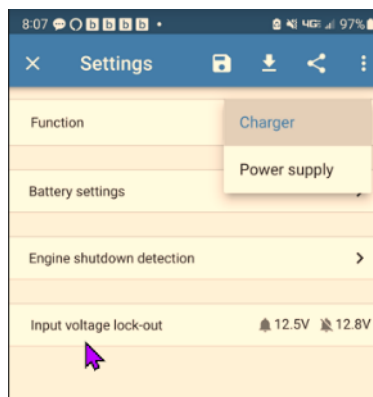
Airstream has determined that the Victron Orion-Tr Smart DC-DC Converter's programming is defaulting to an incorrect setting of "Power Supply" instead of the correct setting of "Charger." It was also found that the connector on the DC-DC harness may have a socket-to-socket connection, instead of the correct pin-to-socket connection.

3. Once logged into the correct Orion device, next to the FUNCTION field, tap to select between "power supply" and "charger." Select the correct setting of "Charger."

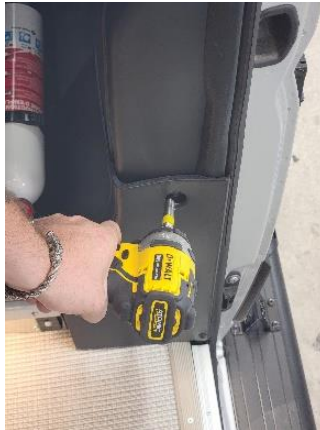
4. Remove the fire extinguisher, and the passenger's side B-pillar cover, to inspect the connection. If a Wago connector, or butt splice, is connecting the Dodge harnesses Blue/Yellow wire to the Airstream Blue wire, no repair is required.

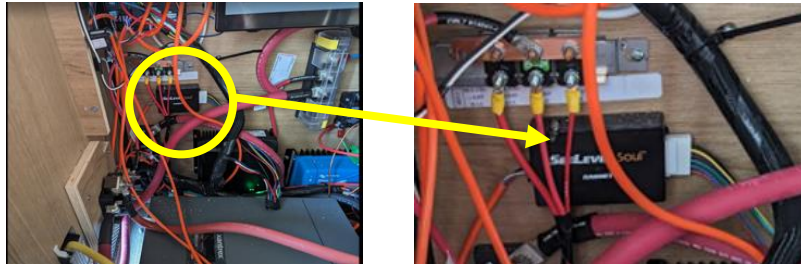
Garnet Instruments has determined that the SeeLevelL Soul Data Module may cause RV-C Network failures in temperatures exceeding 104F (40C). In high heat environments, the processor clock timing shifts out of CAN specification, causing the RV-C network to fail. The shift in timing can also cause the Xantrex inverter to stop communicating on the RV-C Network. A firmware update (4.5.2 or newer) was created for the 708-RVC\_H and tested at temperatures up to 185F (85C) for 72 hours without any failures. Although the issue has been observed and duplicated, some 708-RVC and 708-RVC\_H models passed testing and did not fail.

1. Locate the Soul module, it will be a small black box, mounted to the electrical cabinets wall with a SeeLevelL Soul logo. If the installed Soul module has a 7-pin connector, it does not need to be replaced. If the module has a 9-pin connector, it will need to be replaced with a new 7-pin version.

2. To replace the Soul model, remove the screws securing the module to the wall. Disconnect the 9-pin connector harness and the RVC plug. Mount the new 7-pin module using the same screws and connect the RVC plug.
3. With the new Soul module installed, a new 7-pin harness will be needed to replace the old 9-pin harness. To do so, cut the wires from the 9-pin harness and connect them to the 7-pin harness, that was provided with the new module, using the wiring schematic below.

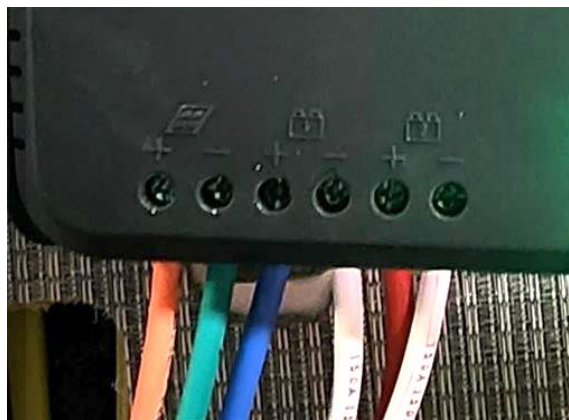
**Correct wiring:**

Airstream has determined that the roof mounted solar panels were wired to the chassis battery as primary and the house battery as secondary. This wiring provides solar charging to the chassis battery before charging the house battery. The GoPower box will need to be rewired to allow the solar panels to charge the house battery, providing better utilization of the solar panels.

- a. SC1e (Blue wire - house battery) wired to Battery #1 +terminal
  - b. SC1c (Red wire - chassis battery) wired to Battery #2 +terminal
3. If the controller is wired with SC1c (chassis) into Battery #1, it will need to be relocated to the Battery #2 +terminal. The SC1e (house) wire will be relocated into the Battery #1+terminal. See wiring schematic below.

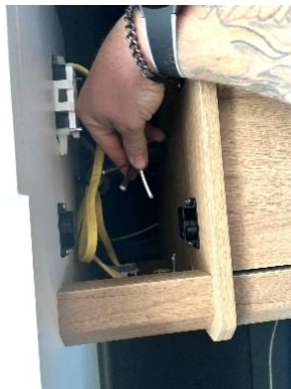
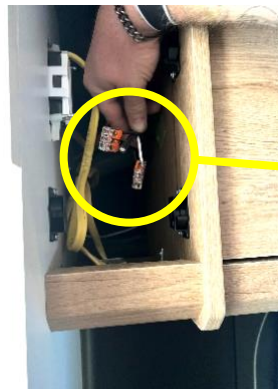
Airstream has determined that the pre-wired TV antenna booster circuit may be unprotected. The ends of the pre-wires should be capped to prevent it from blowing a fuse.

3. Locate the TV antenna booster pre-wires, which are brown and white wires, with a coaxial cable. Cap, both the brown and white wires, with Wago connectors. When finished, make sure to wrap the Wagos with electrical tape.
