Service Bulletin

Bulletin No.: 23-NA-145

Subject: Radio Software Version 167.5

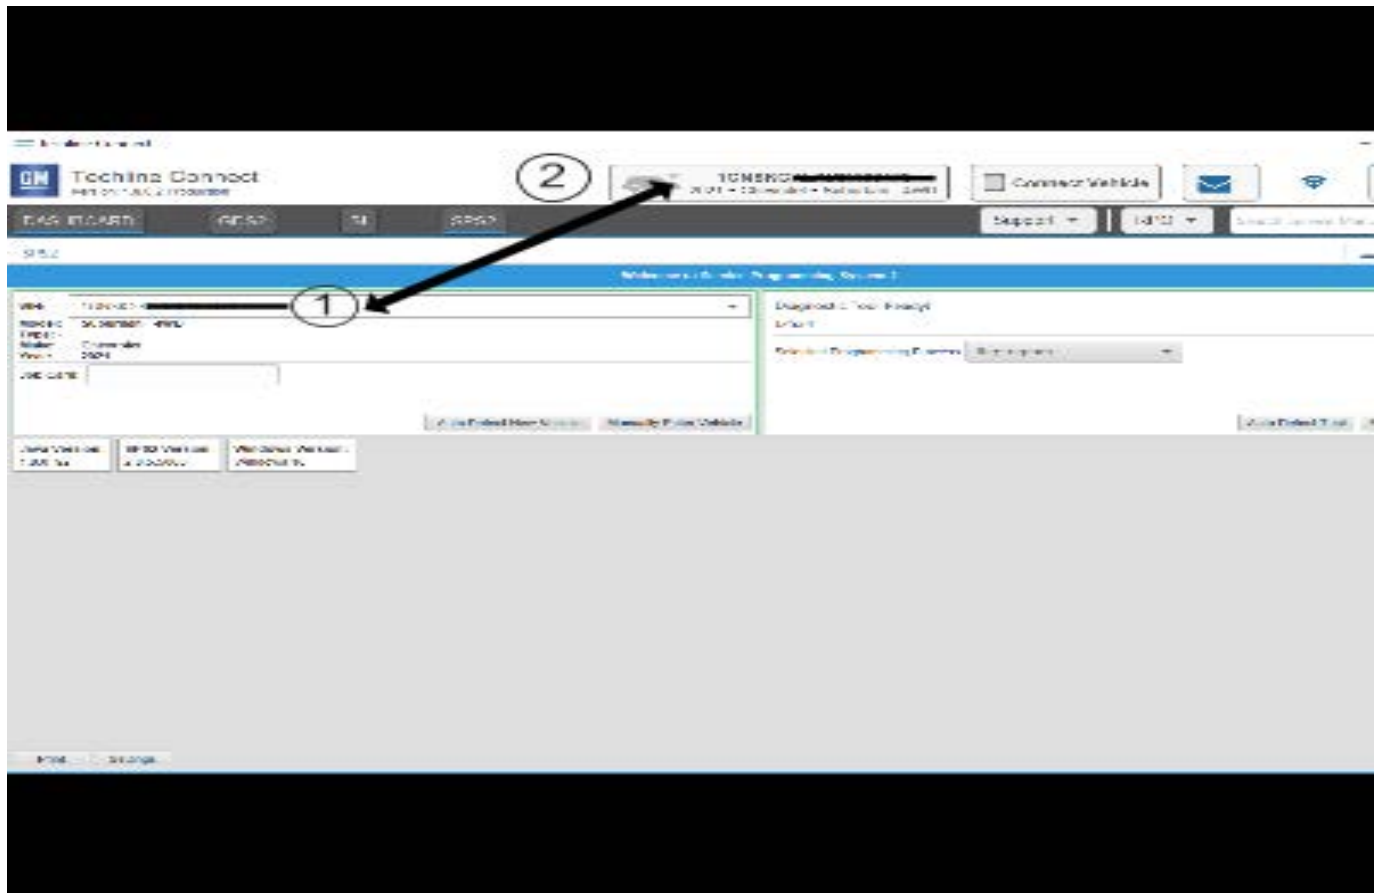
Caution: Be sure the VIN selected in the drop down menu (1) is the same as the vehicle connected (2) before beginning programming.

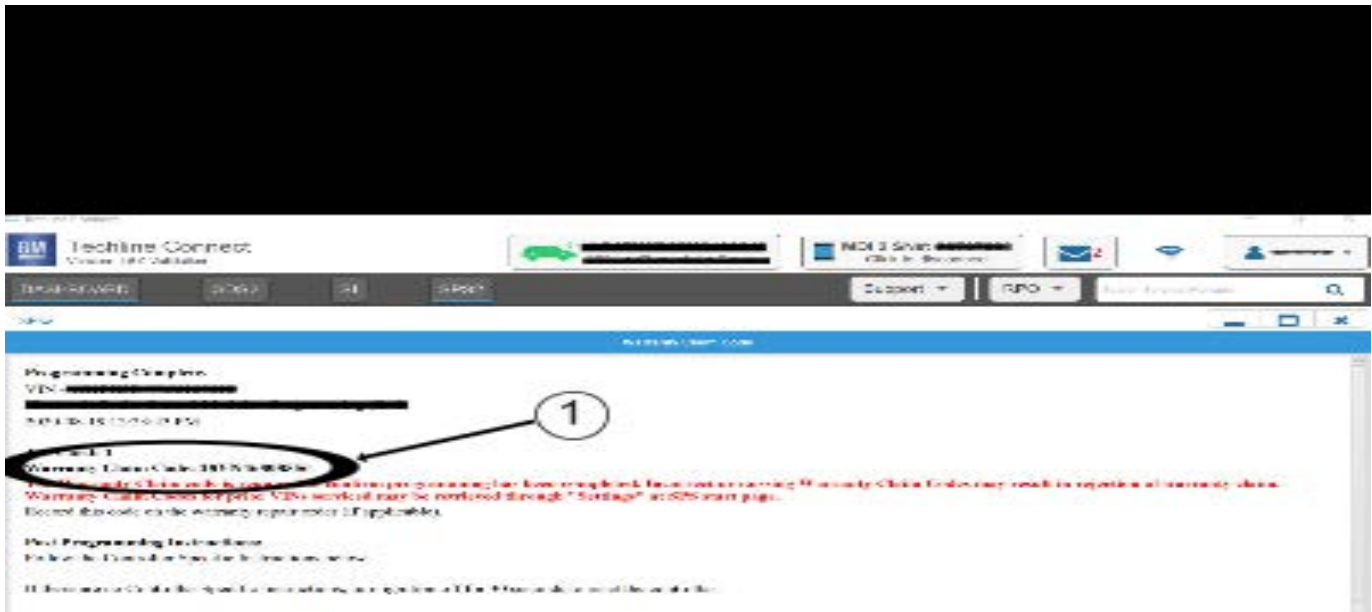
5644478

Note: The screenshot above is an example of module programming and may not be indicative of the specific module that is being programmed. Module selection and VIN information have been blacked out.

Important: To avoid warranty transaction rejections, you **MUST** record the warranty claim code provided on the Warranty Claim Code (WCC) screen shown above on the job card. Refer to callout 1 above for the location of the WCC on the screen.

2. Record the SPS Warranty Claim Code on the job card for warranty transaction submission.
