Service Bulletin

Bulletin No.: 23-NA-211

Subject: Information on Rear Trunk Latch Inoperative

Brand:	Model:	Model Year:		VIN:		Engine:	Transmission:
		from	to	from	to		
Chevrolet	Camaro	2023	2024	—	—	All	All

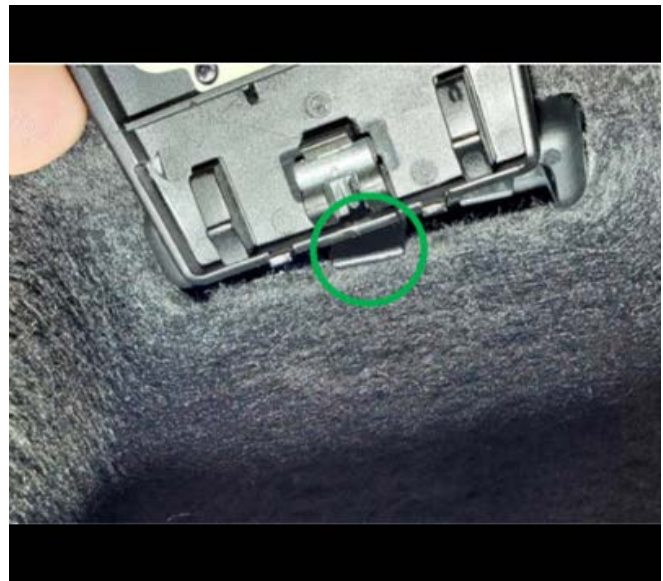
6483345

Correct Install

The carpet position must first be evaluated. Please refer to the visuals below and compare this with the customer vehicle. If the carpet is found out of place, it must be tucked between the ETR bezel and the sheet metal so that the tab is showing.

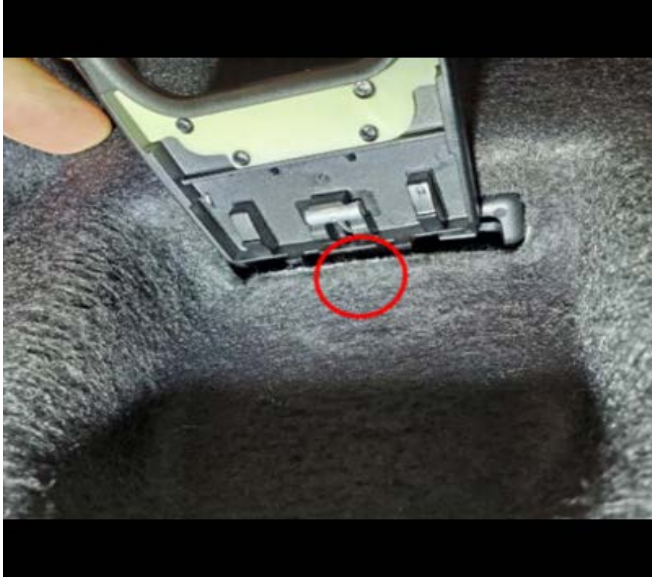
6483347

Incorrect Install

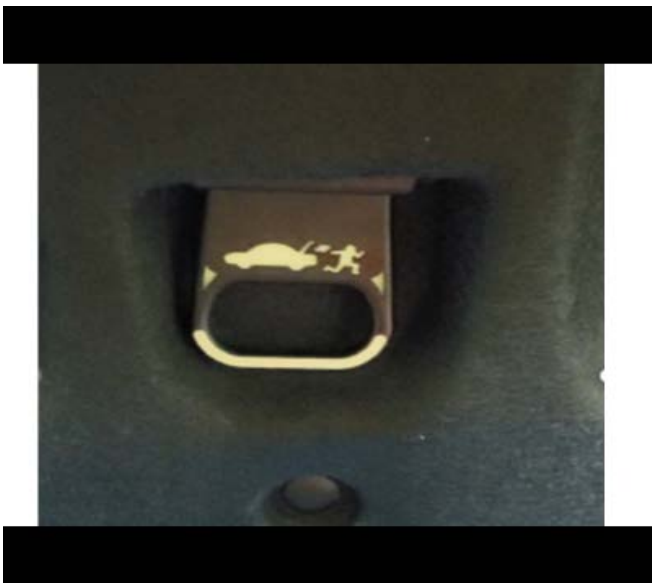
6483348

ETR Handle NOT Snapped in Properly

Note: This is an example of an ETR handle that is **NOT** snapped in properly.

Once that is confirmed as good, then the ETR handle can be snapped into the proper position in the bezel. :

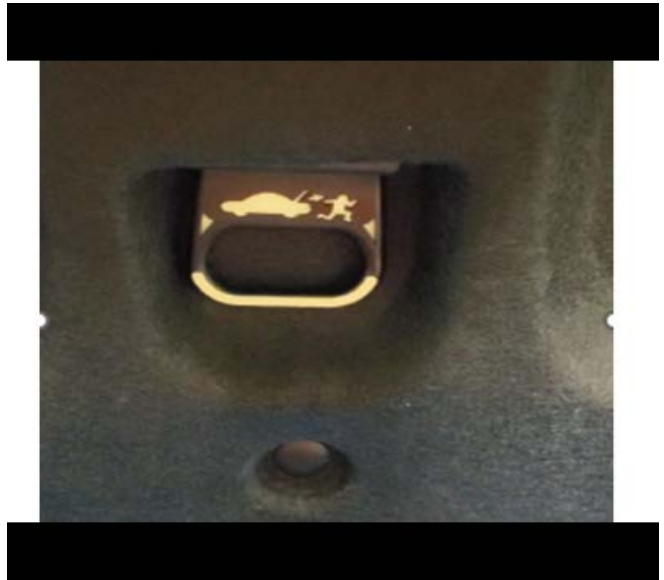
6483349

ETR Handle Snapped in Properly

Note: This is an example of an ETR handle that is snapped in properly. There must be very little distance between the car/person graphic and the bezel.
