Service Bulletin

Bulletin No.: 23-NA-106

Subject: Floor Console Armrest Lower Panel Separating

Brand:	Model:	Model Year:		VIN:		Engine:	Transmission:
		from	to	from	to		
Cadillac	LYRIQ	2023	2024	—	—	All	All

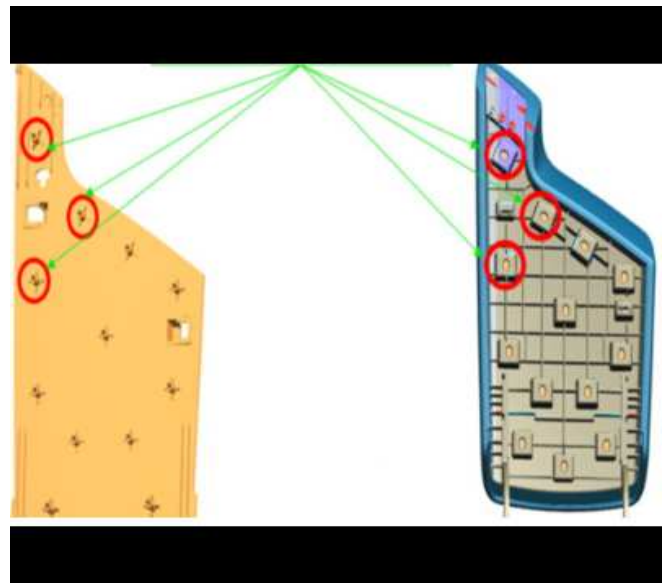
6370321

Involved Region or Country	North America
Condition	Some customers may comment that the upper lid of the console center armrest is separating from the lower section when trying to open.
Cause	The cause of the condition may be that in high temperatures, the retention force is insufficient to retain the panel when opening the armrest.
Correction	If you encounter a vehicle with the above concern, complete the Service Procedure outlined below.

1. Add 3M Scotch-Weld Structural Plastic Adhesive DP8010 adhesive (or equivalent) in the snap retention features at front of armrest lower panel shown above.
