Service Bulletin

Bulletin No.: 23-NA-107

Subject: Roof Related Water Leak, Key Fob Inoperative and/or Various Remote Control Door Lock Receiver (RCDLR) Concerns

Brand:	Model:	Model Year:		Vehicle Build Date:		Engine:	Transmission:
		from	to	from	to		
Chevrolet	Trax	2024	2024	SOP	August 18th, 2023	All	All

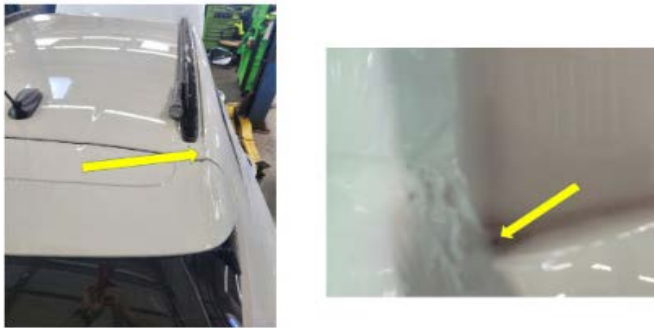
</p> <p>[Redacted]</p> <p>6370899</p> <p>The cause of the condition may be a pin hole / poor sealing in the roof body seam or poor brazing weld. This condition could occur at either the front and/or rear, and on the right and/or left side or cross rail front stud not sealing to body of the vehicle.</p> <p>[Redacted]</p> <p>

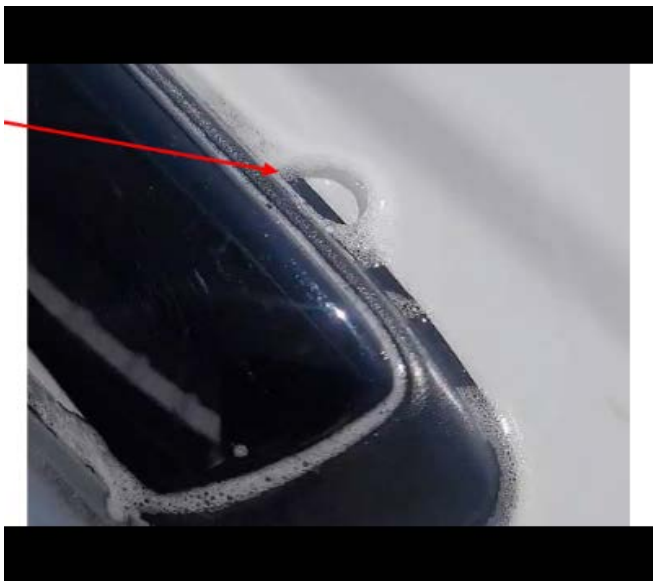
6445101

1. Visually inspect the front right and left roof laser braze, then the rear right and left roof laser braze, for pin holes or a crack.

2. Seal the holes/crack in any laser braze area following the steps below:
 - 2.1. Mix a small amount of Kent® High-Tech Seam Sealer Clear P10200, or Wurth Euroseal Gel Clear 18920104, or equivalent WITH the proper touch-up paint color.
 - 2.2. Avoiding excess sealer build-up within the ditch, work a small amount of the sealer into the hole with a gloved finger.
 - 2.3. Wipe away any excess sealer with a light amount of solvent on a rag or paper towel. The solvent will help the sealer flow into the hole/crack.
3. Clean and dry any wet trim. Refer to *Floor Carpet Drying* in SI.
