# Technical Service Bulletin

## 69 Airbag warning light on, DTC: B10041B stored in the airbag module

69 23 04 2072122/1 December 1, 2023.

Model(s)	Year	VIN Range	Vehicle-Specific Equipment
Q4 e-tron, and Q4 Sportback e-tron	2022 – 2024	All	Not Applicable

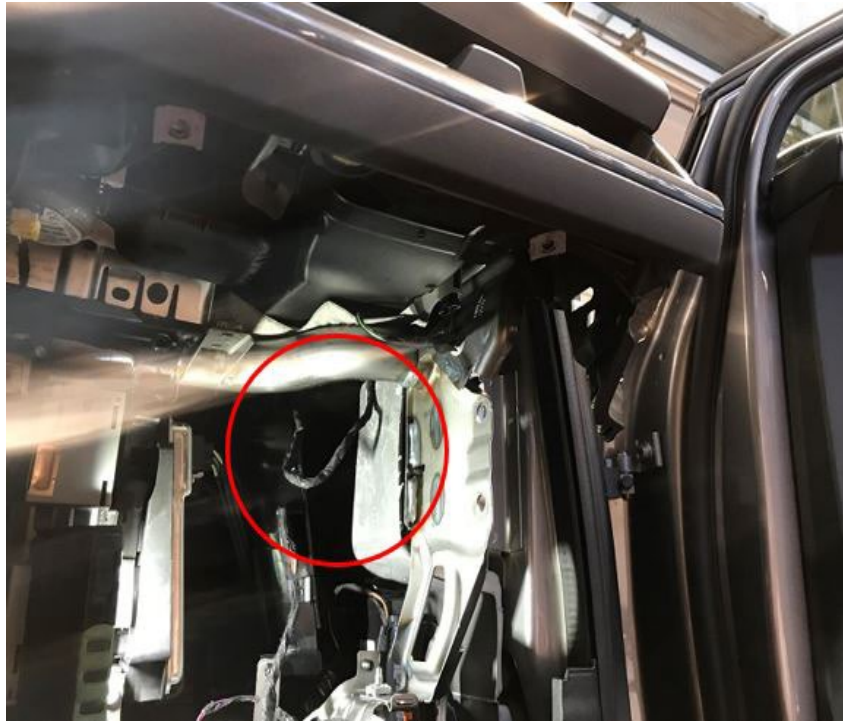
During production the wire harness may have been pinched during assembly.

**Figure 1:** Location of harness inspection.

1. Remove the glovebox and inspect the harness routing in the area of the red circle shown in Figure 1.

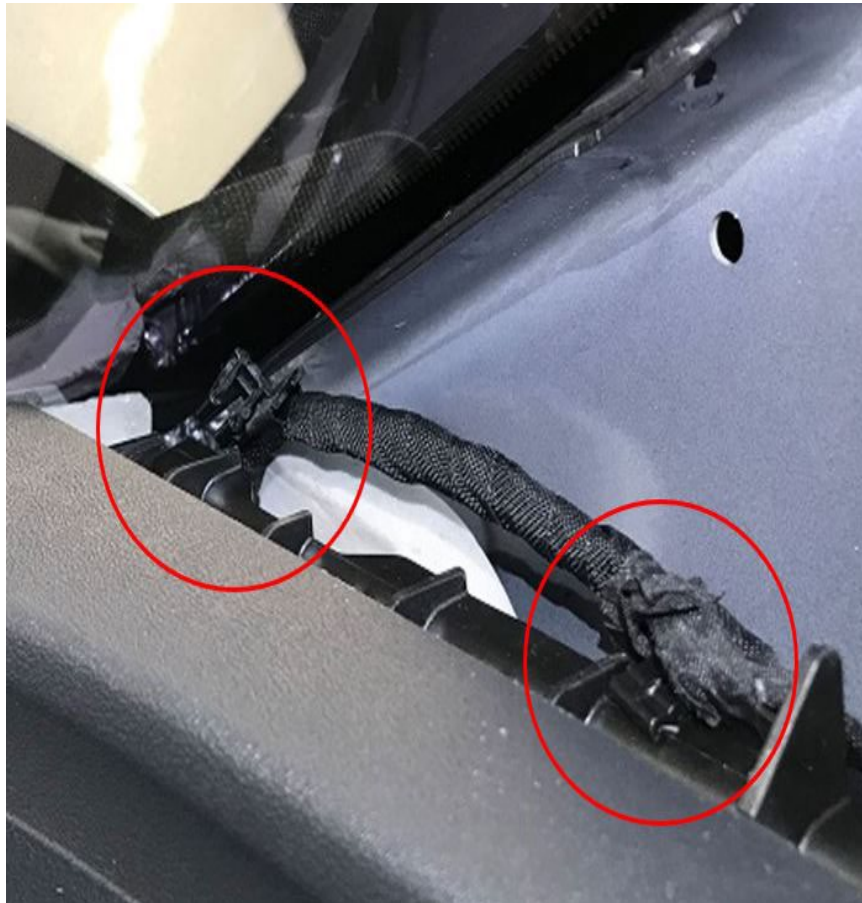
**Figure 2:** Unclip the harness.

- Remove the passenger A-pillar trim.
- Unclip the harness from the securing tabs indicated by the red circles in Figure 2.

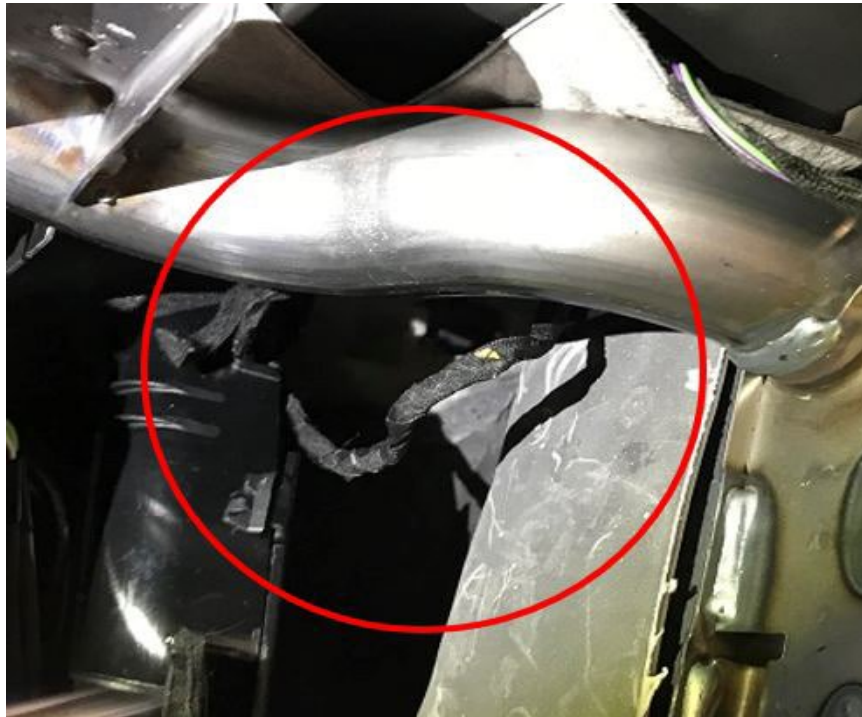
3. Inspect the harness closely as the damage may only be visible after removing the harness tape.

*Figure 3: Secure the wires.*

Repair the affected wires using wiring harness repair set **VAS 1978 B/C**

Secure the wires as needed to ensure they no longer contact other components (Figure 3).
