GLOBAL SAFETY FIELD INVESTIGATIONS
DCS6745
URGENT - DISTRIBUTE IMMEDIATELY

Subject: N232427140 - Customer Satisfaction Program
Tire Size Reprogramming

Models: 2022 – 2023 Chevrolet 6500XD LCF

N232427140 Tire Size Reprogramming

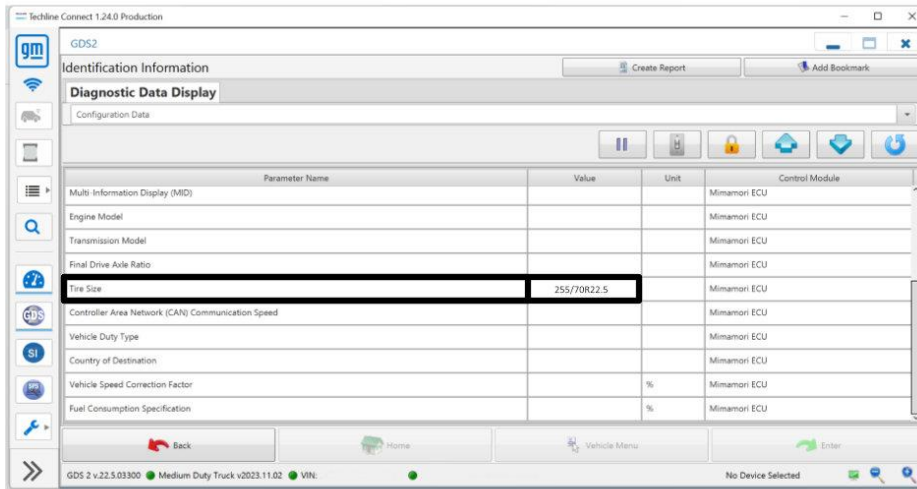
6495265

5. Scroll down the Parameter Names until you find "Tire Size." Verify that the tire size is 255/70R22.5 under the "Value" row.
 - If the value that was recorded in the inspection conducted in Step 2 is 255/70R22.5 and the MMU value is 255/70R22.5, the tire size value is CORRECT. No further action is required.
 - If the value that was recorded in the inspection conducted in Step 2 is 255/70R22.5 and the MMU is 11R22.5, the tire size value is INCORRECT. Continue to the next step to configure the correct tire value.
