Service Bulletin

Bulletin No.: 23-NA-211

Subject: Information on Rear Trunk Latch Inoperative

Brand:	Model:	Model Year:		VIN:		Engine:	Transmission:
		from	to	from	to		
Chevrolet	Camaro	2023	2024	—	—	All	All

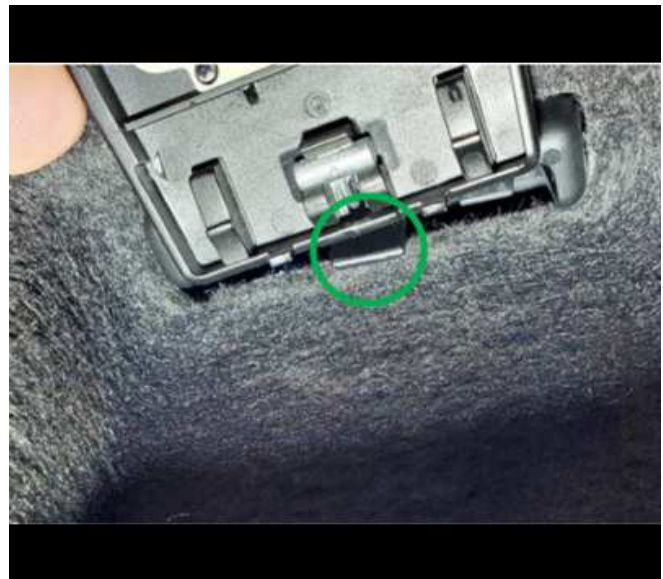
6483345

Correct Install

The carpet position must first be evaluated. Please refer to the visuals below and compare this with the customer vehicle. If the carpet is found out of place, it must be tucked between the ETR bezel and the sheet metal so that the tab is showing.

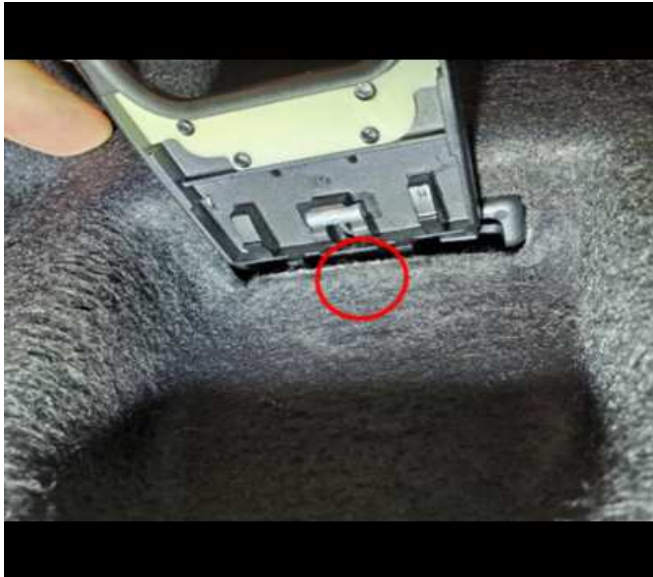
6483347

Incorrect Install

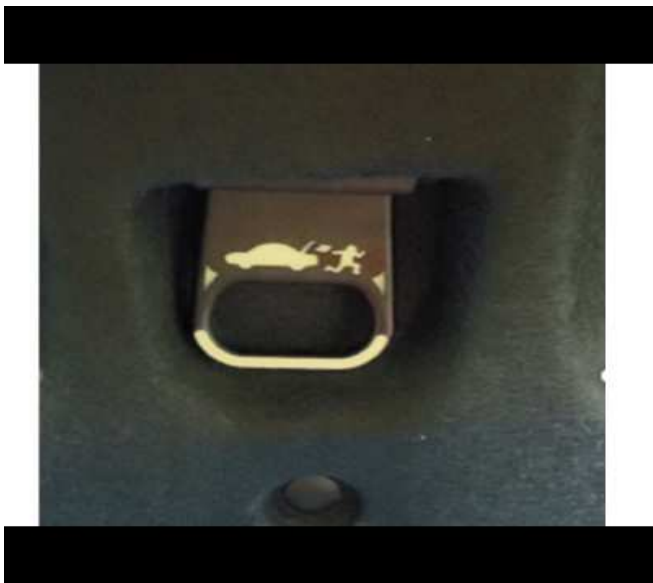
6483348

ETR Handle NOT Snapped in Properly

Note: This is an example of an ETR handle that is NOT snapped in properly.

Once that is confirmed as good, then the ETR handle can be snapped into the proper position in the bezel. :

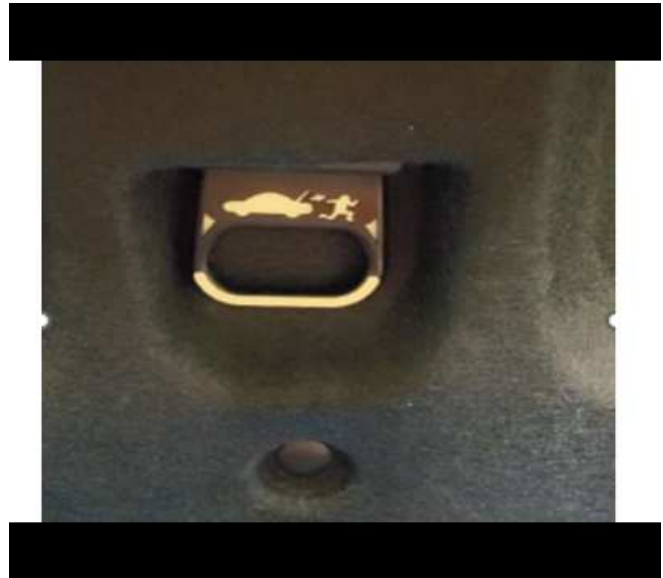
6483349

ETR Handle Snapped in Properly

Note: This is an example of an ETR handle that is snapped in properly. There must be very little distance between the car/person graphic and the bezel.
