# Service Bulletin

Bulletin No.: 20-NA-066

**Subject: Malfunction Indicator Lamp Illuminated with One or More Glow Plug Control DTCs Set**

Brand:	Model:	Model Year:		VIN:		Engine:	Transmission:
		from	to	from	to		
Chevrolet	Silverado 1500	2020	2020	-	-	LM2	-
GMC	Sierra 1500

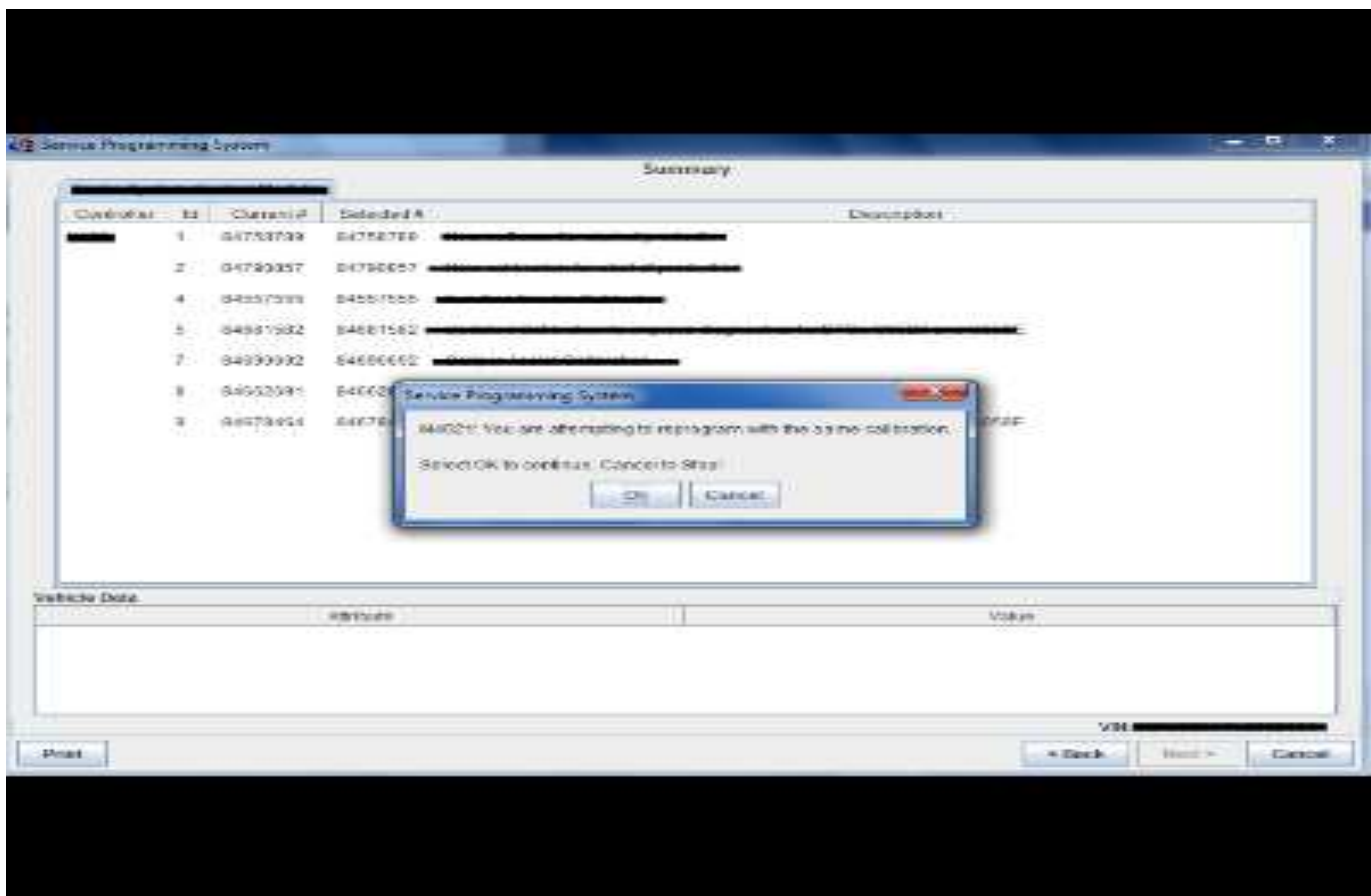
5431207

**Important:** If the Same Calibration/Software Warning is noted on the SPS screen, select OK and follow screen instructions. After a successful programming event, the WCC is located in the Service Programming System dialogue box of the SPS Summary screen. No further action is required. Refer to the Warranty section of the bulletin.

1. Reprogram the GPCM. Refer to *K34 Glow Plug Control Module: Programming and Setup* in SI. Modify as required (e.g., select x module from the controller screen. Then provide step-by-step instructions or refer to SI procedure.

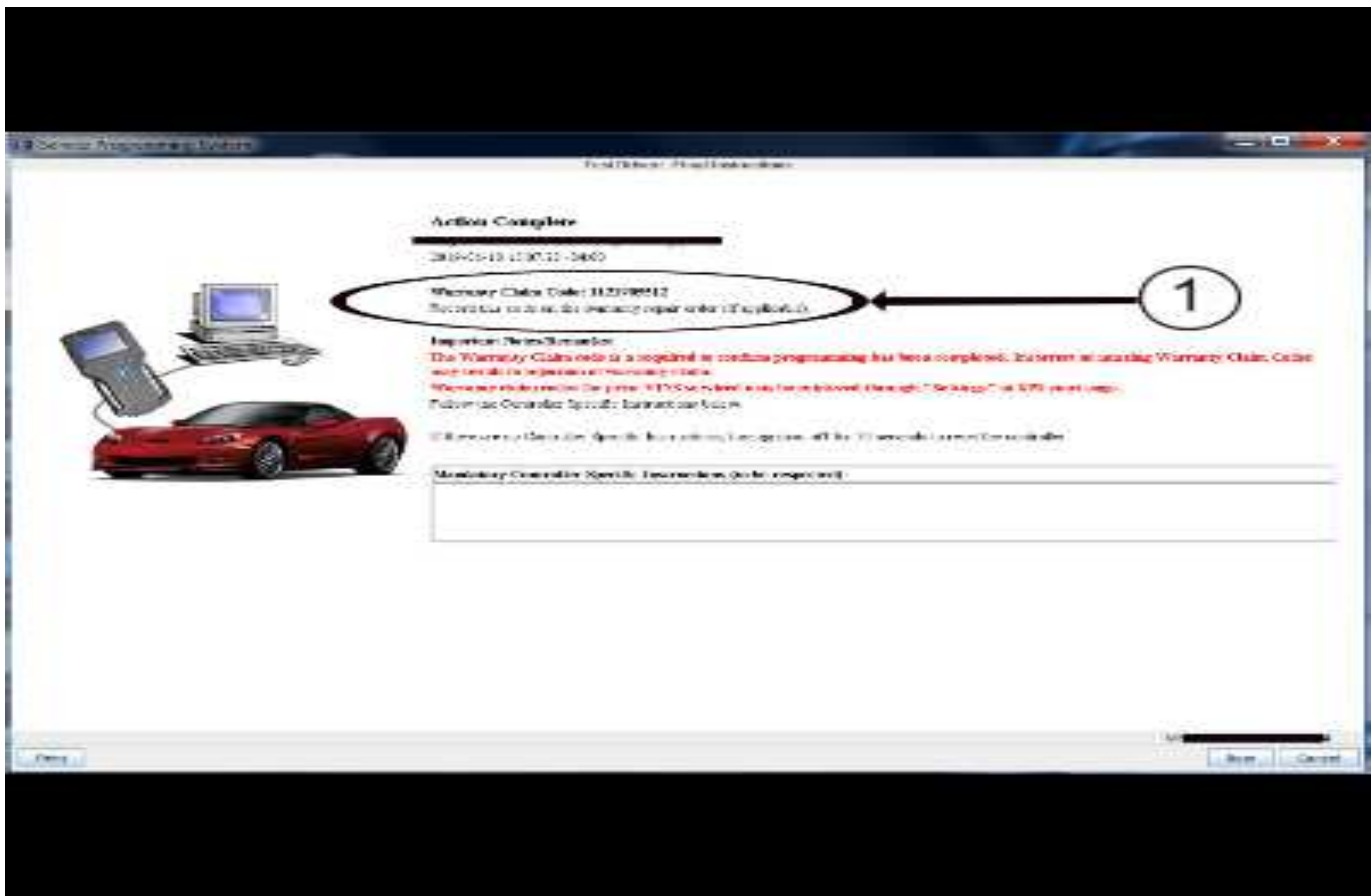
5431209

**Important:** To avoid warranty transaction rejections, you **MUST** record the warranty claim code provided on the SPS Warranty Claim Code (WCC) screen on the job card. Refer to callout 1 above for the location of the WCC on the SPS screen

2. Record SPS Warranty Claim Code on job card for warranty transaction submission.
