20 EVAP charcoal filter line (N80) - ticking/thumping noise in passenger compartment (rear) - V6 3.0 TFSI 20 23 64 2067759/3 December 12, 2023. Supersedes Technical Service Bulletin Group 20 number 23-60 dated May 5, 2023 for reasons listed below.

Model(s)	Year	VIN Range	Vehicle-Specific Equipment	
Q8	2019 – 2025		Not applicable	
SQ8	2024 - 2025	All	Not applicable

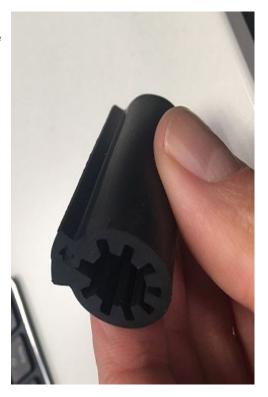
Figure 1: Sleeve 4KD 201 255.

1. Fit sleeves (figures 1, 2) with part number 4KD 201 255 on the activated charcoal filter line (figure 3, item 8).

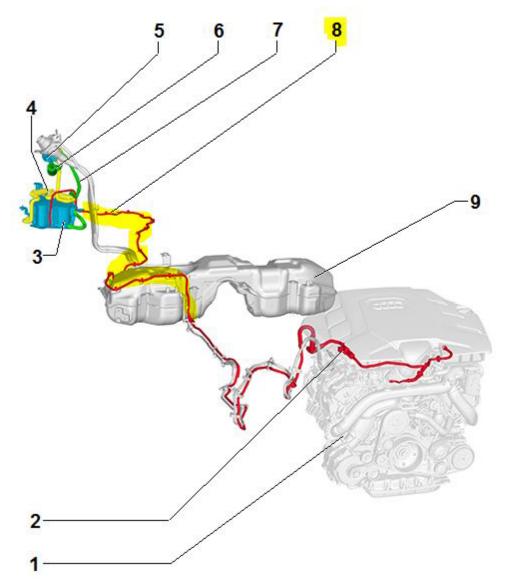
• The activated charcoal filter solenoid valve (N80) vibrates the activated charcoal filter line; this results in a ticking and/or thumping noise.

Figure 3: Sleeve installation location is highlighted.

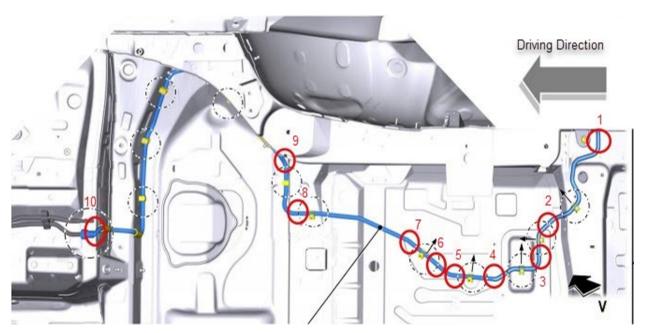
Figure 4: Vehicles without air suspension and without rear wheel steering (PR no. 1BL) - 10 sleeves.

2. The number of sleeves depends on the equipment version of the vehicle (PR number) when it was manufactured. Use the following overviews (figures 4, 5, and 6) to determine how many sleeves are required and their positions.

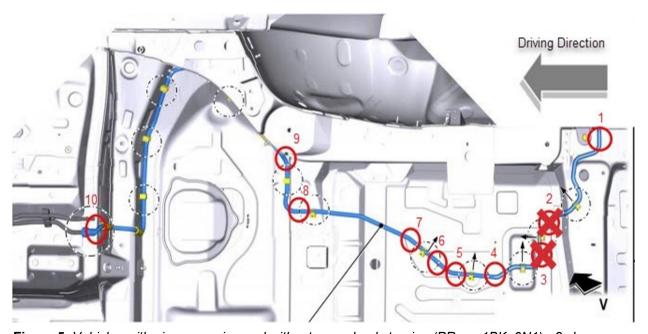
Figure 5: Vehicles with air suspension and without rear wheel steering (PR no. 1BK, 0N1) - 8 sleeves.

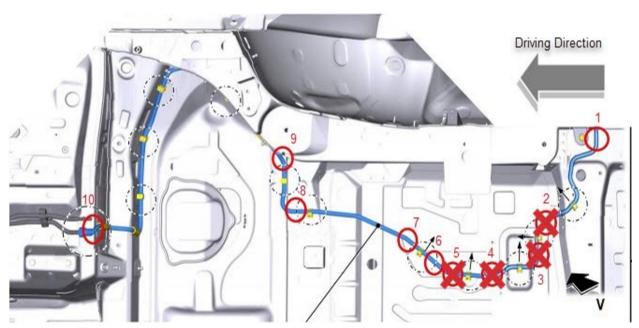
Figure 6: Vehicles with air suspension and with rear wheel steering (PR no. 1BK, 0N5) - 6 sleeves.
