34 Function restriction with event memory entry P071800 - P276800 (symptom 20736 - 20737)

34 23 66 2067653/5 December 12, 2023. Supersedes Technical Service Bulletin Group 34 number 23-64 dated November 1, 2023 for reasons listed below.

Model(s)	Year	VIN Range	Vehicle-Specific Equipment
A4, A4 allroad, A5, A5 Cabriolet, A5 Sportback, A6, A6 allroad, A7, Q5, and Q5 e quattro	2020 – 2023	All	Not Applicable
Q5 Sportback	2021 – 2023		
A7 e quattro	2021 – 2022

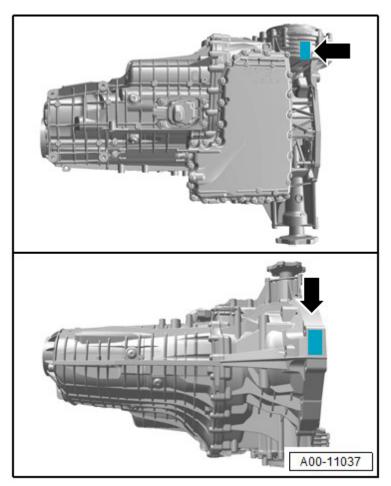
- First determine if the Transmission was built within the date range of June 15, 2020, and April 30, 2023.
- Check one of the transmission data stamps which are located on the bottom of the front differential and the top of the bell housing (Figure 1).

Figure 1. Locations of data stampings.

The Data Stamping contains the following information:

Production Data: 006SVHC021170K180228

Transmission Code: SVH

Serial Number: C021170K

Production Date: 28.02.2018. Day/Month/Year format. Example shown would be February 28th 2018.
