Preliminary Information

PIT5999B Intermittent Audio On IOK Radio: 1-2 Seconds Of Audio Cut Out

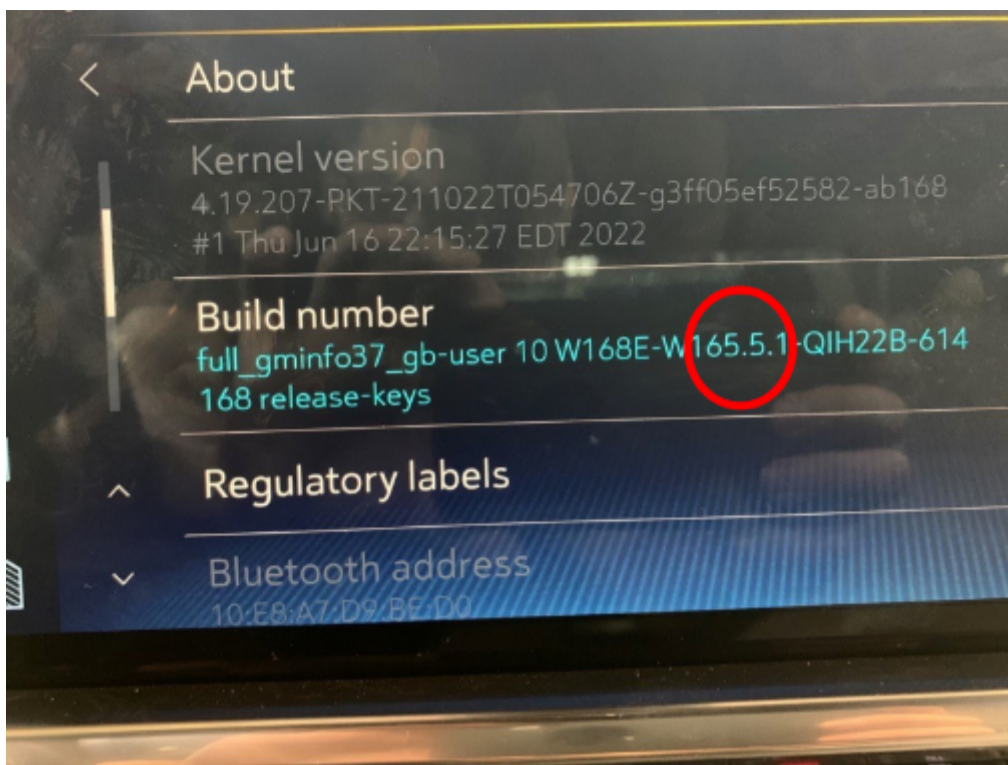
Inspect the current radio software version. Navigate to Settings -> About -> Build Number -> Information "i" to view and verify the software version.

If the build number is less than Y167, update the radio software.
