PIP5847B Diagnostic Tip: Abnormal Engine Ticking or Tapping Noise From Cam Carrier Area And Possible Misfire Or Rough Run With DTC P0300 or P050D

Brand:	Model:	Model Years:	VIN:		Engine:	Transmissions:
			from	to		
Chevrolet	Silverado	2019 - 2024	All	All	2.7 L3B	All
GMC	Sierra	2019 - 2024	All	All	2.7 L3B	All

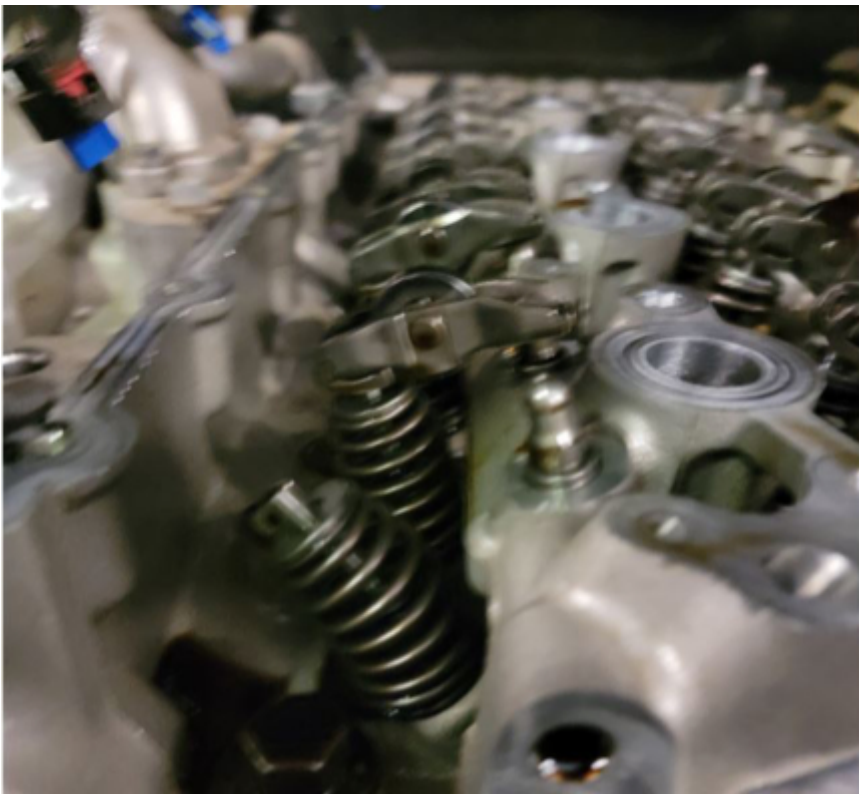
Once the Cam Carrier has been removed inspect each of the Exhaust Follower rollers for increased wear or up and down movement in the roller. The excessive up/down movement is an indication of increased axle pin wear and in worst cases the rollers can come out of position leading to a bent valve or damaged valve stem.

(Picture below showing bent valve due to worn Exhaust Roller Follower)

If a worn Exhaust Roller Follower is found, replace all 8 of the Exhaust Hydraulic Lash adjusters and Exhaust Followers. Also the Exhaust Camshaft should be inspected at this time for damage or premature wear caused by this concern.

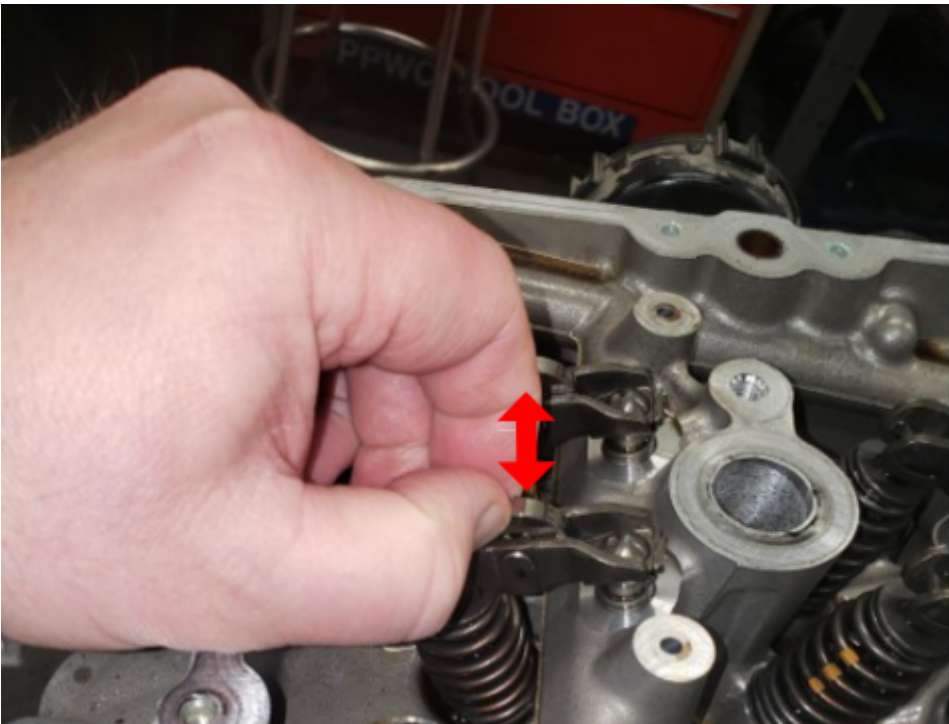
(Picture below shows a typical method used to check for worn roller followers)

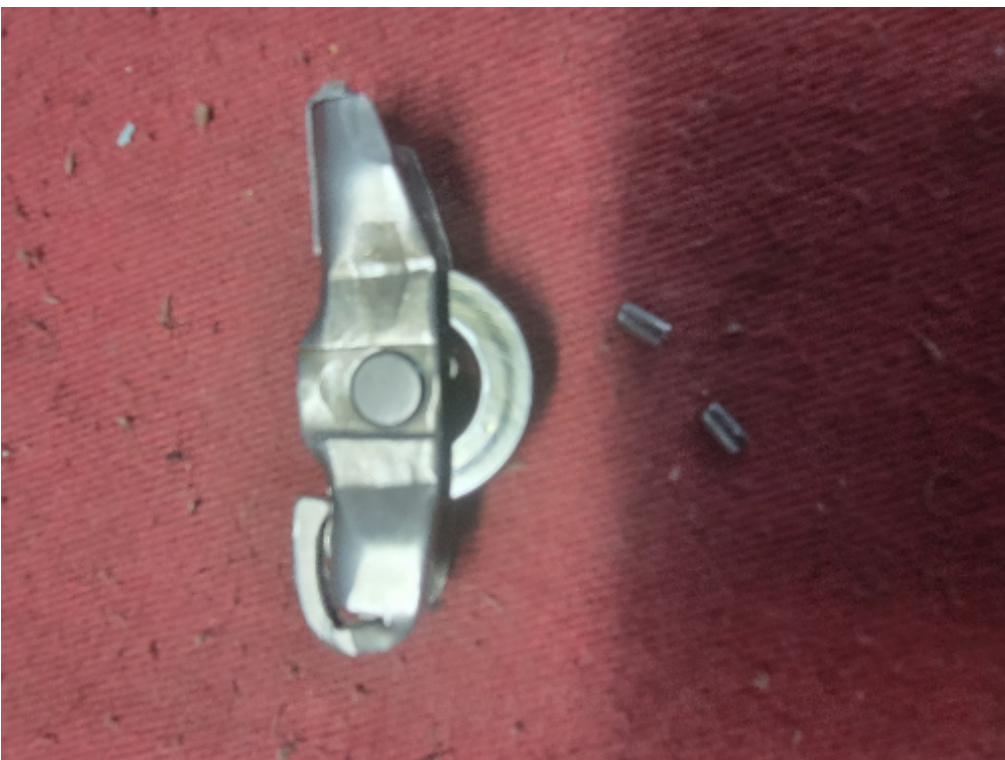
(Picture below shows example of excessive axle pin wear)

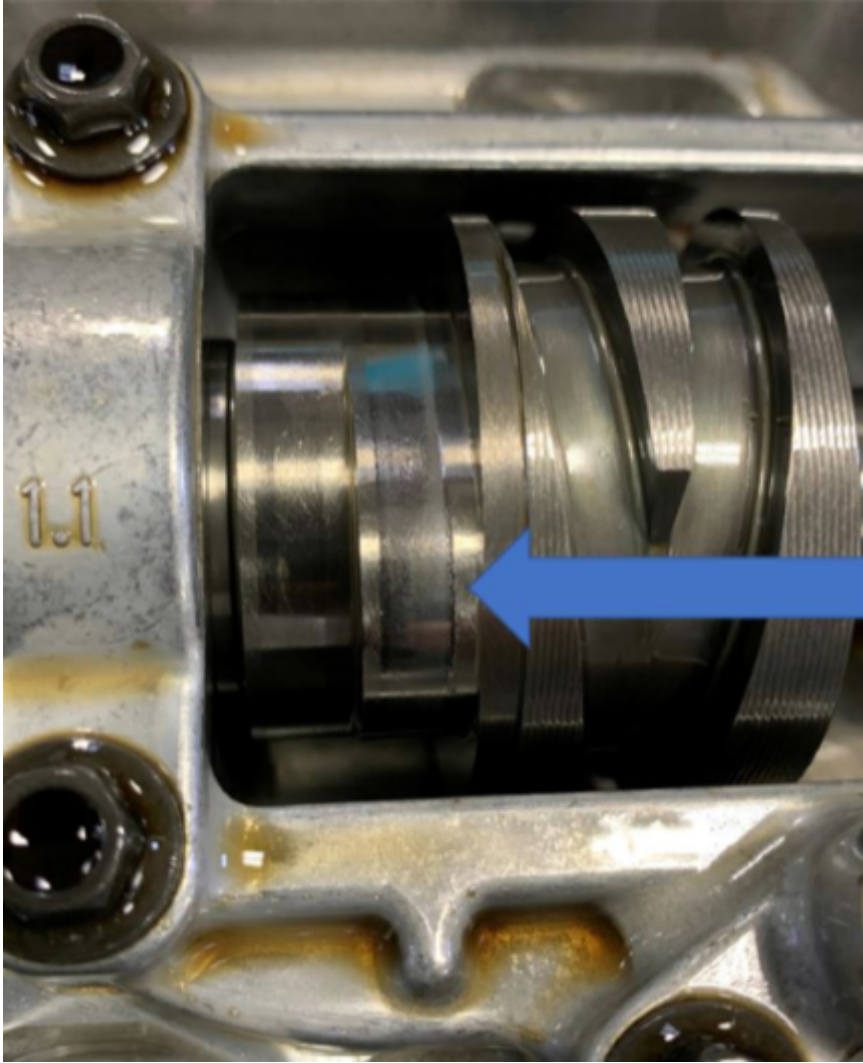
(Blue arrow in picture below showing Exhaust Cam lobe wear due to worn roller follower)
