## STAR ONLINE PUBLICATION

**Case Number:** S2323000078

**Symptom/Vehicle Issue:** Squeak from the Center Console Area

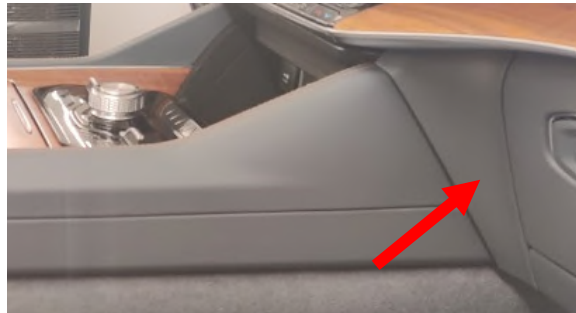
**Diagnosis:** Noise is heard over bump where the console meets the shifter bezel

**Repair Procedure:** Remove both right and left side trim where console meets

The instrument panel
