## STAR ONLINE PUBLICATION

Case Number: S1808000057 Rev. A

**Symptom/Vehicle Issue:** Inspecting And Disconnecting Negative Battery Cables On ESS Vehicles

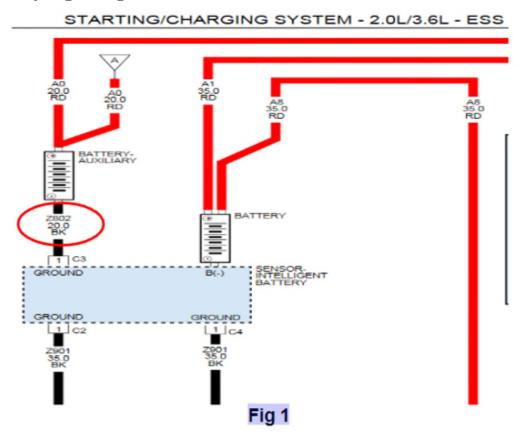
**Discussion**: When performing circuit testing that requires disconnecting the battery(s) on ESS vehicles, disconnect both negative battery connections from the primary and auxiliary battery Fig 1, Fig 2, Z802 circuit.
