Case Number: S2308000123

Symptom/Vehicle Issue: No crank/No start with no DTC's

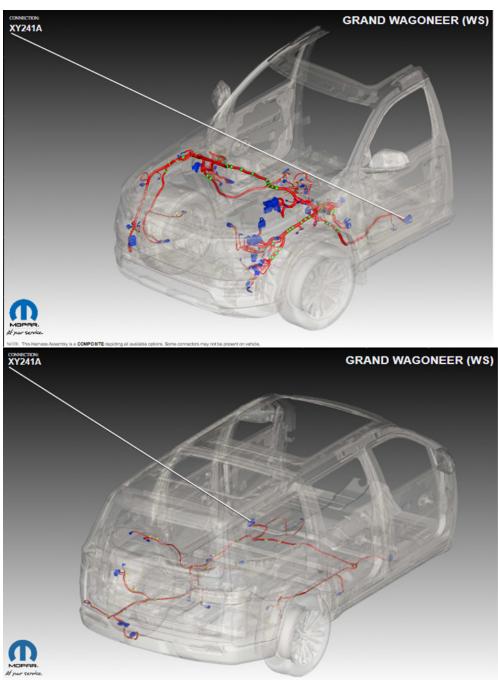
Customer Complaint/Technician Observation: The customer may experience a No crank/No start. Upon investigation the technician will not see any related DTC's to the vehicles no start.

Discussion: Locate the XY241A inline connector, located behind driver's seat. Inspect the wire loom cap for damage or mis-installation. If there is damage present, open the loom cap and inspect all wires for damage. If damage is found, repair as necessary.

Repair Procedure: Perform wire repairs as necessary, depending on the damage observed.
