STAR ONLINE PUBLICATION

Case Number: S238A000051

Release Date: October 2023

Symptom/Vehicle Issue: The customer may observe SAT radio is not operating.

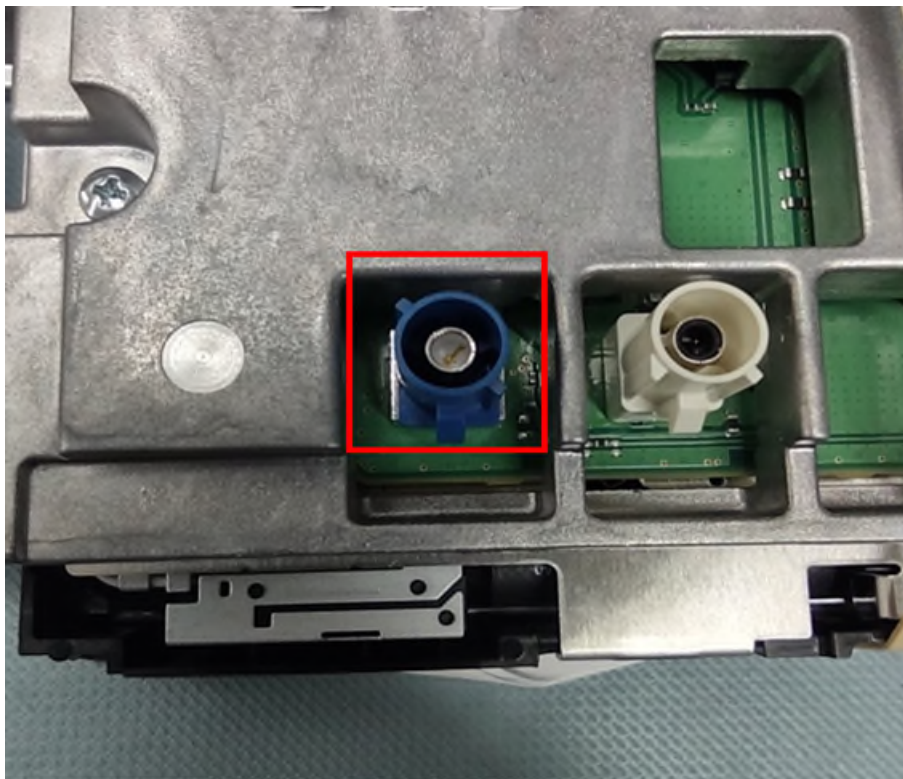
Fig 1

Bent pin may affect SAT operations. If dealer finds a satellite issue, disconnect the radio and confirm the blue (FAKRA) connector is intact and pin is not bend.
